SERVICE BULLETIN

NUMBER: 03-94-24

SUBJECT: Front Transverse Link Bushing Cracking

DATE: 09/04/24

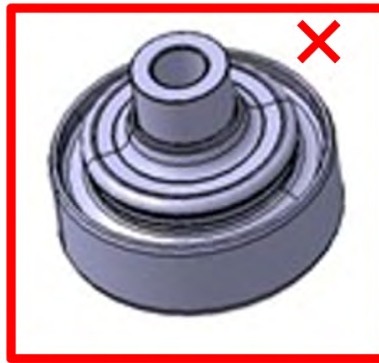
IMPORTANT: The information supplied in this bulletin does **NOT** apply to pillow ball type bushings.

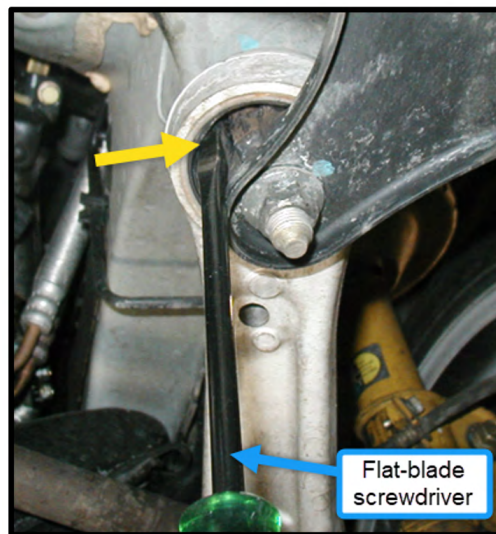
STEP 1: Insert a large flat-blade screwdriver into the bushing and slightly widen the crack.

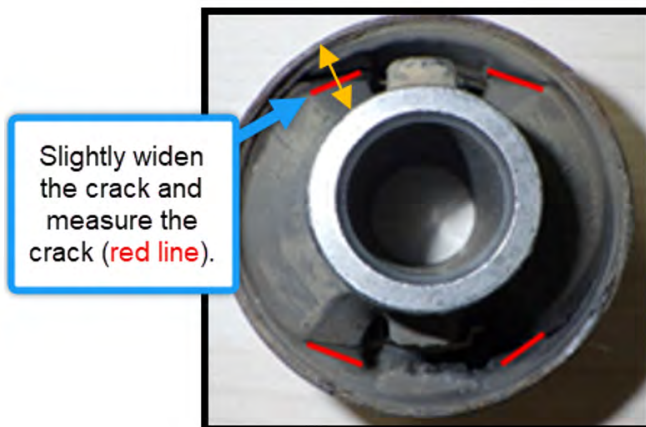
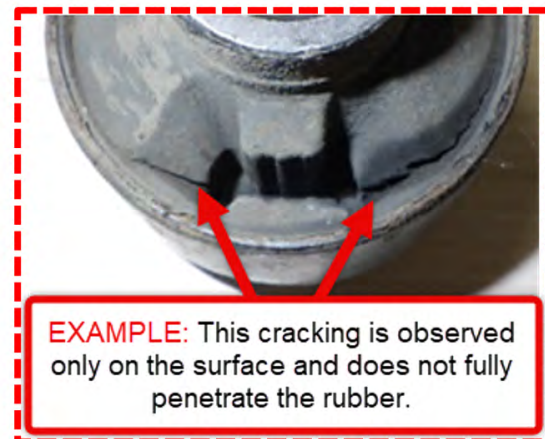
STEP 2: Measure the width of the cracked section(s).

NOTE: Qualifying cracks will penetrate through the rubber section from side to side. Surface cracks are not applicable and require no service procedure.

Cracks with a width greater than **13mm (1/2 inch)** will have an impact on the vehicle ride quality and will require replacement. Cracks with a width of **13mm (1/2 inch)** or less will not cause any functional concerns and will NOT require replacement.
