SERVICE BULLETIN

APPLICABILITY: 2023-24MY Legacy 2.4L
 2023-24MY Outback 2.4L
 2023-24MY Ascent
 2023-24MY WRX

NUMBER: 16-150-24
DATE: 09/13/24

SUBJECT: Transmission Control Module (TCM) / Software Enhancement

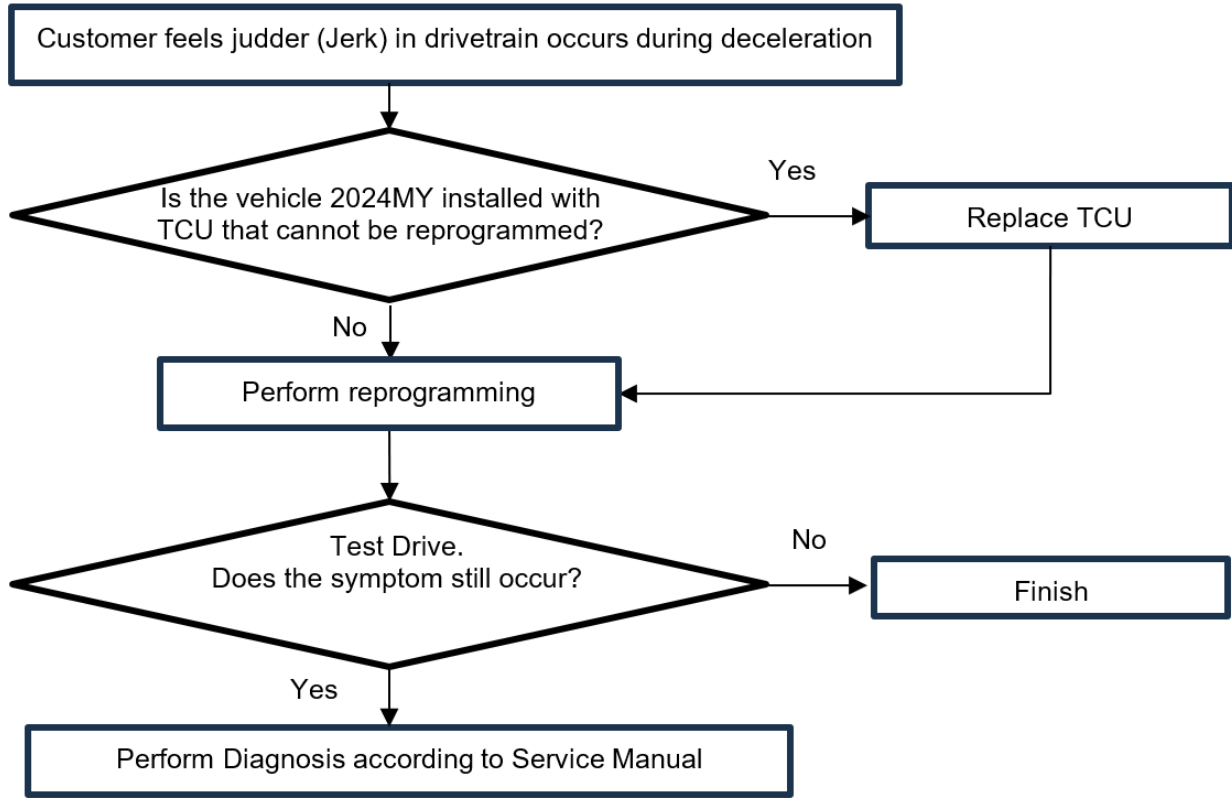
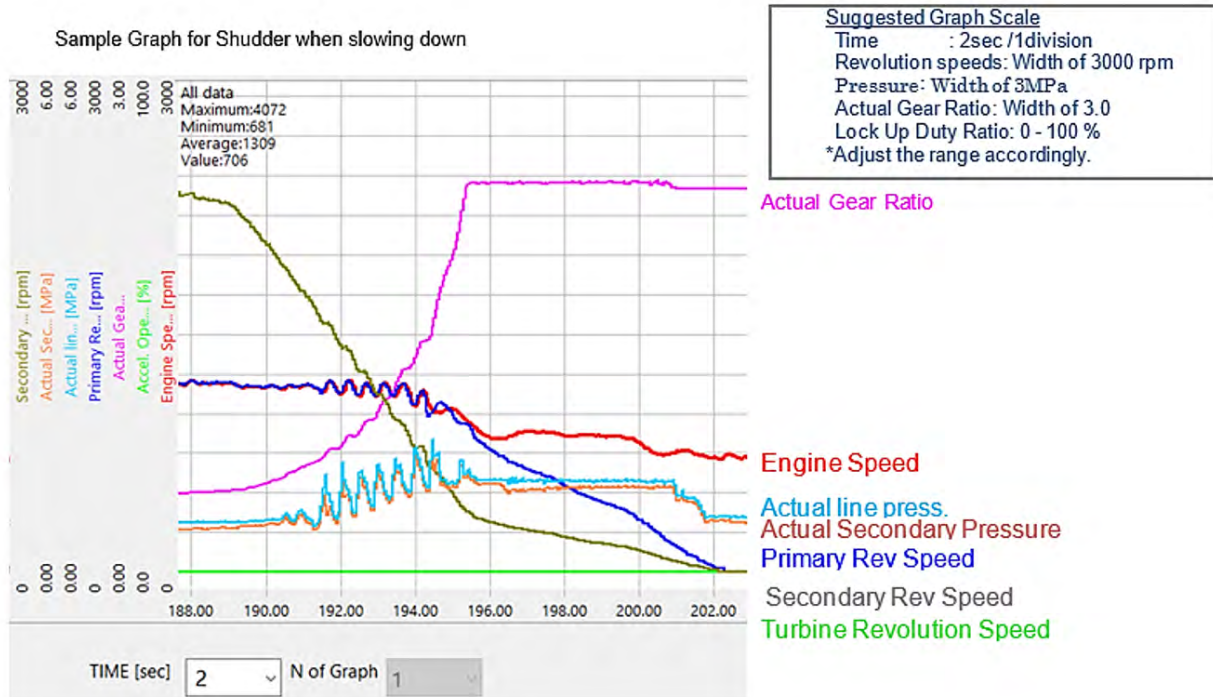
SYMPTOM 1: A jerk or judder sensation felt from the powertrain during braking with the air conditioning on.

Reference: Judgement Criteria

Actual line press. and Actual Secondary Pressure are fluctuating while feeling shudder when slowing down

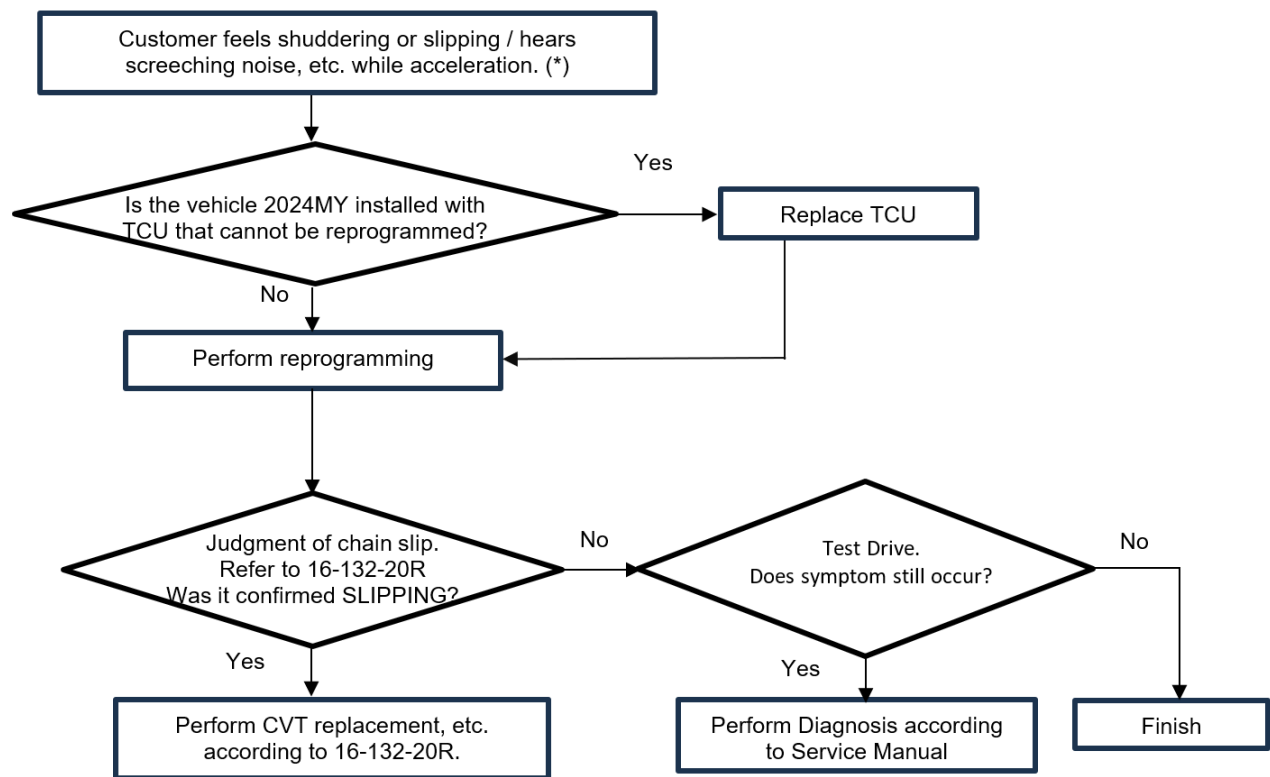
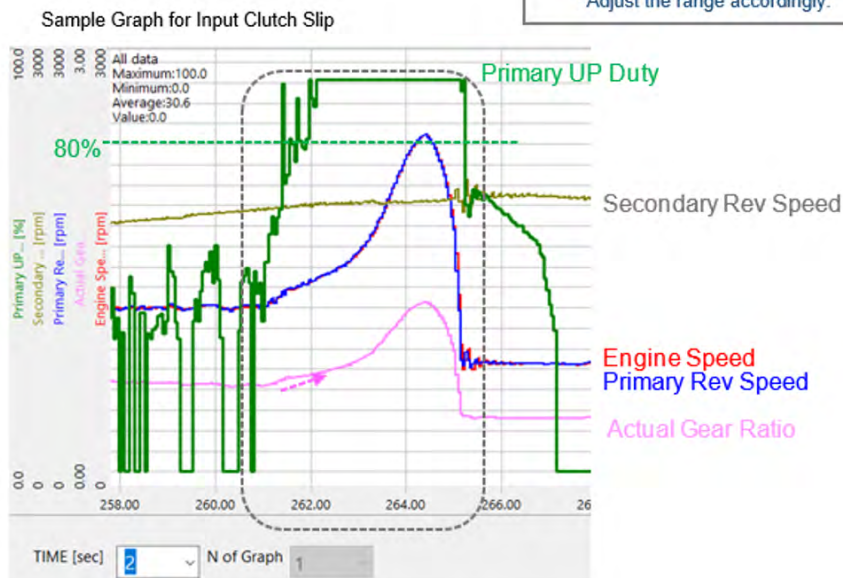
SYMPTOM 2:

SYPMTOM 2: A shudder is felt from the powertrain along with a screeching type of sound.

(*) **NOTE:** In case of chain slip caused by input clutch slip, customers may experience symptoms under the following driving conditions.

- (1) Constant speed driving between 25 and 62 mph.
- (2) Gentle acceleration between 25 and 62 mph.

Reference: Judgement Criteria

- All of the following are satisfied.
- Primary UP Duty > 80 %
 - Actual Pulley Ratio changes to Low
 - Above conditions last for 0.5sec or more
