SERVICE BULLETIN

APPLICABILITY: 2019-24MY Forester

NUMBER: 12-255-24R

SUBJECT: Knocking Type Sound from Engine Compartment

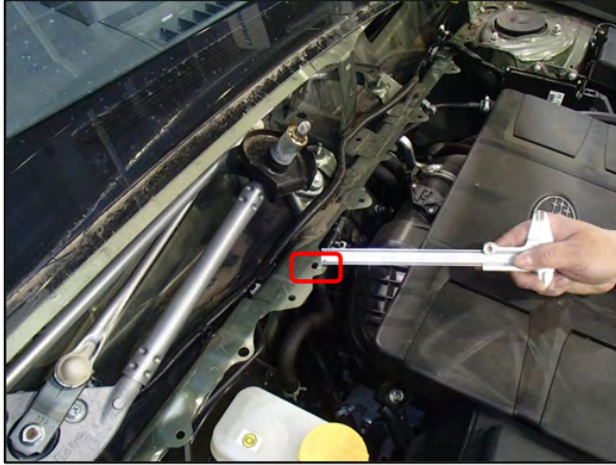
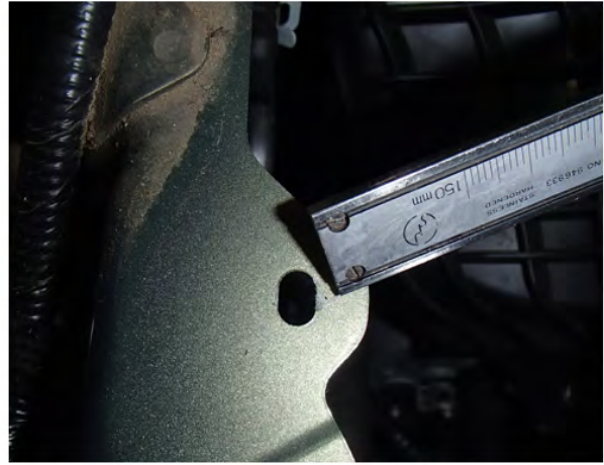
STEP 3: Locate the elongated dowel hole on the passenger side. This is the receiving hole for the passenger side dowel pin.
