SERVICE BULLETIN

APPLICABILITY: 2019-24MY Ascent

NUMBER: 06-92-24R

SUBJECT: Front Brake Pulsation/Squeal Diagnosis & Repair Front Brake Warranty Extension

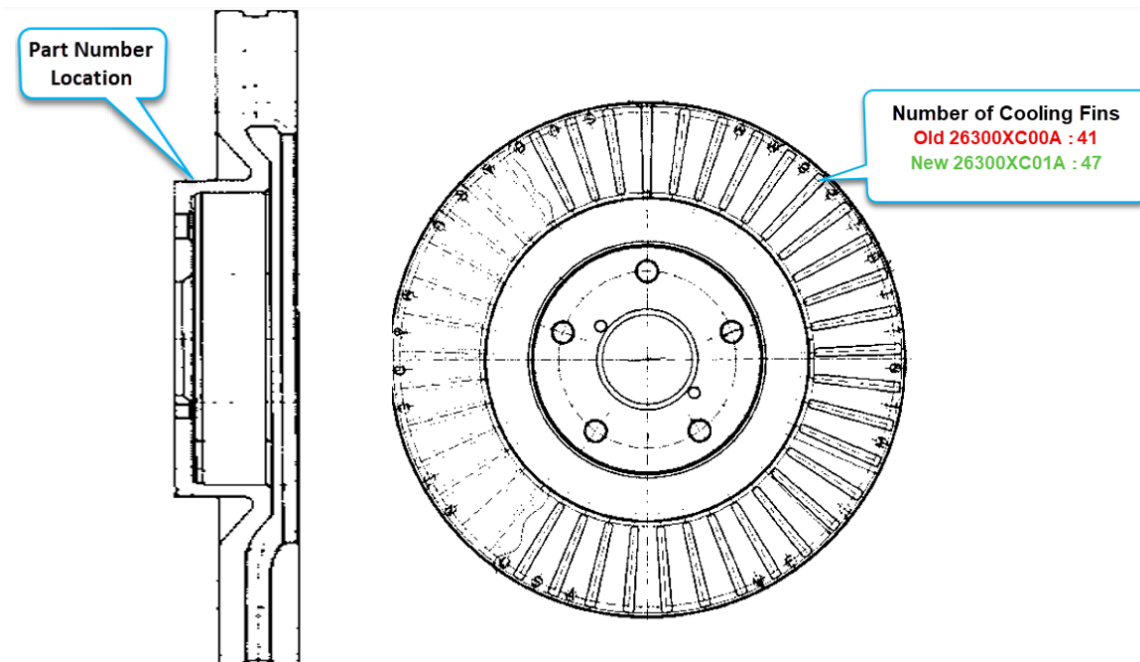
STEP 2: Raise the vehicle using the lift manufacturer's specified procedures. Remove both front wheels. Inspect the brake disc part numbers to confirm the brake disc version currently installed on the vehicle. See the images below for part number location.

NOTE: The new parts have 47 cooling fins, and the old parts have 41 cooling fins.

YES: Resurface the brake discs using a Subaru approved brake lathe. Perform a road test and confirm there **is** no front brake squeal/pulsation. **Record and note the before and after brake thickness.** **IMPORTANT: ALWAYS** use an approved brake lathe. A list of approved equipment can be found on the Subaru tools and equipment site: <https://subaruretailersolutions.com/equipment/category/601>

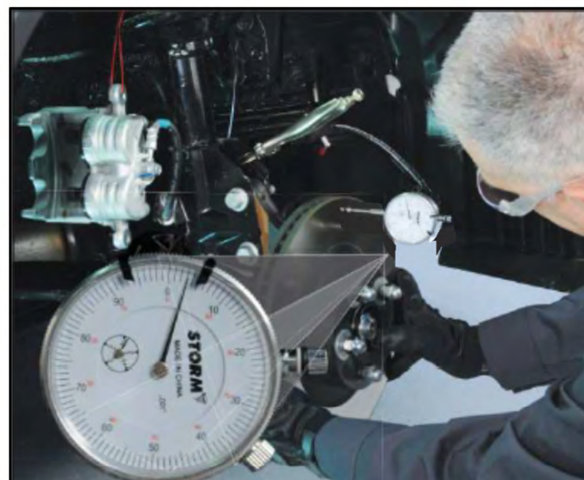
STEP 8: Install the new brake disc. Secure the disc to the hub using the five lug nuts in conjunction with matching suitable washers. Torque the lug nuts in a star pattern to **120 Nm (88.5ft-lb)**. Using a dial gauge, inspect the outer brake disc runout. Confirm the observed measurement does not exceed 0.05 mm (0.002 inch). If the measurement exceeds the specified value, remove the brake disc from the hub. Using the wheel studs as a guide, rotate the disc clockwise one wheel stud position and reinstall the brake disc. Inspect the runout using the procedures described above. The brake disc position can be rotated up to 4 more times to confirm the position with the least amount of runout. Install the brake disc at this position. In rare cases of the measurement not reading within specification after the five position inspection, exchange the brake disc **with the** other side of the vehicle and repeat the measurement. If the measurement continues to produce results out of specifications, replace the brake disc. **Record and note all measurements.**

IMPORTANT: For best accuracy, the runout measurement should be taken 10mm from the outer circumference of the brake disc. See the example image below.
