## Preview Solution CBR-570-6

### **US17 GHG Common Rail Fuel System Component Electrical Faults - Model Year 2017 To 2024**

Published 20 September 2024

Valid for Volvo models VN,VAH,VHD Mack models AN,GR,GU,LR,CHU,CXU,PI,MRU,TE model years 2017 to 2024

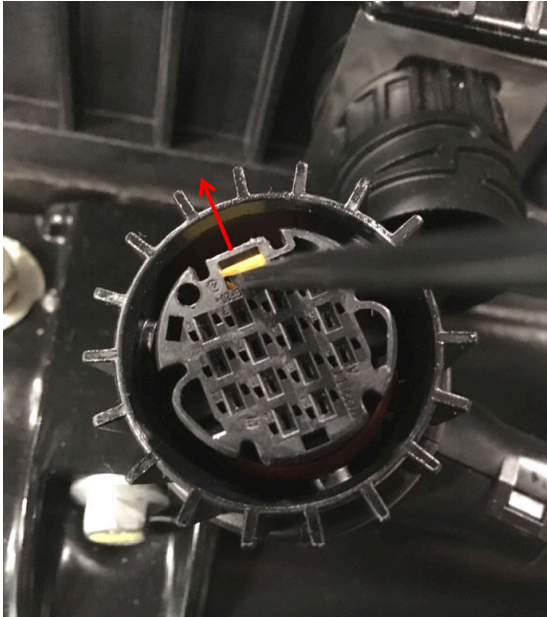
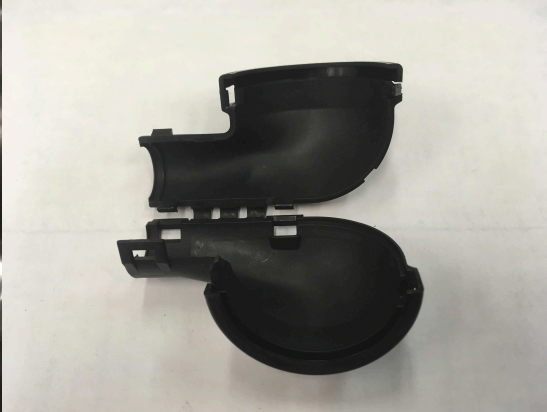
Follow Guided Diagnostics for any of these components with associated electrical faults. However, the cause for some of these faults has been identified with terminals not locked properly in place on the VCI 1 and VCI 2 connector. The VCI connectors are located on the lower valve cover base. The plastic wire cover on the connector should be removed for better visual inspection. This is an area where special attention should be taken to inspect for an issue.

Examples of terminals not properly locked in the VCI connectors causing electrical faults. See pictures below

Remove terminal completely from the VCI connector and inspect the locking tab. (see picture below) If the tabs are ok reinsert the terminal in the VCI connector and pull on wire with steady force to ensure positive lock of the terminal. Push the yellow lock tab back down when completed.
