SER24-044 Rev B
9/9/2024

SUBJECT: X4 7300/7500 SV4 Tube Assembly/Coolant Tube Contact

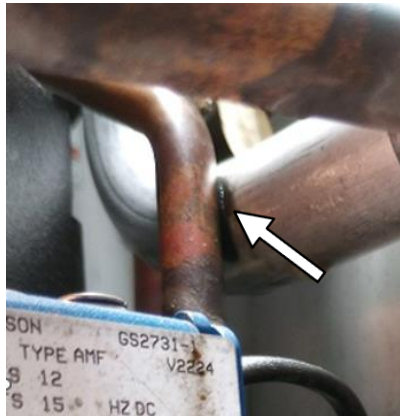
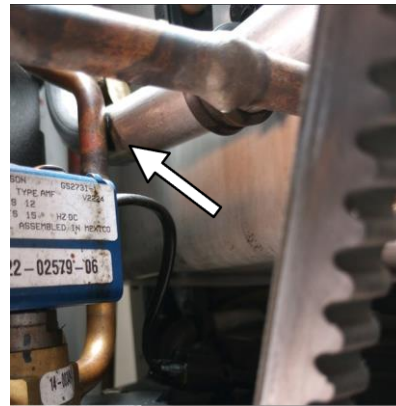
Certain X4 trailer refrigeration units (VAN91741971 to VAP91749838) may require the SV4 tube assembly to be inspected and adjusted to ensure no contact exists between the engine coolant tube and SV4 tube assembly. In limited cases, the SV4 tube assembly may require repair. See images below.

Repair Scenarios		
Scenario 1	Scenario 2	Scenario 3
Inspect/adjust SV4 tube assembly	Inspect/adjust SV4 tube assembly Repair refrigerant leak	Inspect/adjust SV4 tube assembly Repair refrigerant leak Replace engine coolant tube
\$45.50	\$182.00 + Parts	\$364.00 + Parts
