Countries: CANADA, UNITED STATES Document ID: IK1201498
 Availability: ISIS, IsSIR Revision: 0
 Major System: ENGINE Created: 6/3/2024
 Current Language: English Last Modified: 9/20/2024
 Other Languages: NONE Author: Greg Scheff
 Viewed: 126

Title: Adding a Shim to Certain Crankshaft Position Sensors (CKP) on A26B Engines

Applies To: Low mileage A26B engines

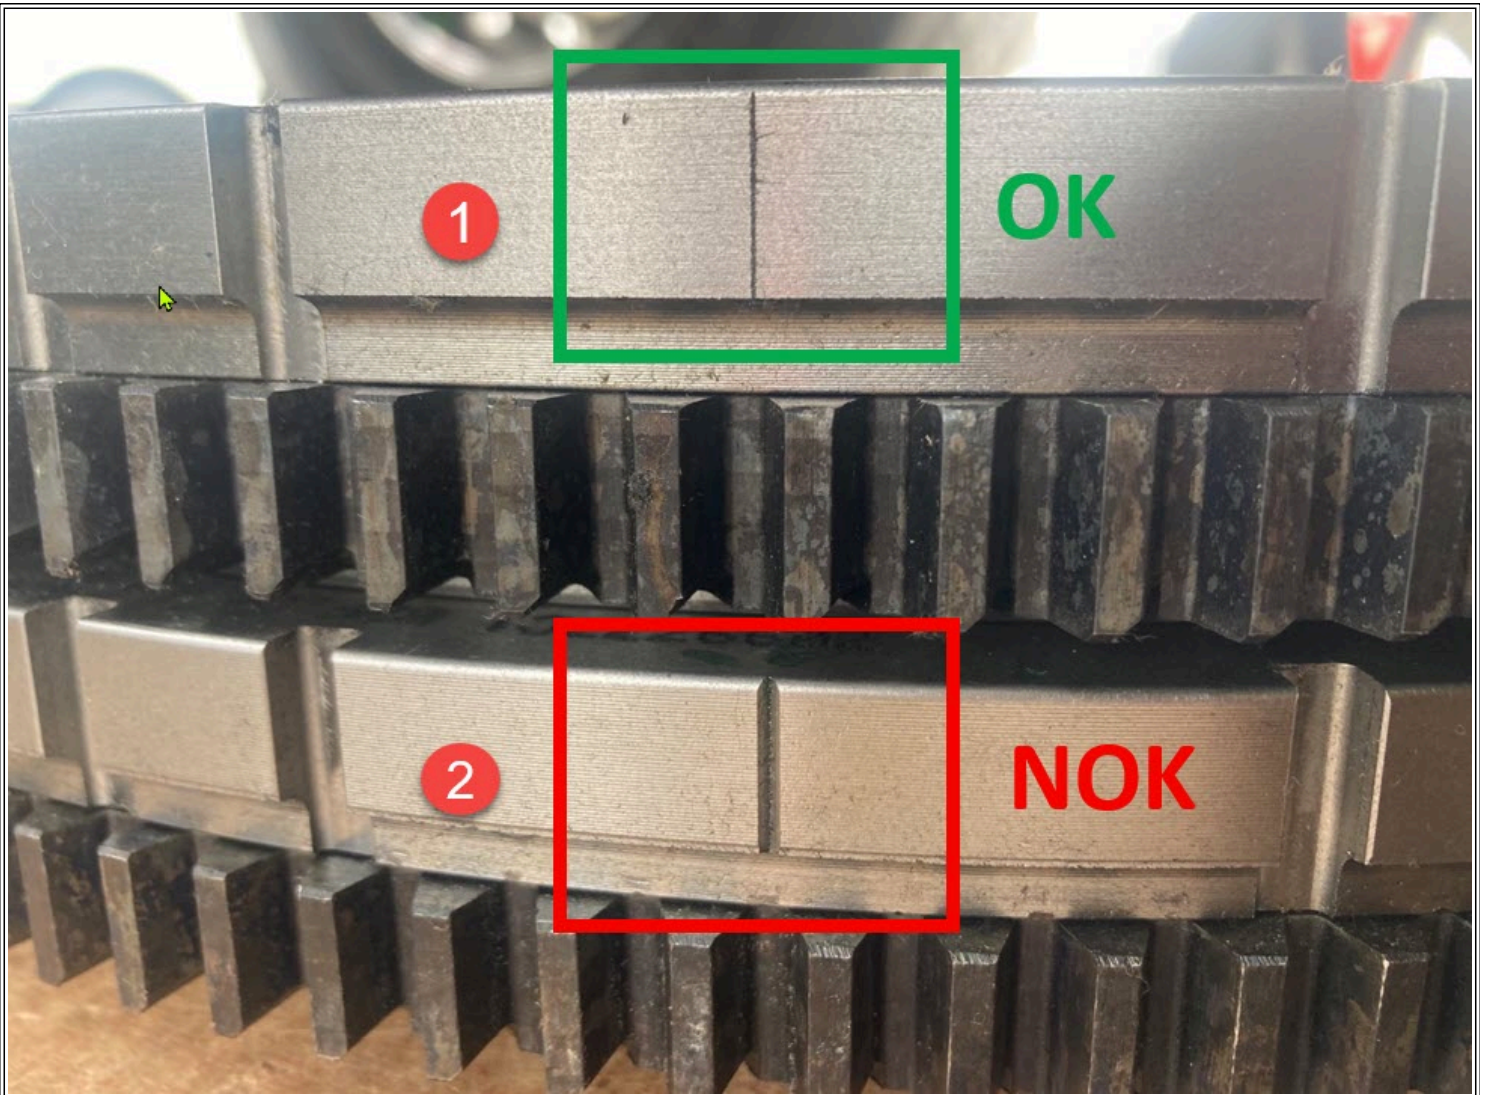
Figure #1: Flywheel TDC Stamp

Step	Action	Decision
#2	<p>DIAGNOSTIC: Inspect the TDC stamping on the Flywheel</p> <p>Remove the inspection cover from the bottom of the flywheel housing, bar the engine over to TDC.</p> <p>Visually inspect the TDC stamp and compare to Figure #1 below. If required, measure the depth and the width to see if it is within specifications.</p> <p>Maximum Width: 0.55mm Maximum Depth: 0.275mm</p> <p>Is the TDC mark within specifications?</p>	<p>Yes. Continue through published diagnostics for any DTC's that are present. If no resolution is found consider opening a tech service case file for further assistance.</p>
		<p>No. Continue to step 3</p>

Item 1: OK, mark is very light and narrow. Slightly more than a simple scribe marking

Item 2: NOT OK, mark is very deep and wide, when measured is out of specification listed in step 2

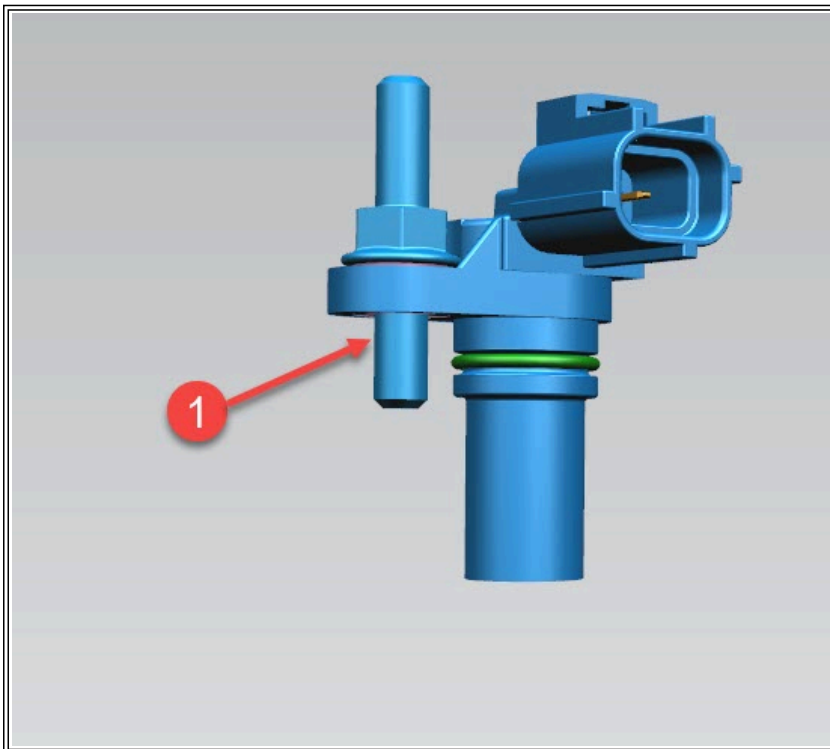
Figure #2: Timing Sensor Shim Location

Item 1: Shim to be installed here, around the sensor hold down bolt

Step	Action	Decision
	<p>DIAGNOSTIC: Install a 0.50mm shim under the crankshaft position sensor hold down bolt.</p> <p>Remove the crankshaft position sensor from the flywheel housing. Insure the sensor tip is clean and undamaged. Install the 7108581C1 shim under the sensor and around the hold down bolt (Figure #2 Item 1). This will lift the sensor from the housing 0.50mm.</p> <p>Install the shimmed sensor and torque the bolt to 13 +/- 1.3 Nm then retest for the condition.</p>	<p>Yes. Clear any DTC's and return the unit to service.</p>
#4	<p>Did installing the shim resolve the operational complaint?</p>	<p>No. Consider opening a tech service case file for further assistance.</p>
