# WARRANTY BULLETIN

**NO:** D-23-04  
**DATE:** October 2, 2024

**SUBJECT:** 2018 - 2024 (Current) Jeep  
Wrangler (JL) and 2020 - 2024 (Current)  
Jeep Gladiator (JT) - Corrosion Warranty  
Claim Simplification (Rev. E)

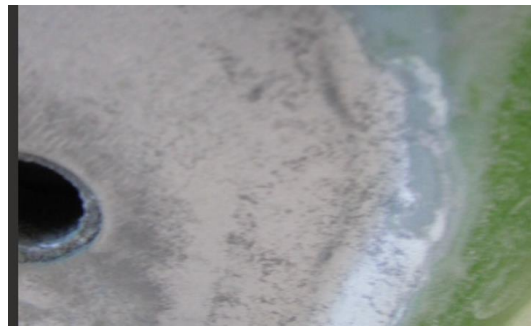
1. Pitting found after sanding the affected area (Fig. 1)

**Pitting Found After Sanding Example (Fig. 1)**

Note: If pitting is found during the sanding process, please use LOP 23-75-XX-XX for up to 0.5 hours in conjunction with the 23-85 replacement LOP.

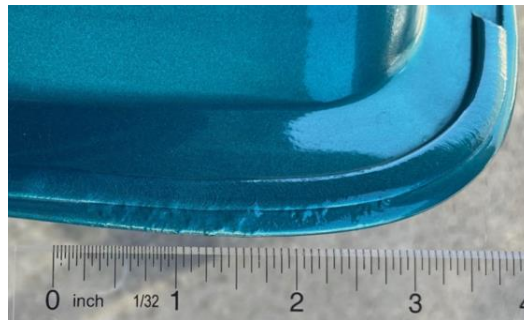
## 2. Corrosion found on the seam of the panel (Fig. 2)

Seam Panel Area Examples (Fig. 2)

Note: If corrosion is found on the seam of the panel, the door shell will be replaced. No additional sanding in the hinge or seam area is supported.

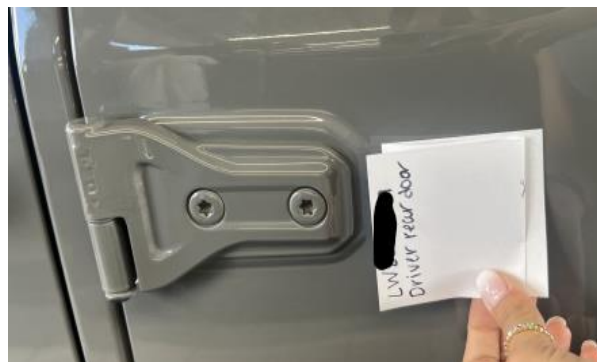
VIN Example (Fig. 3)

Dealers will need to take photos of the affected areas identified during the inspection to support the repair. A clear photo of the corrosion is needed and **MUST** include the VIN and affected body panel. The VIN and affected body panel can be included on a sticky note, written with a grease pen, a copy of the RO in the photo, masking tape, etc. (Figure 3)
