Field campaign

Topic	Emergency call module and communication unit (0075) - Software update - Dongle removal (SC24/13)
Market area	United States E05 Bentley USA and rest America (6E05)
Brand	Bentley
Transaction No.	2073967/2
Campaign number	ED06
Note	
Type	
US code

Bentayga Series

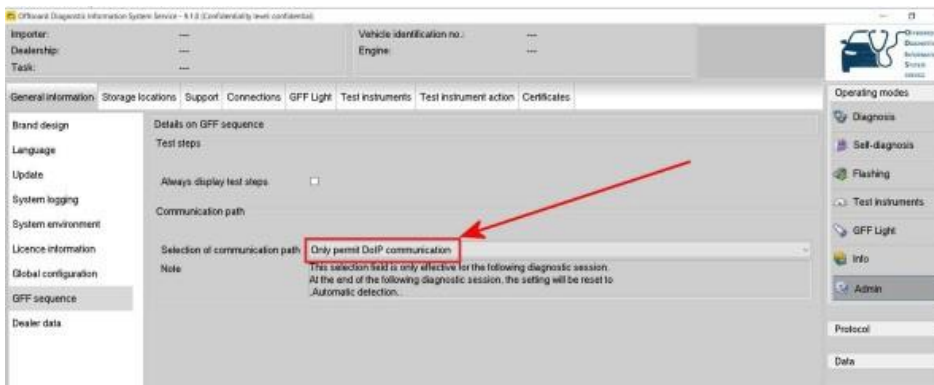
Figure 2

VERY IMPORTANT: Before conducting the onward instructions / entering the SVM code, the operative **MUST** recheck the DoIP set up in ODIS and ensure that DoIP is selected (Figure 2) before proceeding

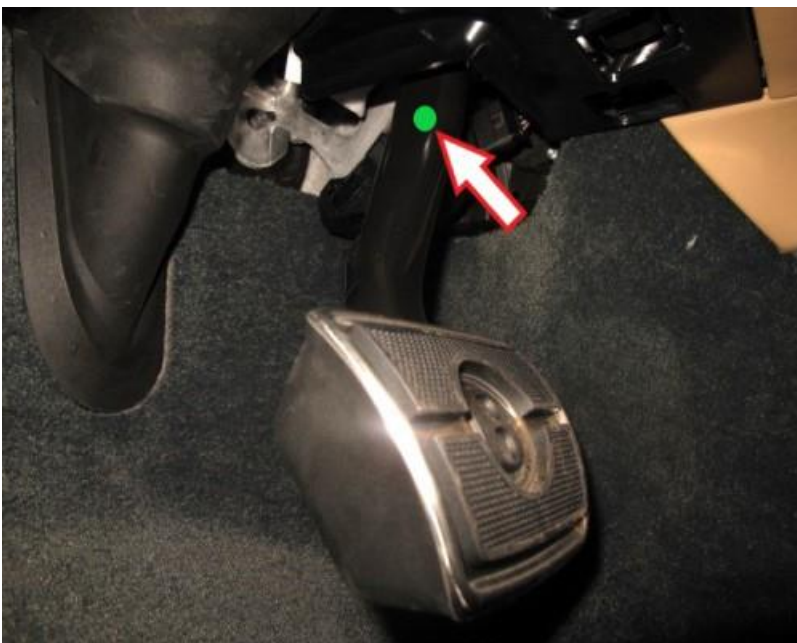
Green paint completion mark at the location shown in Figure 6 confirms completion

11) Apply a green paint completion mark on the brake pedal arm as shown in Figure 6
