RCA-18-24-001-1: Tighten Hub to Knuckle Fasteners

Document Type	Customer Satisfaction Campaign Bulletin	
Date	September 20, 2024	
Affected Region(s)	USA, Canada	
Affected Model(s)	R1T, R1S	
Model Year(s)	2023-2024	
Approximate Build Dates Refer to Open Containments in ServiceOS to	March 2023-February 2024	
determine if this document applies to a specific vehicle.		
Vehicle System	18 - Suspension	
Minimum Service Location	Mobile

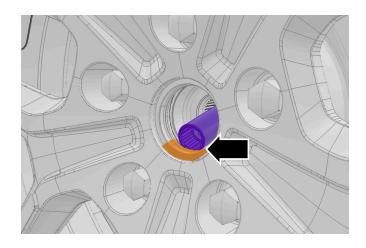
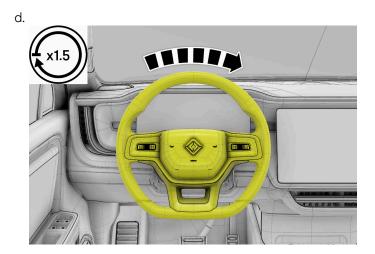
Rivian is initiating a customer satisfaction campaign for some model year 2023-2024 R1T and R1S vehicles. On these vehicles, the wheel hub to knuckle joint may have been assembled with an updated fastener using a torque value intended for the previously-used fastener. A fastener torqued to the previously-used lower value may cause an audible noise while driving at low speeds but will not impact vehicle performance. Rivian will retorque the affected fasteners. Rivian is launching this campaign for customer satisfaction and to ensure the quality of Rivian vehicles.

e. At the rear of the component: Tighten:

Tip: Use a 3/8 inch drive socket and a 1/2 to 3/8 inch adapter.
