## Preview Solution CBR-407-7

### Mack Chassis - Correcting The (ABS) MID 136 SID 66 FMI 7 Fault Code

Published 13 September 2024

Valid for all Mack models with equipped with ABS

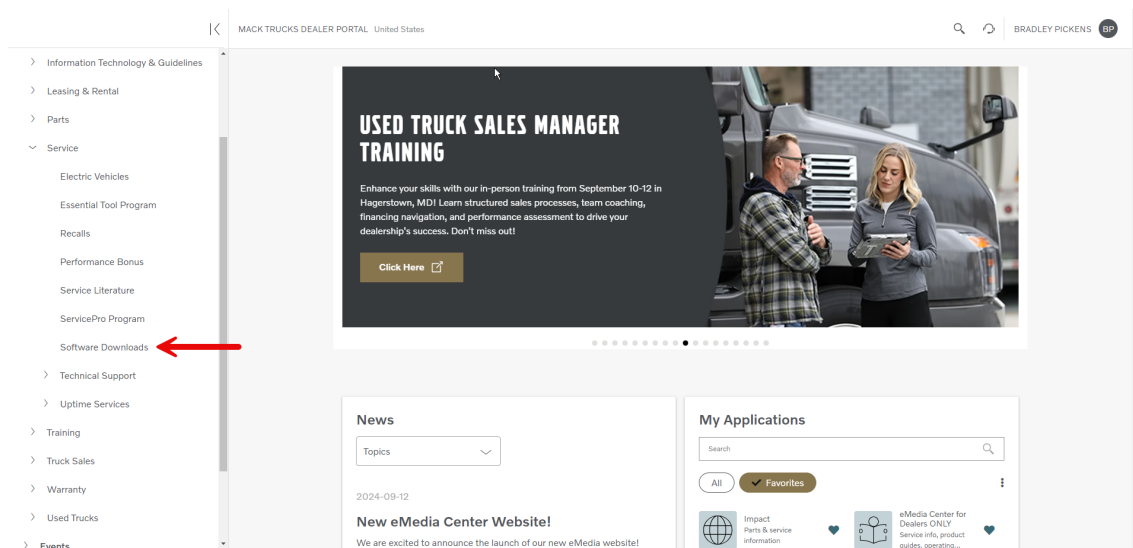
To correct the MID136 SID 66 FMI 7 fault code the latest Bendix VCP file will need to be downloaded.

From TDP (Trucks Dealer Portal) Click on the Information Tab - Service - Software Downloads - Bendix VCP, install it on the Tech Tool laptop and then reprogram the ABS ECU.
