Technical product information

| Topic | Rattle / vibration noise from the dashboard (Drivers side) - Head Up Display (HUD) trim panel |
| Brand | Bentley |

Bentayga Series

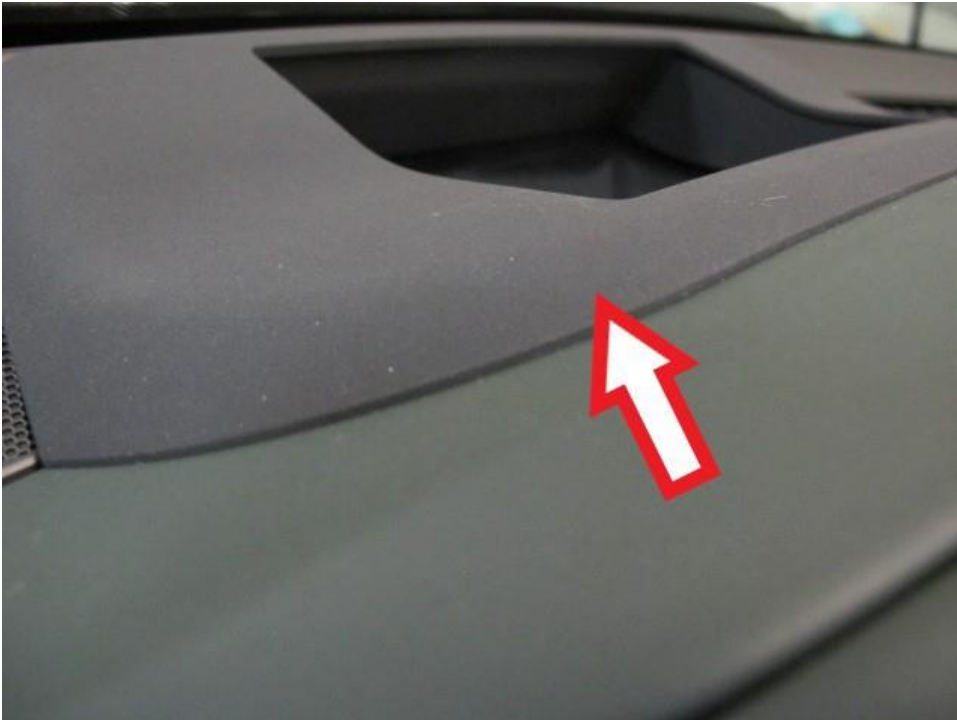
Figure 1

Rattle / vibration noise from the dashboard (Drivers side) - Head Up Display (HUD) trim panel (Figure 1)

The HUD trim panel is constructed from two individual mouldings which are heat staked (plastic welded) together, in the event the plastic welds become detached the symptom described may be evident, please refer to the instructions within the Measure section should the symptom be as described
