Service Alert

Subject: MULTIPLE WARNING LIGHTS ON, VEHICLE ONLY STARTS WITH KEY TRANSMITTER NEAR START BUTTON DUE TO POOR CONTACT AT FUSE F1	Service Alert No.: SA-040/24
	Last Issued : 09/11/2024

2024-2025 CX-90

2025 CX-70

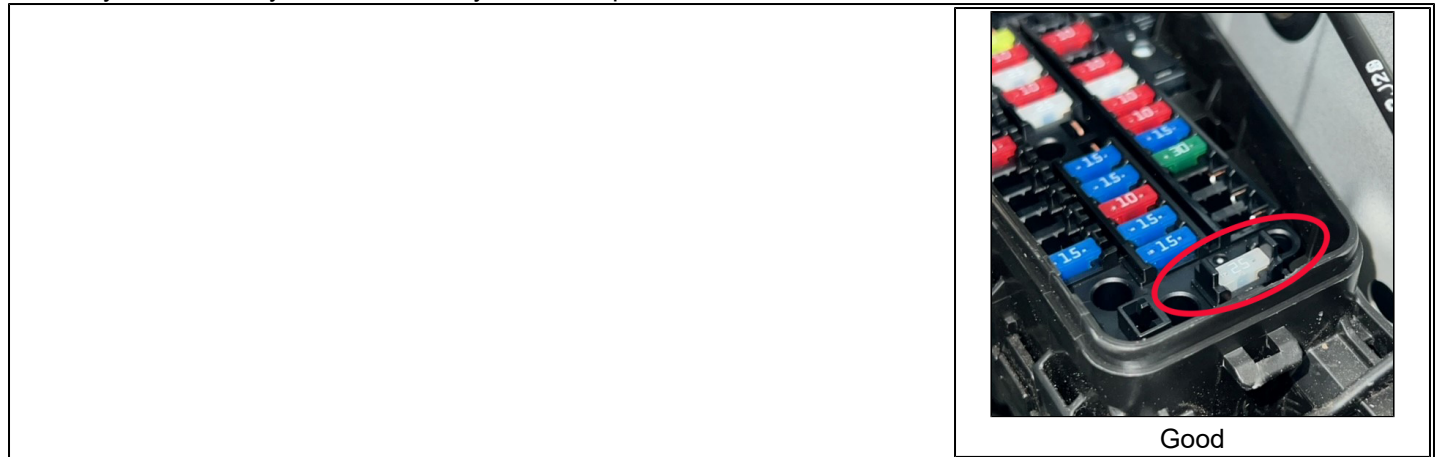
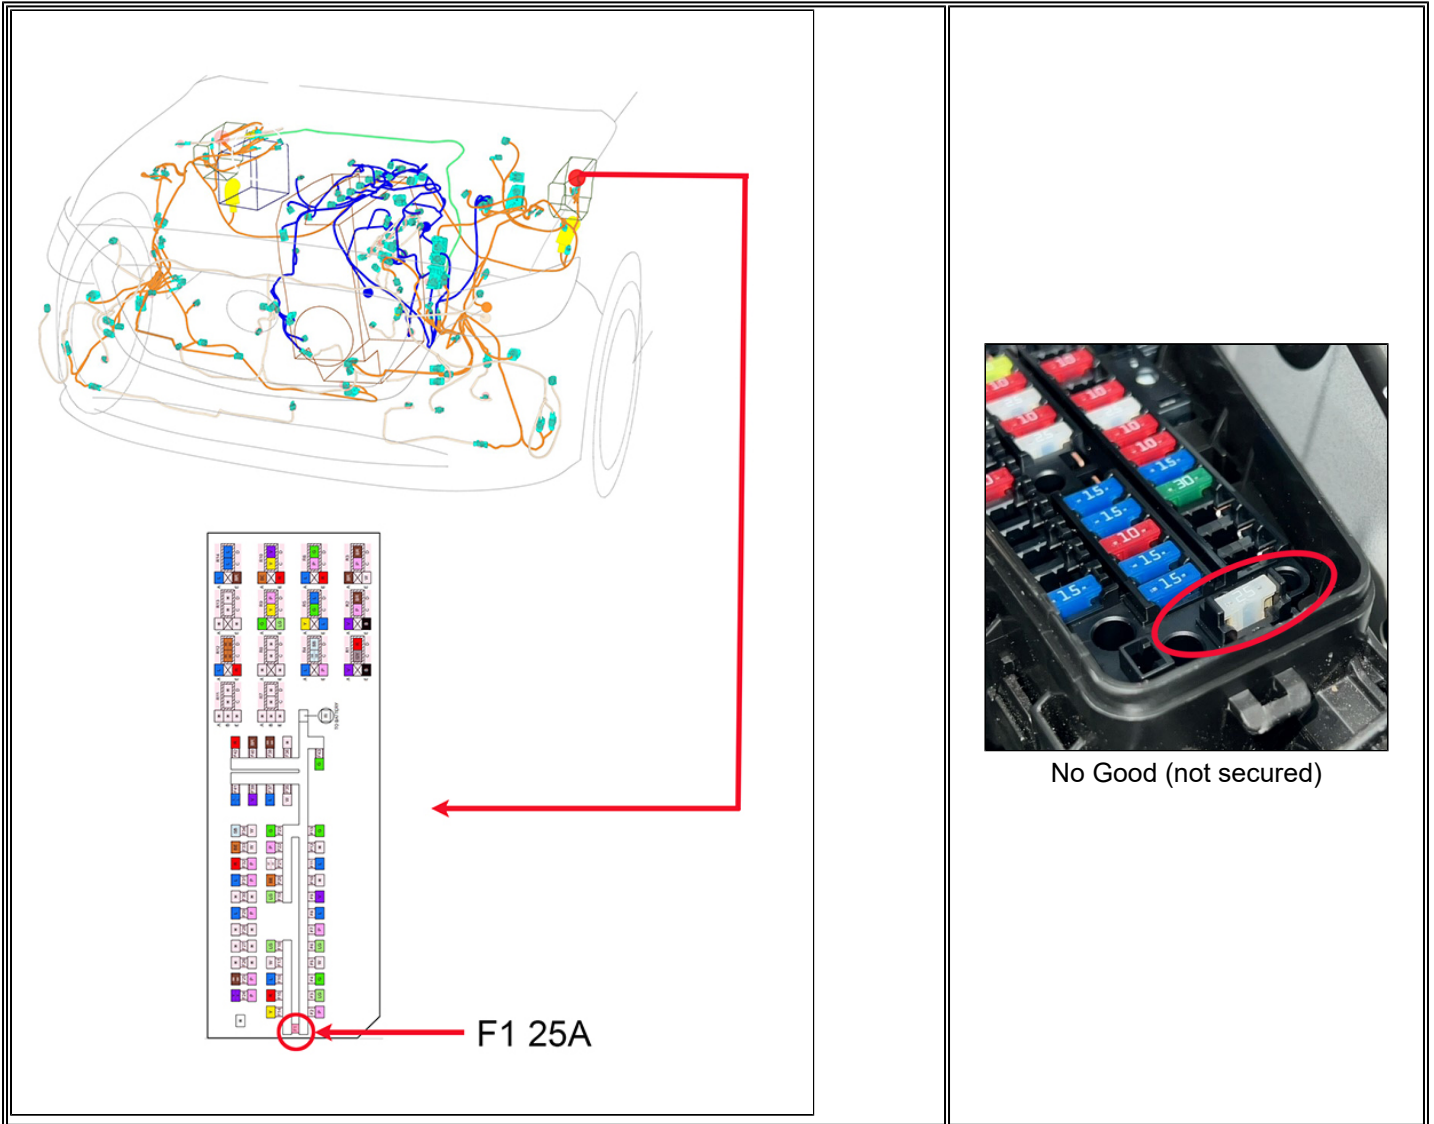
This may be caused by Fuse F1 not fully seated or poor terminal tension.

NOTE: The F1 25A fuse is removed during transportation. The F1 25A fuse must be inserted completely before the vehicles are delivered to customers.

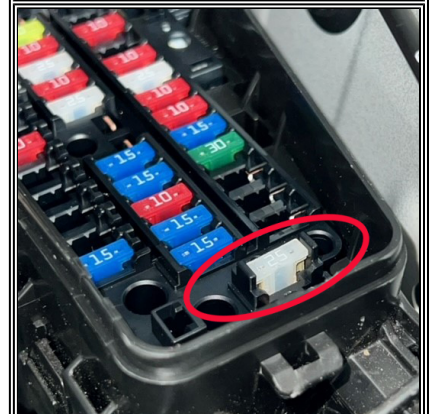
NOTE: The positioning rib may cause insufficient insertion.

No Good (not secured)

- **Yes** - Secure fuse F1
- **No** - This service information does not apply. Proceed to normal MGSS troubleshooting.
