Subject: LOW WASHER FLUID LEVEL WARNING LIGHT COMES ON WITH WASHER FLUID IN THE TANK	Service Alert No.: SA-061/24
	Last Issued : 09/25/2024

2025 CX-70
2024-2025 CX-90

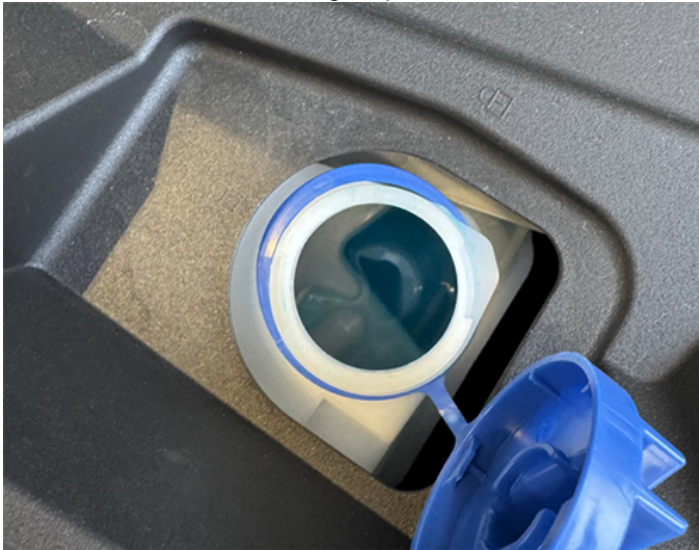
Some customers may complain about a low washer fluid level warning message even though a visual inspection of the washer tank looks like it still has a fair amount of fluid in it. With the CX-90 and CX-70 introduction of the front-engine and rear-wheel-drive layout, the washer tank shape was changed from a vertical to a horizontal type. This makes it look like there is still enough liquid left if viewed from the spout when the warning light comes on.

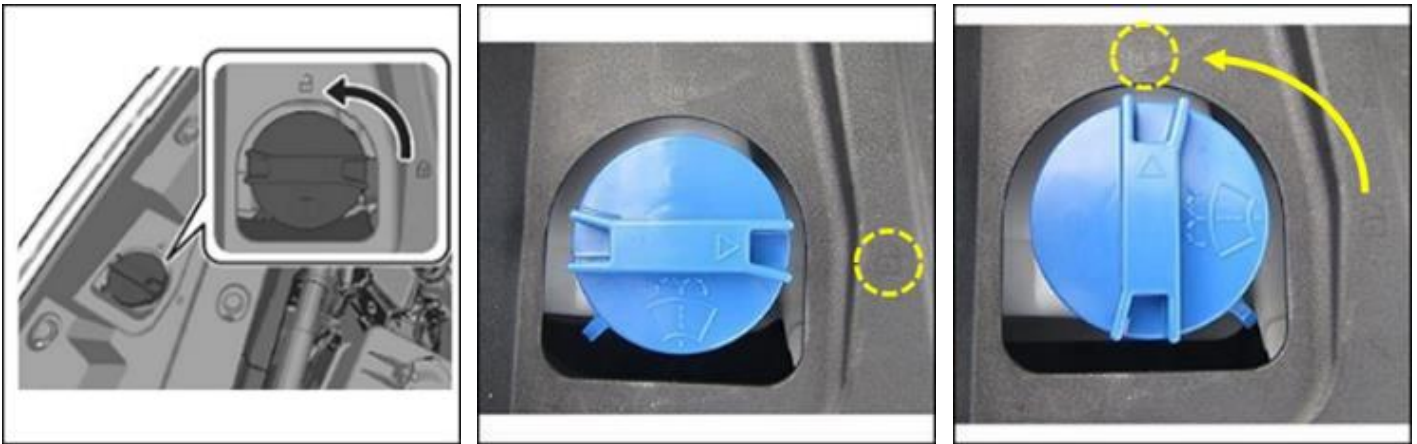
NOTE: The shape of the washer fluid tank cap has been changed from a pop-up type to a rotating type. When replenishing the washer fluid, **DO NOT** open the cap by pulling it, as it may be damaged. Open the cap by rotating it 90 degrees counterclockwise, as shown in the following figures.

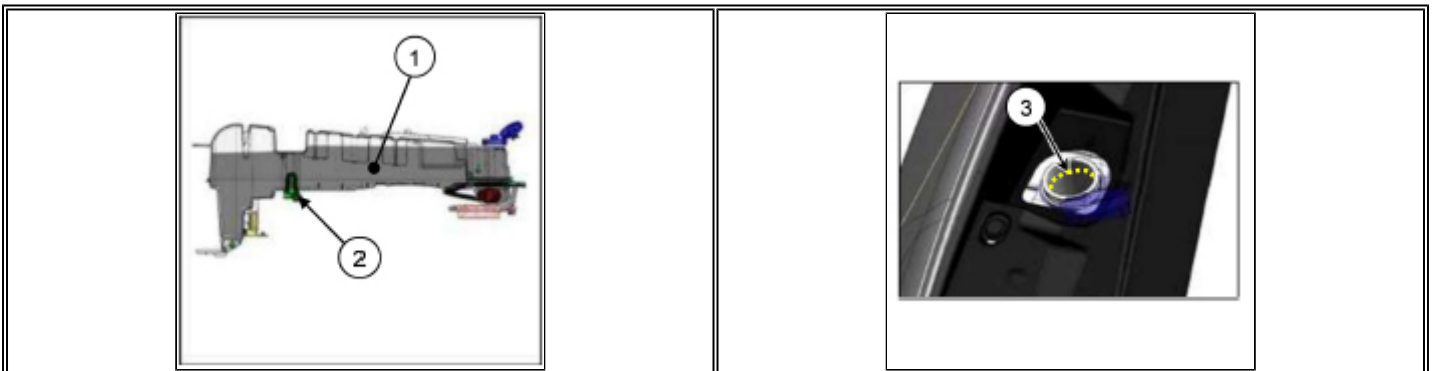
The warning light is designed to come on early so that the washer fluid does not run out at a short notice during long-distance driving. The light comes on when approximately 0.26 gallons (1.0 liter) of the washer fluid remains in this model, compared to 0.13 gallons (0.5 liters) for other models. The capacity of the washer fluid tank itself is 1.1 gallons (4.2 liters), and approximately 0.8 gallons (3 liters) should be replenished when poured to the FULL position (the edge of the spout).

1. Washer fluid (shaded): filled with 1.1 gallons (4.2 liter)
2. Washer fluid level sensor
3. Full level of washer fluid: Fill washer fluid up to the line.

Before attempting any repairs, first try filling the washer fluid tank to the spout line.
