Service Alert

Subject: BLIND SPOT MONITORING (BSM) MALFUNCTION DUE TO REAR SIDE RADAR SENSORS INSTALLED FACING WRONG DIRECTION	Service Alert No.: SA-063/24
	Last Issued : 09/06/2024

2019-2025 Mazda3
2020-2025 CX-30
2023-2025 CX-50

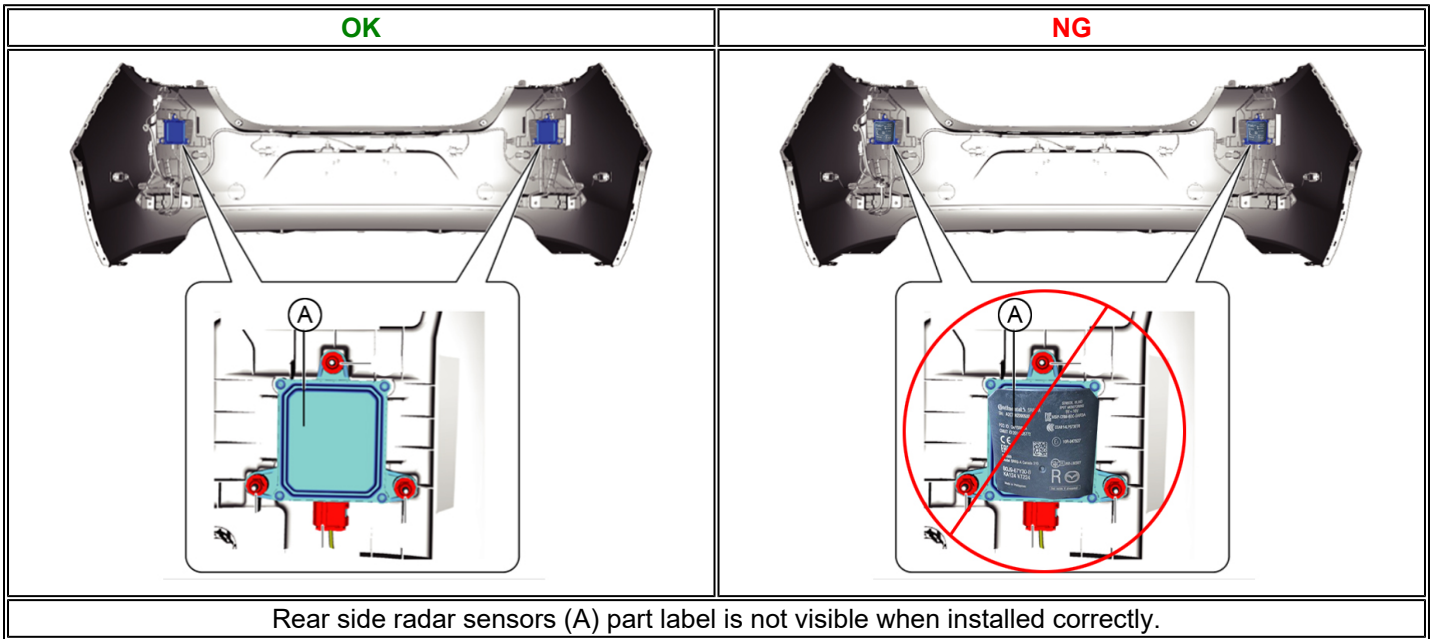
The Blind Spot Monitoring (BSM) system can malfunction with the following symptoms if the rear side radar sensors are installed facing the wrong direction.

- BSM system indicates vehicle on the opposite side.
- i-ACTIVSENSE indicator ring will not turn green
- Rear Cross Traffic Alert (RCTA) does not work
- Rear side radar sensor aiming may fail
- TPMS DTC(s) stored

Is the part label visible?

- **Yes:** Remove the rear side radar sensor(s) and install it correctly.
- **No:** This service information does not apply. Continue with normal diagnosis on MGSS.
