Technical Service Bulletin

Mazda North American Operations
Irvine, CA 92618-2922

Subject: REAR BRAKE NOISE	Bulletin No.: 04-001/24
	Last Issued : 09/10/2024

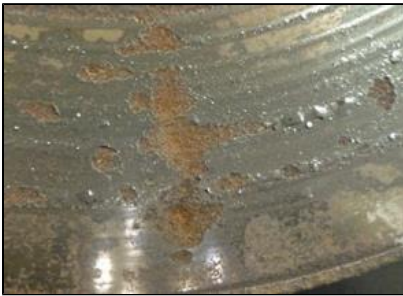
Sample case: If lathe is not applicable.
Some areas of the surface have fallen off due to rust and are too thin.

1. Verify the customer concern of grinding noise and/or vibration.
2. Check the disc surface to see if the cause of noise and vibration is the disc's rust (Some areas of the surface have fallen off due to rust and are too thin, which may look like black stains on the surface). If rust is the cause of the noise or vibration when applying the brakes, lath the discs or replace them with new ones and replace the brake pads.

- Check the disc thickness using a micrometer before lathing, if the thickness is below 8.7 mm for 2WD or 9.7 mm for AWD, replace the disc with new ones (DO NOT lath). Measure the thickness in the relatively less rusted area where the pads are hitting but not in the severely rusted area.
- Disc replacement is acceptable if an on-car lathe is not available.
