## STAR ONLINE PUBLICATION

**Case Number: S2403000004**

**Symptom/Vehicle Issue:** Tapping, Knocking Type Noise/Vibration While Driving.

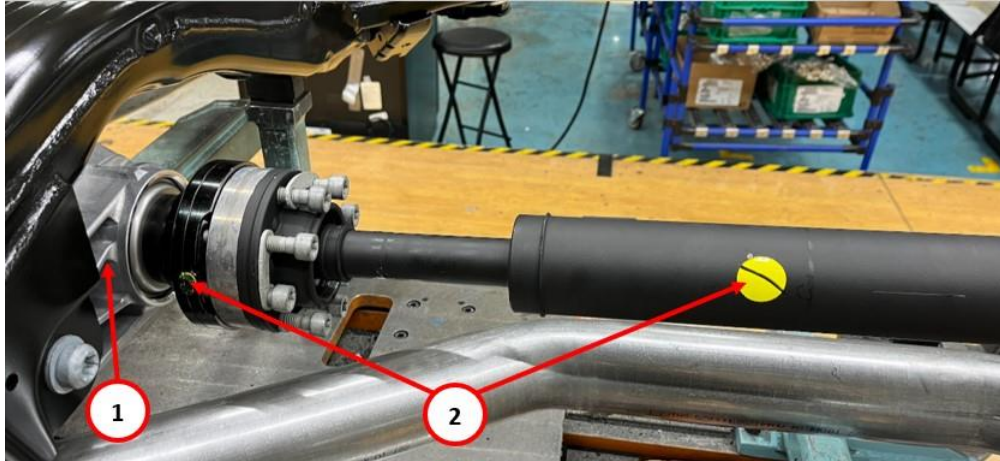
Figure1

3. Verify that the yellow alignment mark on the rear section of the driveshaft aligns with the RDU driveshaft flange. Please see (Figure 1). Were the alignment marks properly aligned?

1. RDU
2. Alignment Marks

- a. Yes>>> Go to [step 4](#).
  - b. No>>> Remove the driveshaft to RDU flange bolts in accordance with published service procedures in Service Library and align the marks before reinstalling. Proceed to [step 4](#).
4. Verify that the yellow alignment mark on the front section of the driveshaft align with the Transfer Case driveshaft flange. Please see (Figure 2). Were the alignment marks properly aligned?

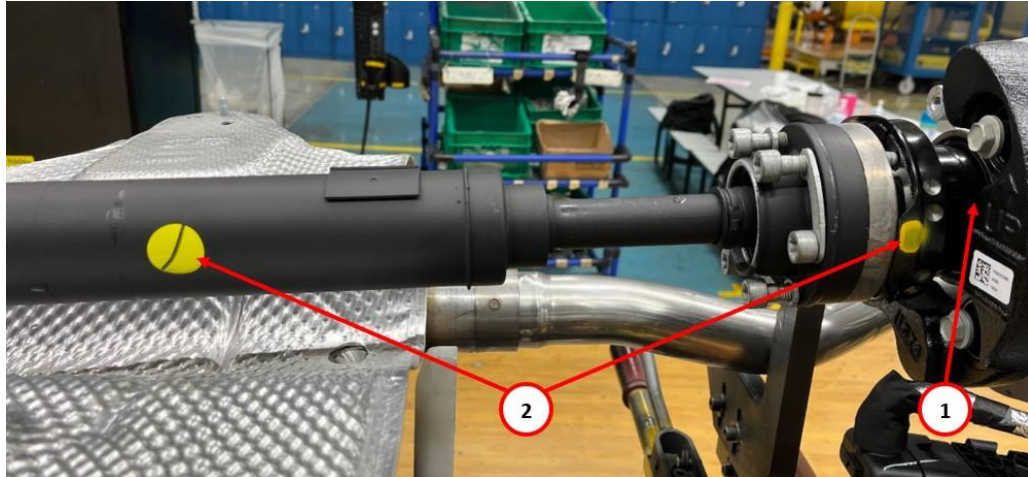
Figure 2

1. Transfer Case
2. Alignment Marks

- a. Yes>>> No further action is needed. Procedure is complete.
- b. No>>> Remove the driveshaft to Transfer Case flange bolts in accordance with published service procedures in Service Library and align the marks before reinstalling.
