JLRTB02052NAS5

TECHNICAL BULLETIN

Rear Doors Difficult To Open

MODEL:	MODEL YEAR:	VIN:	ASSEMBLY PLANT:	APPLICABILITY:
Defender (LE)	2020-2024	000431-356580	Nitra (Slovakia)	5-Door

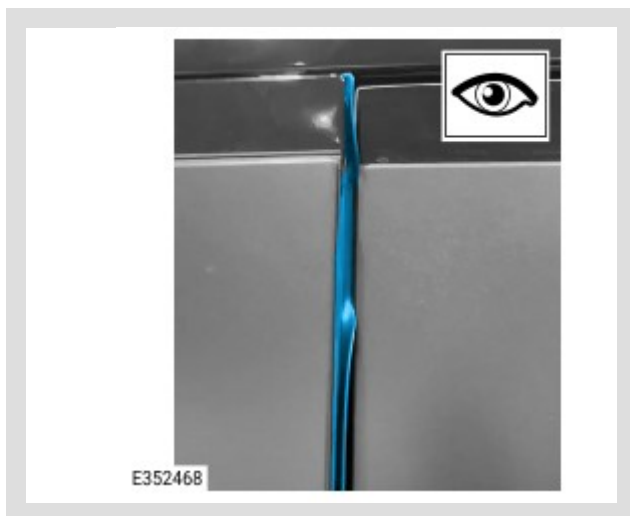
1.

If the door seal is catching on the exterior trim panel, proceed to **Service Instruction A**.

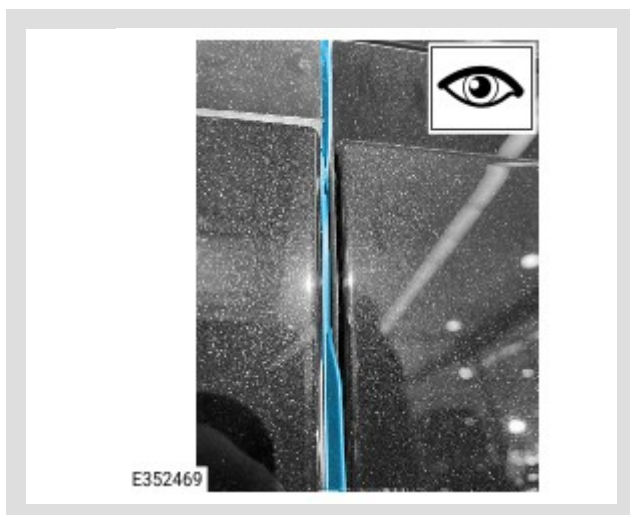
2.

If the margin seal is catching on the C-Pillar glass, complete **Service Instruction C**.

- Check the operation of the rear door(s).
 - If the door is no longer difficult to open, do not continue with this technical bulletin.
 - If the door is still difficult to open, complete Service Instruction A and Service Instruction B.

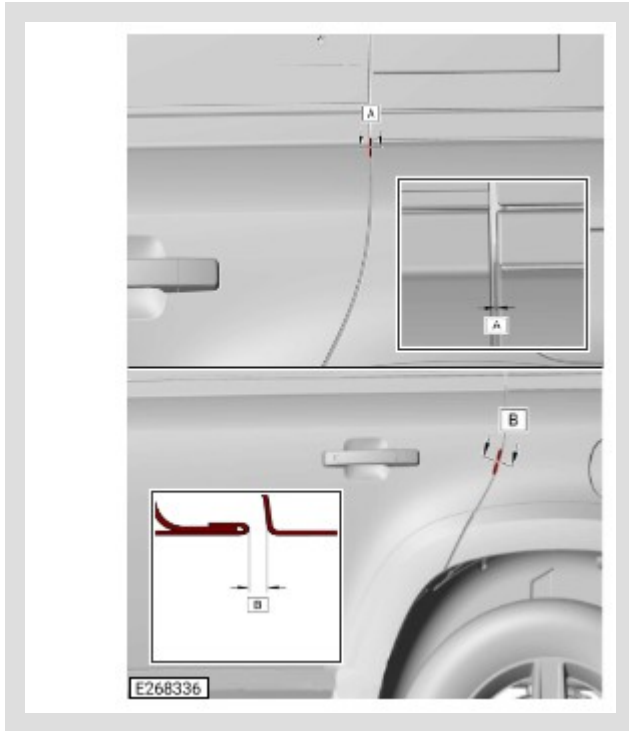
Check the alignment of the rear door(s) in the areas shown in the illustration.

SECTION	DESCRIPTION	GAP	PROFILE
A	Rear door to rear quarter	N/A	0.0 ± 0.5 mm
B	Rear door to rear quarter	3.5 ± 0.7 mm	0.0 ± 0.7 mm

Only adjust the rear doors that are either out of alignment tolerance or do not have a gap of 2.8 mm.

Adjust the rear door(s) to be as far rearward as possible while still being within tolerance, the gap must be 2.8 mm (see TOPIx Workshop Manual section 501-26: Body Repairs: Vehicle Specific Information and Tolerance Checks - General Procedures - Rear Door Alignment).
