No.: 24CSA-16  
September 2024

TO: Service Locations  
FROM: Powertrain Service Engineering  
SUBJECT: **Gen 5 DD15 Cylinder Head Cup Plug Replacement**

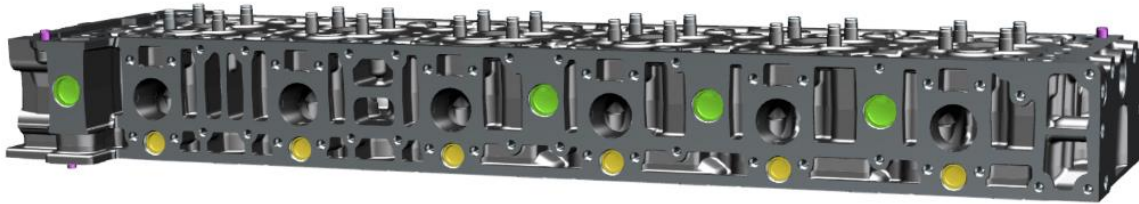
Some Gen 5 DD15 units may come in for a coolant leak (seep/drip) at one or more of the 24mm cup plugs on the exhaust side of the cylinder head.

There are six 24 mm cup plugs located below the exhaust ports on a Gen5 DD15 cylinder head. See yellow plugs in image below.

Please reference the appropriate section in the **Gen 5 DD15 Platform Workshop Manual** titled **Replacement of the Cylinder Head Cup Plugs (Below the Exhaust Manifold)**. This procedure provides instructions on how to remove all six 24mm cup plugs, create threads in the plug bores with a special service tool, and install pre-released threaded plugs.
