DAIMLER TRUCK NORTH AMERICA AFTERMARKET

No.: 24CSA-17
September 2024

TO: Service Locations
FROM: Service Engineering
SUBJECT: **Gen 5 DD13 Turbocharger Oil Return Line Cracks**

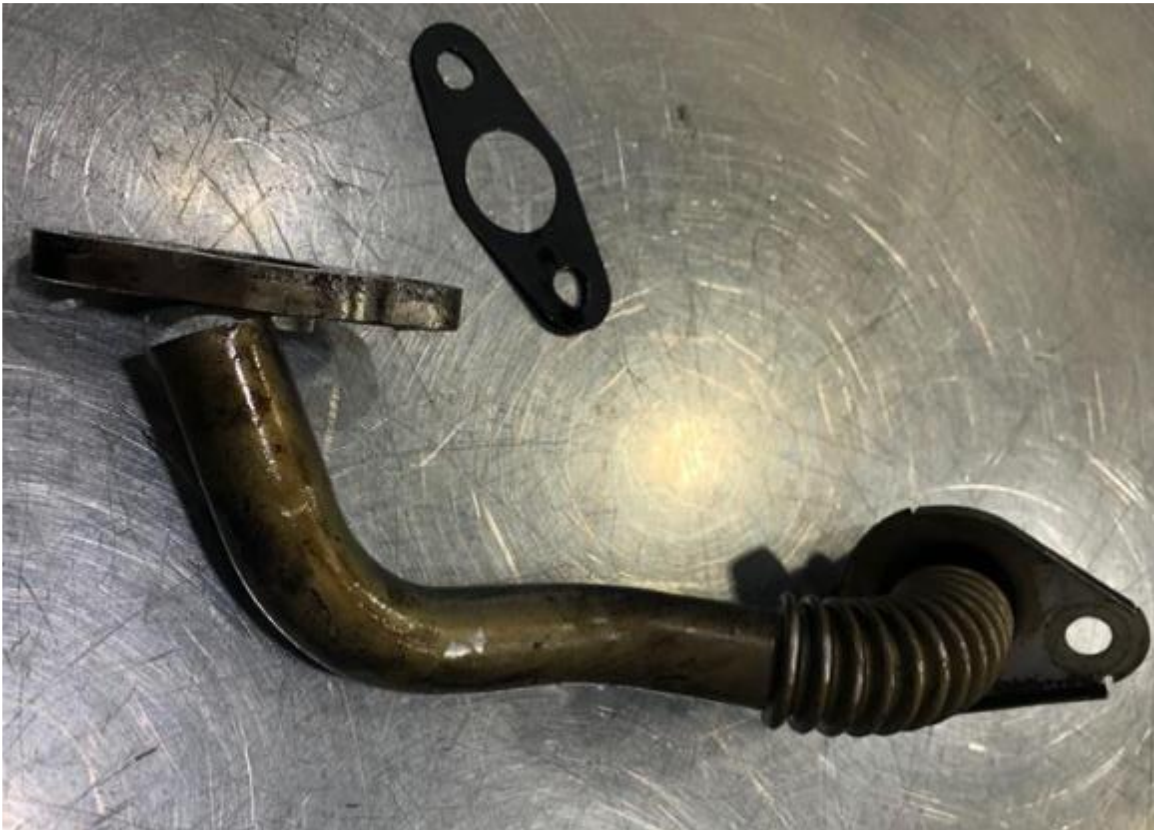
Some DD13 Gen 5 turbocharger oil return lines have cracked, causing an oil leak. Engineering is requesting additional steps and the return of replaced parts to aid with understanding the root cause. If completed, please return the parts directly to DDC. This process is only to be performed until January 1, 2025, and only when the customer approves of the additional repair time that may occur.

Example of a broken turbo oil return line

In addition to the cracked return line, please return the turbo mounting bracket, support bracket, and all associated bolts. See instructions below.

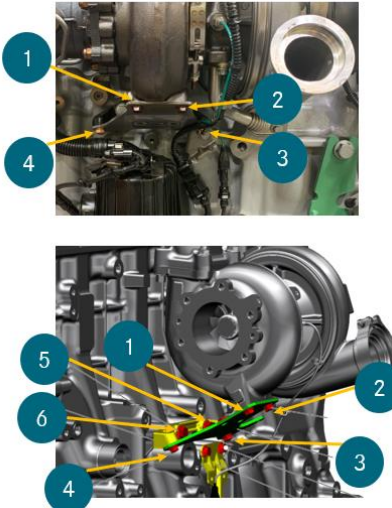
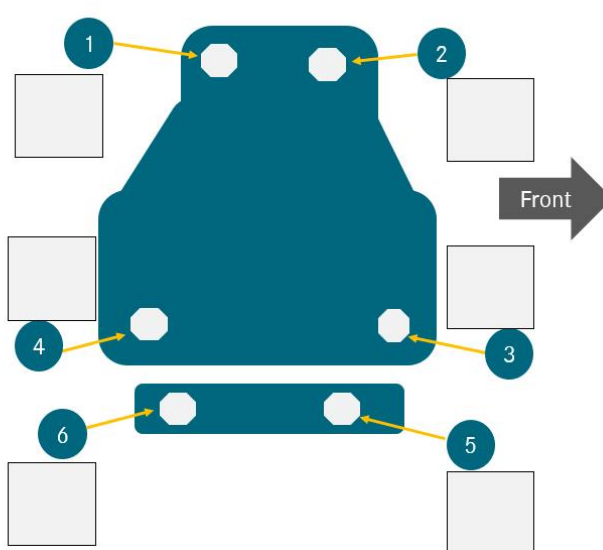
Note: Due to clearance, bolt #4 needs to be removed with a wrench and torqued with a crowfoot socket.

1. With a paint marker, number the six bolts for the turbo mounting brackets, as shown in the diagram below when applicable.
2. Follow section 'Removal of the Turbocharger' in the DD13 Gen 5 Workshop manual for instructions on removing the turbo mounting bracket and support bracket.

3. When removing the bolts, note the break-away torque in NM and document the values in the boxes below.
