09/27/2024  
CAL FTL 35-002

**Subject: Z-Bracket Welded too High on Rear Axle Differential Housing**

**Model: New Cascadia**

**Model Year Affected: 2024 & 2025**

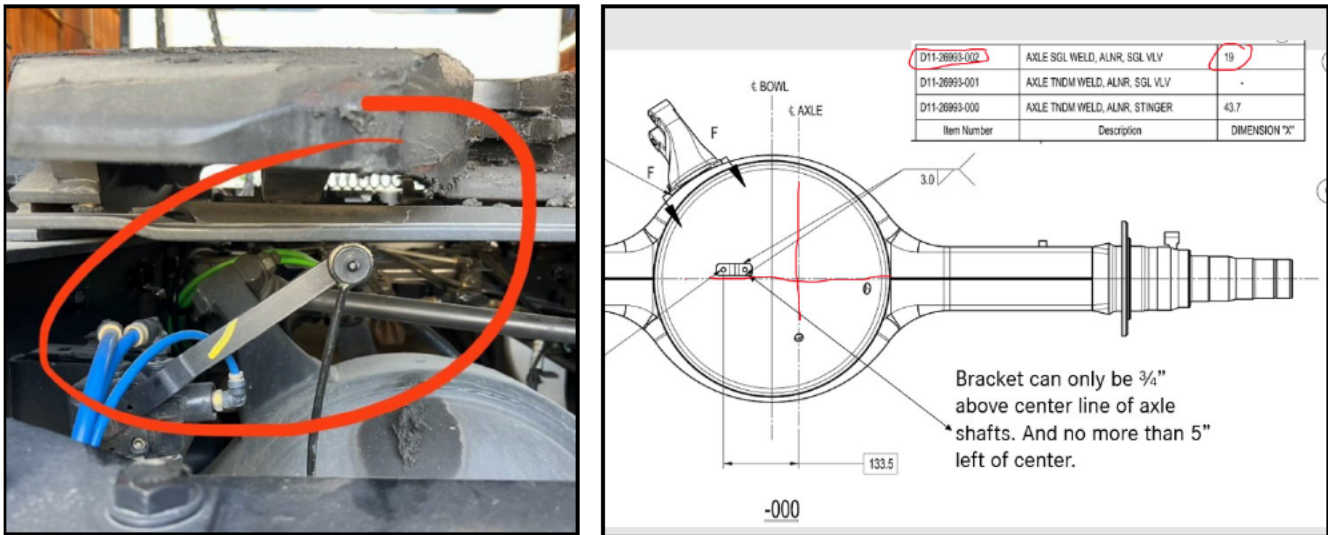
After finding one vehicle Z-bracket welded too high on the rear axle differential housing causing linkage to contact bottom of the 5th wheel slide plate, DTNA has taken a proactive approach to assess if other vehicles may have the same issue. With the following inspection, the vehicles will be surveyed to collect more evidence. Vehicles produced at the Saltillo production facility from January 1, 2023, to August 5, 2024, should be inspected for the following.

**Fig. 1 High-Welded Z-Bracket Causing 5th Wheel Contact**

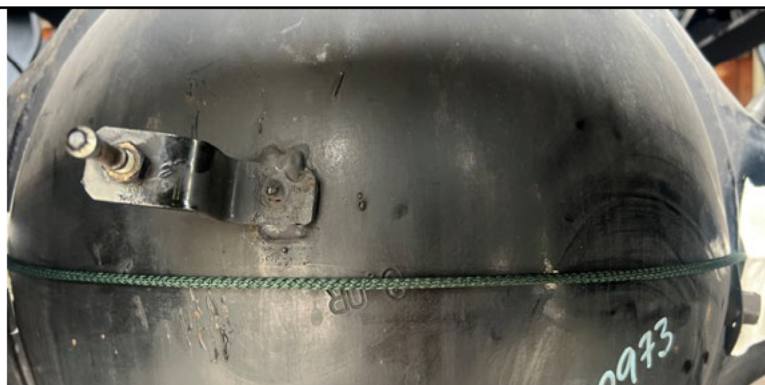
### Leveling Valve Bracket – VA8797

**Fig. 2 Before Fix**
