42-080 ABS Wheel Speed Fault Code Correction for MBSP Equipped Vehicles

TSB-42-080-FTL

► New Cascadia

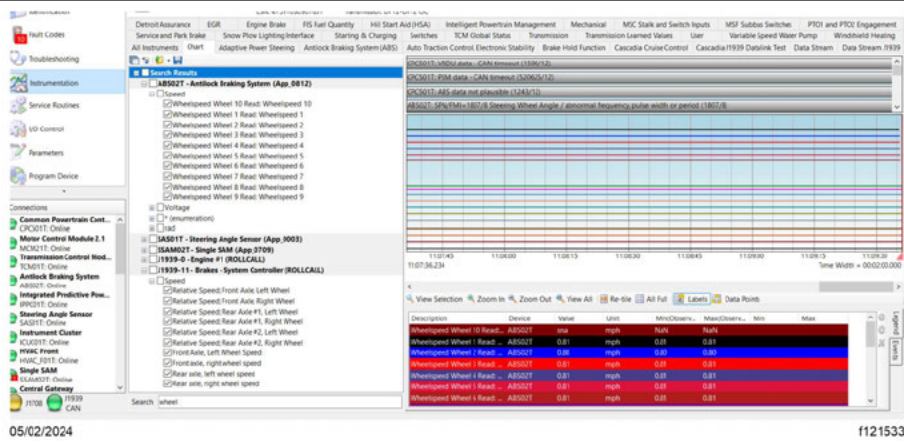
Fig. 1, DiagnosticLink Wheel Speed and Relative Speed Signals

13. During the test drive, monitor the wheel speeds using DiagnosticLink and ensure that the ABS module and all J1939 connections are active. Do the wheel speeds appear erratic, spike up, or show readings when the vehicle is stationary? It is recommended to refer to the chart instead of the ABS tab/panel. See Table [Wheel Speed Chart Signals 4](#) and Fig. [1](#) for the charting selections in DiagnosticLink.

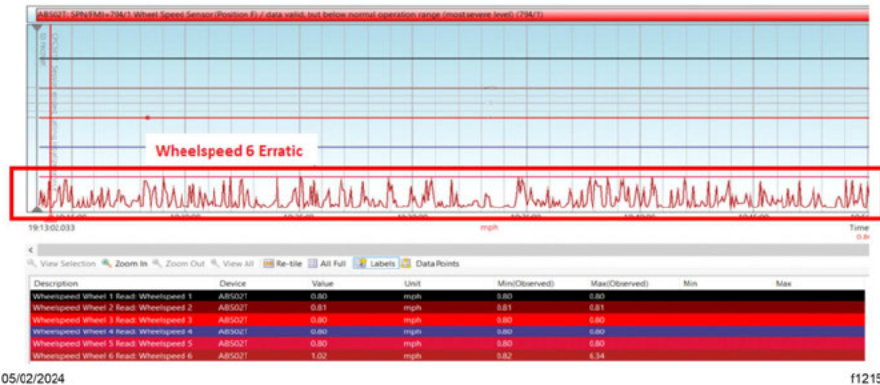
Fig. 2, DiagnosticLink Signal Traces

14. See Fig. [2](#) for the traces of the selected wheel speed and relative speed signals. Note the erratic signal on wheel speed 6.

- a. If the readings are erratic regardless of location, or if the issue only happens in damp or wet conditions, install the individual overlays for all four rear wheel ends. See Table [WABCO Harness Part Numbers 5](#) for length and part number of WABCO harnesses.

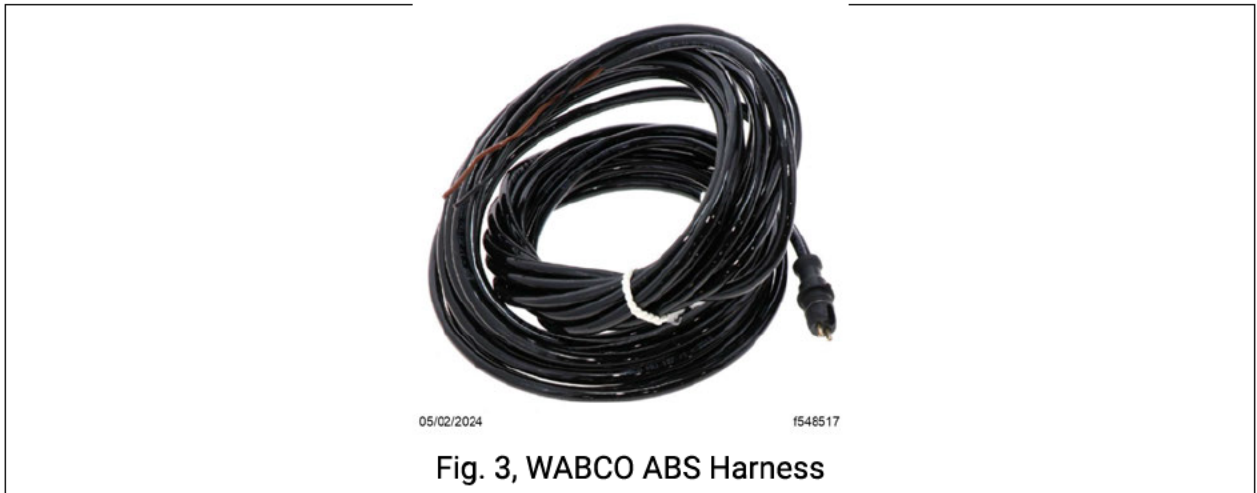
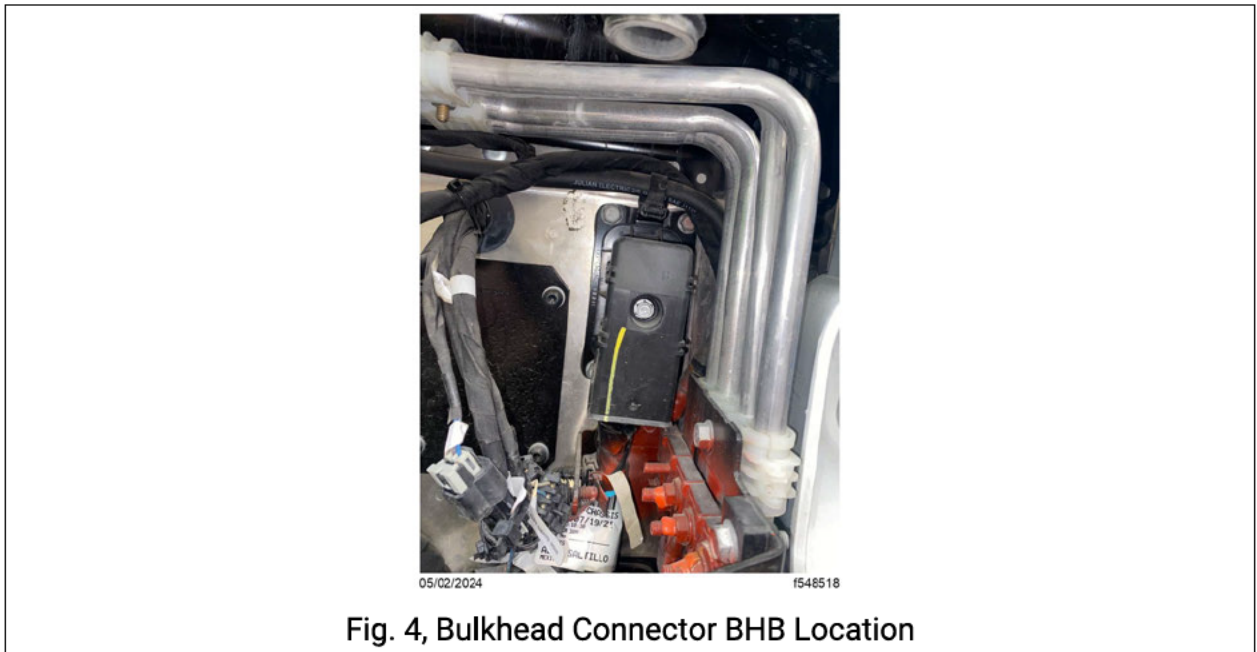
- b. All harnesses listed above in Table [WABCO Harness Part Numbers 5](#) will require termination at the bulkhead connector BHB. See Fig. [3](#) and Fig. [4](#) for bulkhead connector BHB location.

- c. The lengths of the WSS overlay harness required will vary based on the wheelbase of the vehicle. See 'Determine Vehicle Wheelbase' below.
- d. All the harnesses listed in Table [WABCO Harness Part Numbers 5](#) will require trimming to length and termination at the 76-pin bulkhead connector BHB. See Fig. [3](#) for image of a typical WABCO ABS Harness and Fig. [4](#) for bulkhead connector BHB location.
- e. Choose the closest available harness length in order to minimize harness waste when trimming to length.
- f. Installation of the terminal part number 23-13211-410 (Qty: 8 Nos.) requires crimping tool SPX J-38125-6 (non-ratcheting) or SPX J-38125-7 (ratcheting).

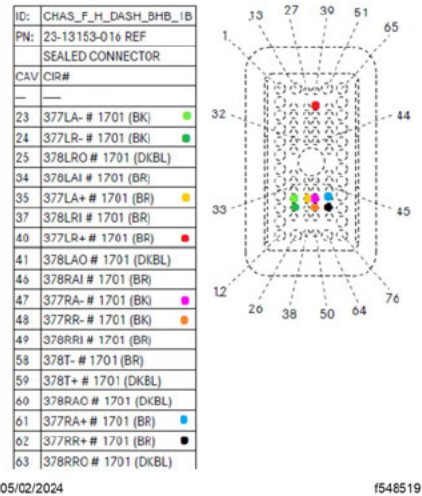
Fig. 6, BulkHead Connector BHB

h. During the harness replacement, ensure that the 76-pin bulkhead connector BHB is free from moisture or corrosion. If moisture is detected, clean the connector using compressed air and dielectric spray. If corrosion is found, note that repairs for additional circuits fall outside the scope of this service bulletin.

j. Verify that the terminals are installed into the correct cavity of the 76-pin bulkhead connector BHB. See Fig. 6.
