82-003 Fixing Unintended Wiper Sweep

TSB-82-003-WST

Creation Date:2024-09-25

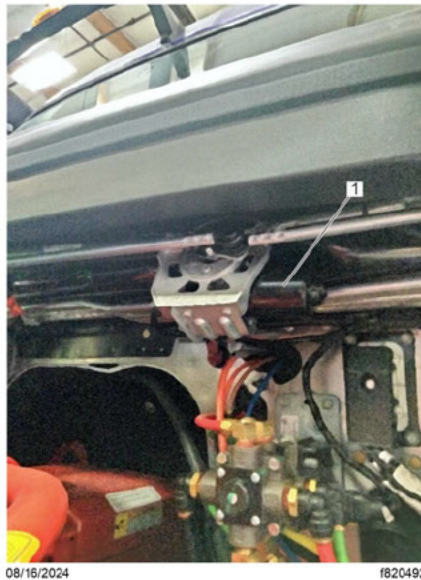
Fig. 1, Wiper Motor

Some Western Star vehicles built prior to January 1, 2023 have a race condition with the wipe function. If the wiper motor receives power before the ASAM, the wiper sweeps once at key-on. This may result in a random unintended wiper swipe. ASAM controllers built after January 1, 2023 (ASAM2021), received new hardware and software that corrected for the unintended wipe. The ASAM21 controllers are not backward compatible and cannot be installed on vehicles built prior to 2023. Replacing the wiper motor will resolve the issue. See Fig. 1. Follow the procedure below to replace the wiper motor.
