# HDEP High Pressure Fuel Line Seal Failures

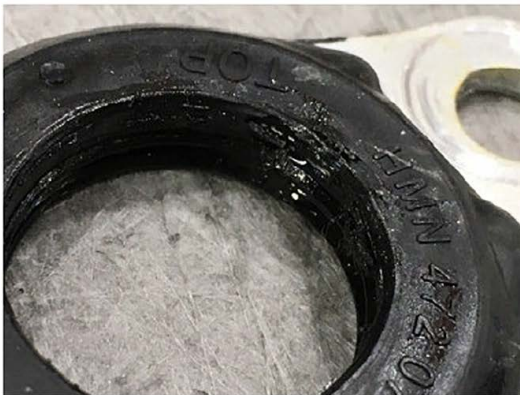
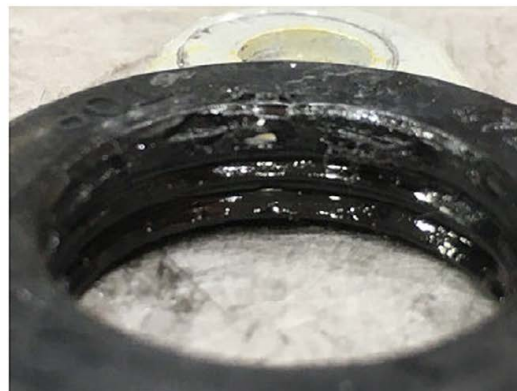
- Oil leaks present between the rail to injector fuel lines and mating seals since HDEP start of production.
- Especially high failure rate between 18 and 24 MIS for DD15 Gen 5.
- High failure rate for ALL years of HDEP in North America (same seal design used for all variants of HDEP since 2006).
- Cyclical failure rates higher during winter months, peaking in late winter.

- Injector tube nut “extension” - June 2021
- P-80 installation lubricant (ICA) - March 2022
- T54 installation dry lubricant (PCA) - April 2022
- Fuel rail alignment tool - DD15 only - June 2022
- New seal design planned to be implemented in production in December.
- Service Updates:
  - Updates to the service manual to remove P80 and/or Oil from work instructions.
  - Updates to the service manual to change and modify the assembly sequence to install the seal last by slipping the seal completed past the tube nut.

- Replace seal(s).
