## 47X Twinsteer Idler Arm

## Field Service Campaign SF689

Published : July 2024

### Subject: Twin Steer Idler Arm

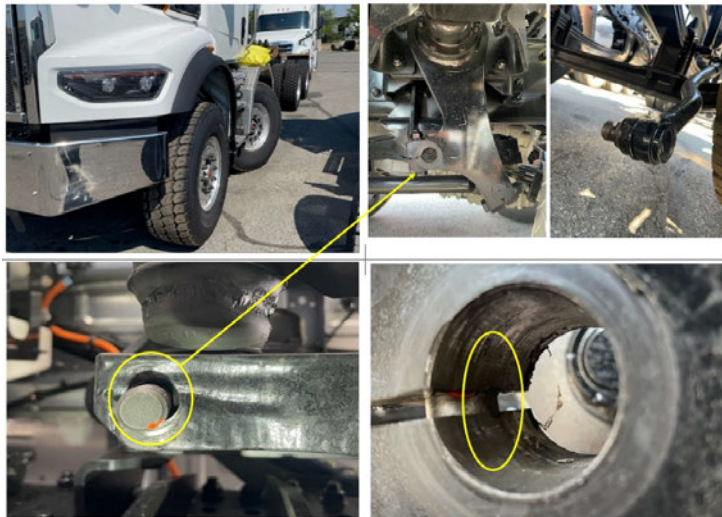
Idler arm plate pinch bolt hole location may be incorrectly manufactured by supplier allowing draglink to become detached.

- Supplier fixture dimension incorrect

- Supplier update to fixture and 100% inspection of parts

- Service Campaign SF689
- Published 07/25/2024
