INSTRUMENT CLUSTER LENS SCRATCHED

Service Alert No.: SA-068/24

Last Issued : 09/11/2024

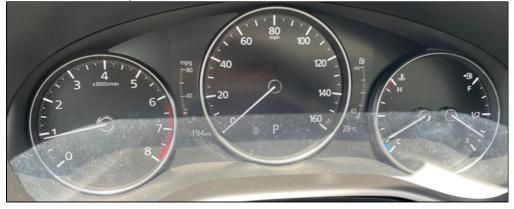
Some customers may complain about scratches on the instrument cluster lens.

1. Verify the customer concern.

- 2. Replace the instrument cluster lens.
- 3. Verify the repair.

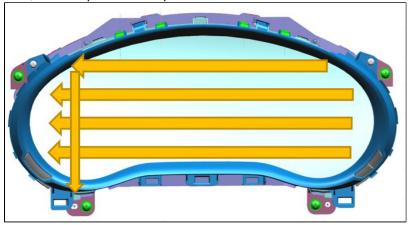
**CAUTION**: A hard or rough cloth and detergent should never be used for cleaning the lens; otherwise, it may scratch it. Also, never wipe with hard pressure.

3. Use the microfiber cloth and wipe the lens softly in one direction as shown below.

- If the lens is scratched, it cannot be repaired. The lens will need to be replaced.
- Advise dealer detail shop to use this cleaning procedure to prevent lens damage during new vehicle delivery.
