Service Alert

Subject: TELEMATICS COMMUNICATION UNIT (TCU) REPLACEMENT / ACTIVATION PROCEDURE	Service Alert No.: SA-070/24
	Last Issued : 09/12/2024

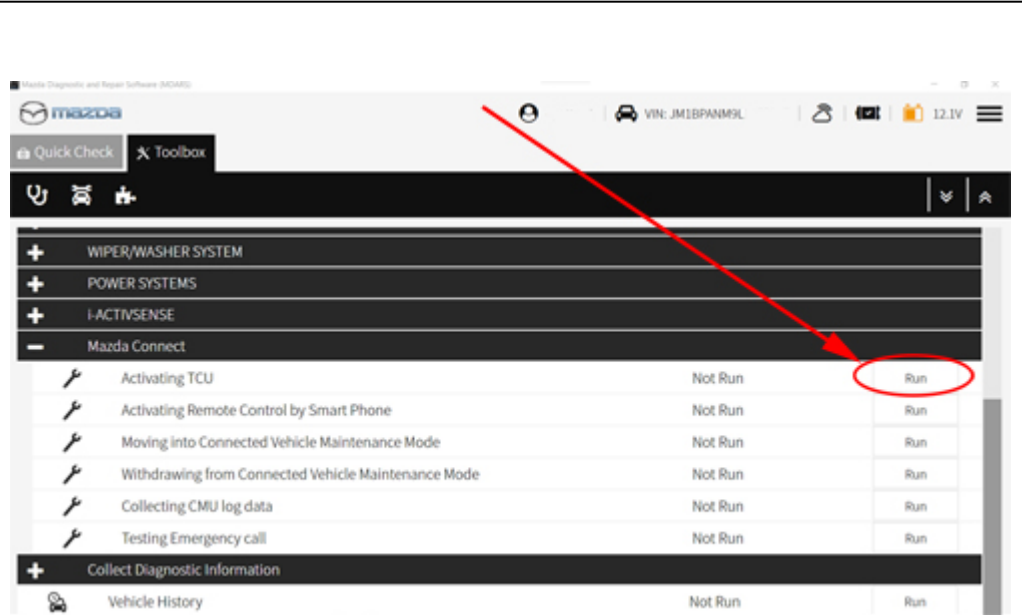
NOTE: MDARS may show "Incomplete". This may be caused by:

- Advanced key is not in the vehicle.
- Connected vehicle maintenance mode is enabled.
- Pacemaker radio wave interference prevention is enabled.
- key transmitter power saving function is enabled. See SA-020/21.

9. Select Activating TCU (links TCU to server) -> "Run". Wait for "initialization complete" message.

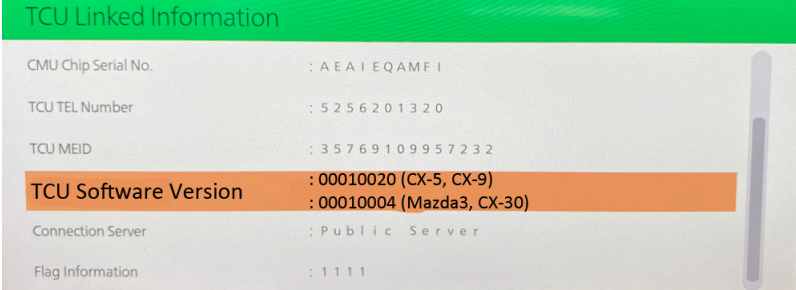
d. Scroll down to TCU Software Version and confirm the software version is at the latest version as listed on MGSS.

TCU Linked Information	
CMU Chip Serial No.	: AEA1EQAMF1
TCU TEL Number	: 5256201320
TCU MEID	: 35769109957232
TCU Software Version	: 00010020 (CX-5, CX-9) : 00010004 (Mazda3, CX-30)
Connection Server	: Public Server
Flag Information	: 1111

- **Yes:** Repair is complete.
- **No:** Go to MGSS -> Infotainment/TCU -> [Telematics Communication Unit \(TCU\) Updates](#) to update the TCU software version.
 - See Warranty Information for software update payment.
