992 GT3/GT3RS – Exhaust Flap Actuator Wiring Damaged

Revision	Release Date	Changes
0	September 17, 2024	Original document

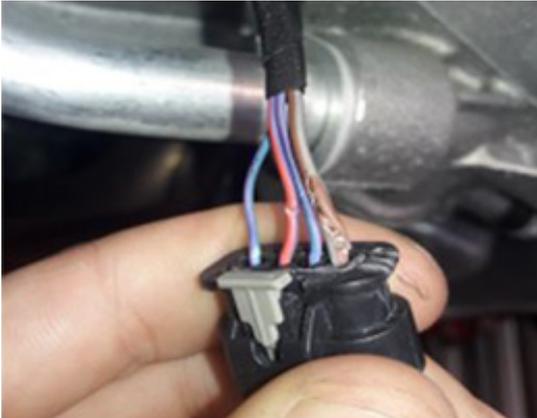
Figure 1

This condition can result from damaged wiring on the exhaust flap actuator(s). This is due to contact of the air guide/diffusor with the actuator of the exhaust flap. The contact can be caused by a deformed air guide/diffusor due to either transport damage or contact with objects in the road.

1. Inspect the wiring of the electrical connectors of the exhaust flap actuators for damage. (see image below)

- If damage is found proceed to **Step 2**.
 - If no damage is found, please skip the rest of the work instruction and continue with diagnosis of the faults.
2. Check for damage to the diffuser and underbody panels that could cause contact with the wiring harnesses for the exhaust flap actuators.
In a PCSS job, please document all findings (regardless of condition) on the diffuser or underbody panels with pictures. See example of underbody damage due to outside influence below.

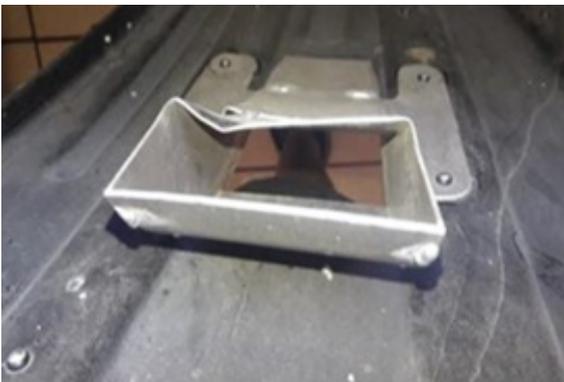
Figure 2

- If damage is found on the diffuser or underbody panels, and the damage is not found during PDI, this is likely caused by outside influence and cannot be claimed under warranty.
