Warning Message “Ignition lock faulty - service required” in the Instrument Cluster / Fault Memory Entry “B143C29” in the Rear-End Electronics Control Unit (SY 47/24)

Model Line: **911 (992)**

Model Year: **As of 2020**

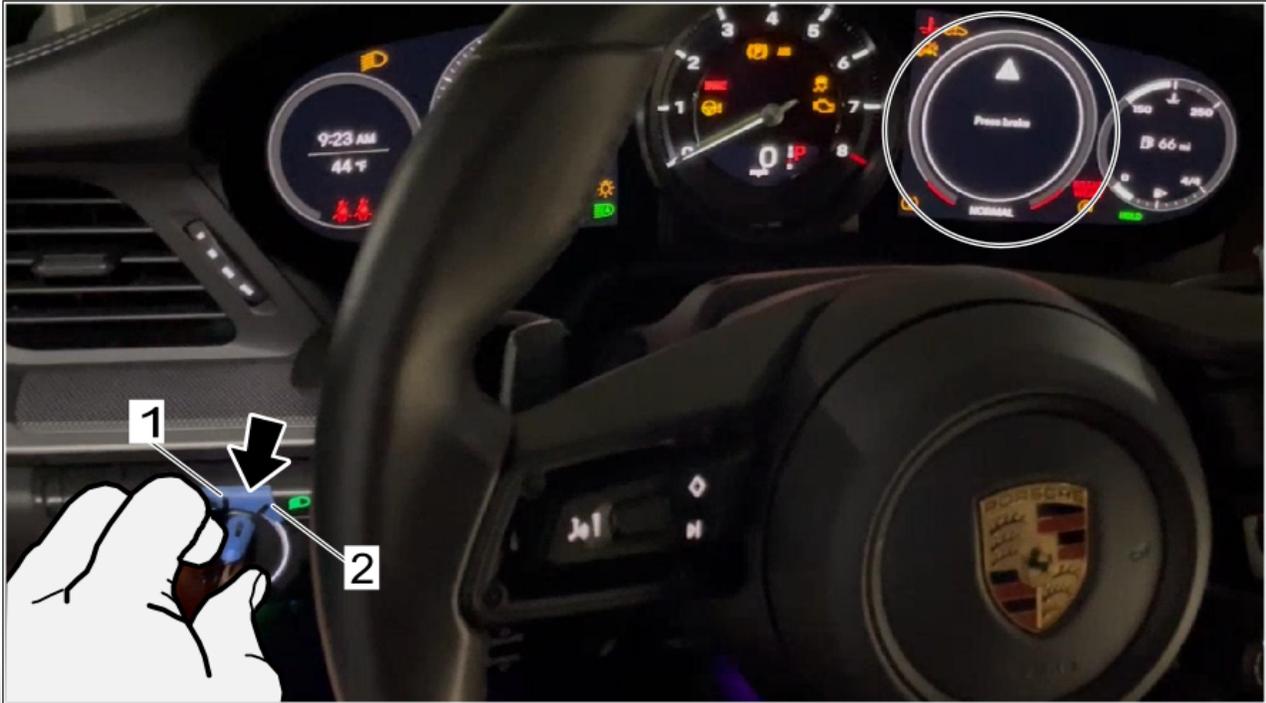
Ignition starter switch position

Cause: When the ignition starter switch is actuated, the engine is started through the system from the moment when the ignition starter switch is between switch position **-1-** (ignition on) and switch position **-2-** (engine start) ⇒ *Ignition starter switch position -Arrow-*.
If the ignition starter switch for the engine start is not **fully** turned to the switch position “Start engine” ⇒ *Ignition starter switch position -2-* but is released immediately after engine start instead, thus returning to the switch position “Ignition on” ⇒ *Ignition starter switch position -1-*, the fifth consecutive incomplete start will result in the symptom described above.

- 1 – Switch position "Ignition on"
- 2 – Switch position "Start engine"

Arrow – Engine start begins

Circle – Engine start release by "pushing brake" at ignition starter switch position ⇒ *Ignition starter switch position*

- Remedial Action: 1 Inform the customer to turn the ignition starter switch to the "Start engine" ⇒ *Ignition starter switch position -2-* switch position each time in order to start the engine so that the system will work as intended.
- 2 Re-code control unit for rear-end electronics (BCM2).
- 3 Delete fault memory entry "B143C29 - Ignition starter switch, signal implausible (010066)" in the rear-end electronics control unit.
