Door Symptom - Noise Complaints from the Door Trim Panel Area: Observe Documentation Specifications (SY 68/22)

Model Line: **Taycan (Y1A / Y1B / Y1C)**

Model Year: **As of 2020**

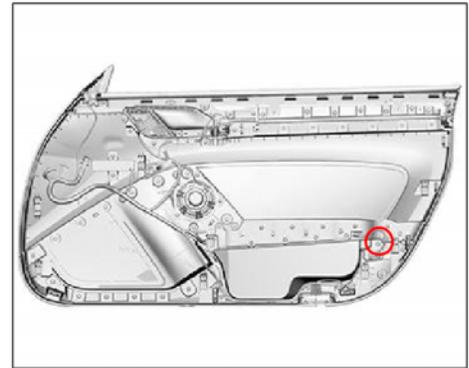
Appendix xy: Loose cable for door trim panel

- Electric line in the door trim panel loose. Electric line secured with a tie-wrap. For exact fault location, see Appendix xy ⇒ *Appendix xy: Loose cable for door trim panel*
