Door Symptom - Noise Complaints from the Door Trim Panel Area: Observe Documentation Specifications (SY 68/22)

Model Line: **911 (992)**

Model Year: **As of 2020**

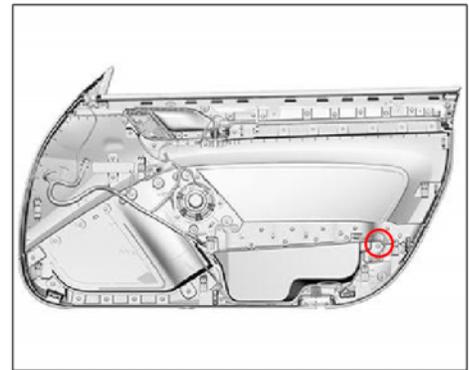
Appendix xy: Loose cable for door trim panel

- Electric line in the door trim panel loose. Electric line secured with a tie-wrap. For exact fault location, see Appendix xy ⇒ *Appendix xy: Loose cable for door trim panel*
