SERVICE BULLETIN

Communication #: I-24-08

Model Year(s): 2020–2024

SUBJECT: SOFTWARE UPDATE FOR UNNECESSARY CURRENT DRAW

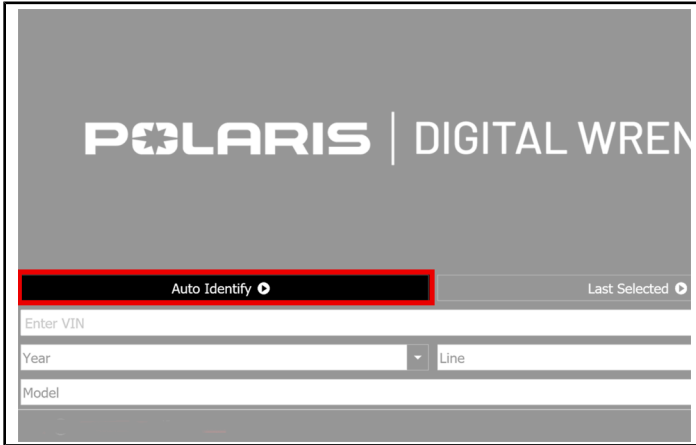
1. Open the Digital Wrench II application.
2. Select **Auto Identify**.

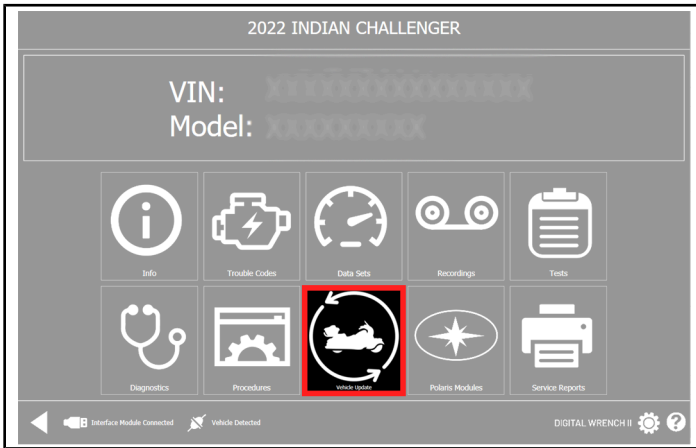
3. Select **Vehicle Update**.

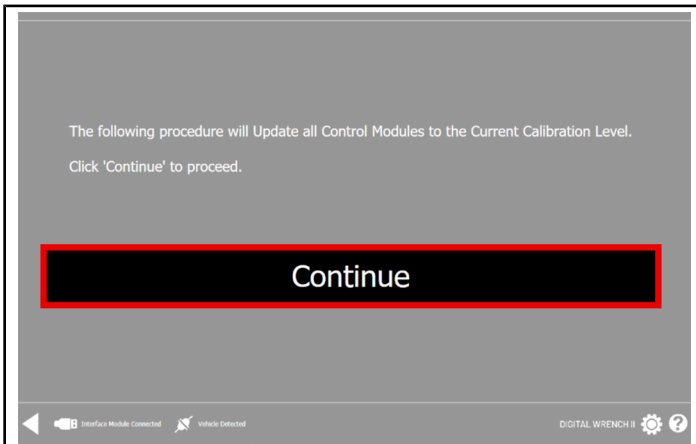
4. Select **Continue**.

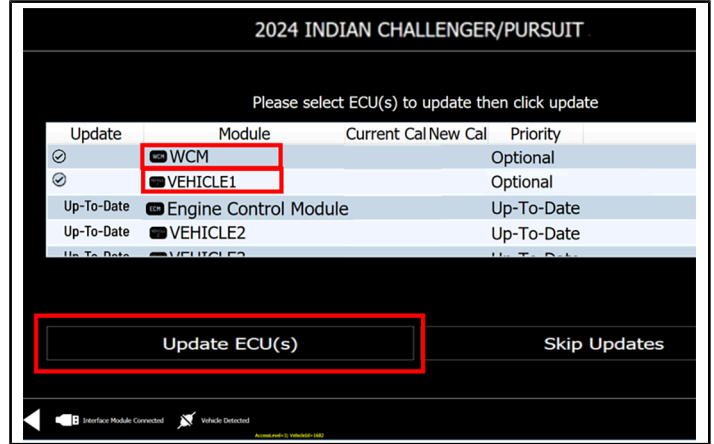
5. Select **Vehicle 1 (VCM1)** and **Wireless Control Module (WCM)**. Then select **Update ECU(s)**.

IMPORTANT
Make sure you selected both **WCM and VCM1** to update both controllers.

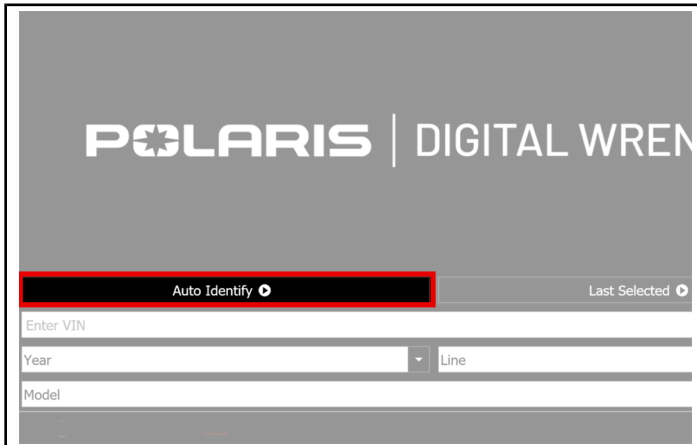
1. Open the Digital Wrench II application.
2. Select **Auto Identify**.

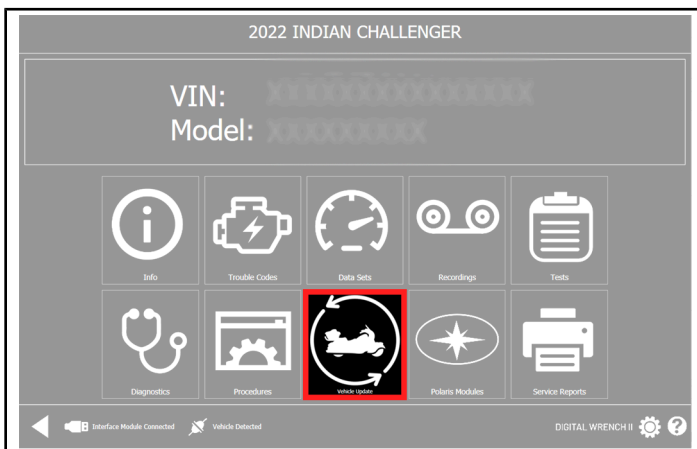
3. Select **Vehicle Update**.

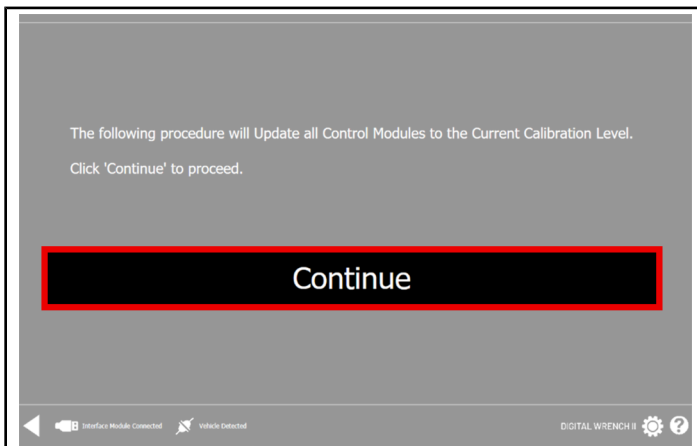
4. Select **Continue**.

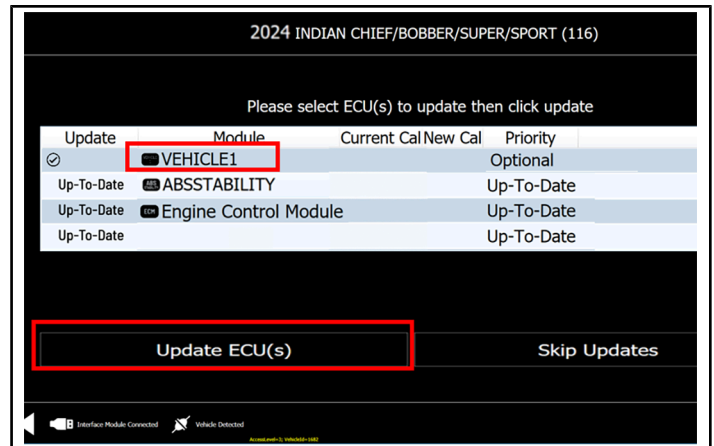
5. Select **Vehicle 1** (VCM). Then select **Update ECU(s)**.

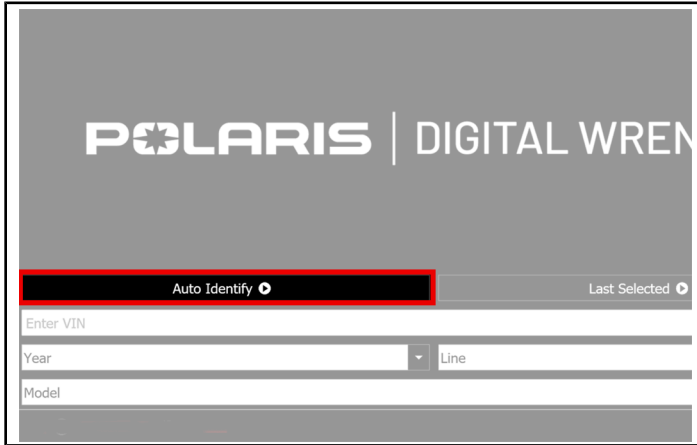
1. Open the Digital Wrench II application.
2. Select **Auto Identify**.

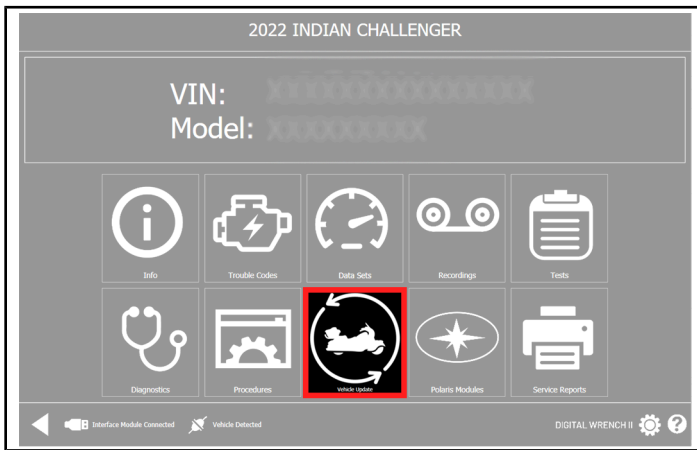
3. Select **Vehicle Update**.

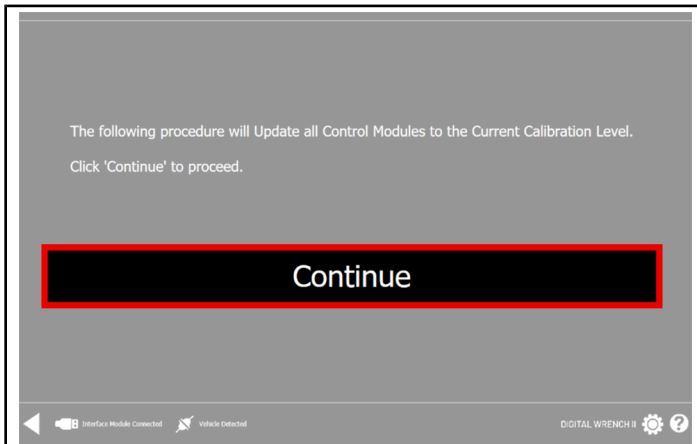
4. Select **Continue**.

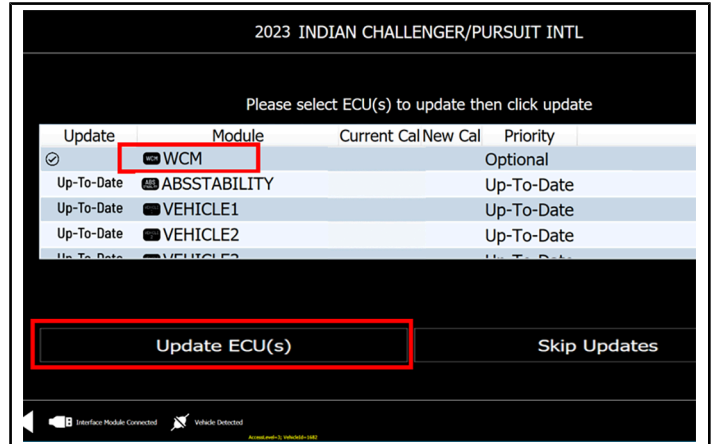
5. Select **Wireless Control Module (WCM)**. Then select

Update ECU(s).
