FCA CARIBBEAN WARRANTY BULLETIN

NO: ID-23-03

SUBJECT: 2018 - 2024 (Current) Jeep
Wrangler (JL) and 2020 - 2024 (Current)
Jeep Gladiator (JT) - Corrosion Warranty
Claim Simplification (Rev. F)

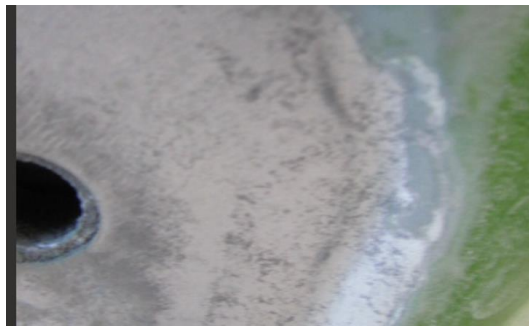
Pitting Found After Sanding Example (Fig. 1)

1. Pitting found after sanding the affected area (Fig. 1)

Note: If pitting is found during the sanding process, please use LOP 23-75-XX-XX for up to 0.5 hours in conjunction with the 23-85 replacement LOP.

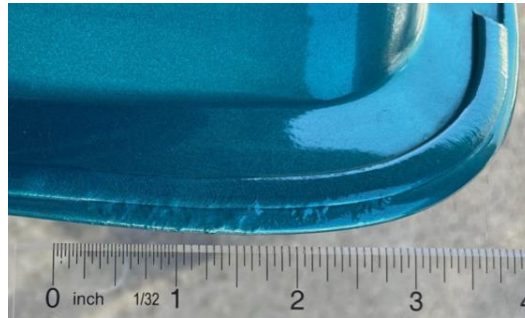
Seam Panel Area Examples (Fig. 2)

2. Corrosion found on the seam of the panel (Fig. 2)

Note: If corrosion is found on the seam of the panel, the door shell will be replaced. No additional sanding in the hinge or seam area is supported.
