Technical product information

Topic	Engine light in the DIP - Various oxygen sensor / Fuel ratio DTC's logged within the Engine Control Module(s)
Market area	Bentley: worldwide (2WBE),China 796 VW Import Comp. Ltd (Vico), Beijing (6796)
Brand	Bentley
Transaction No.	2075331/1
Level	EH
Status	Approval
Release date

Continental GT/C - Flying Spur - Bentayga Series

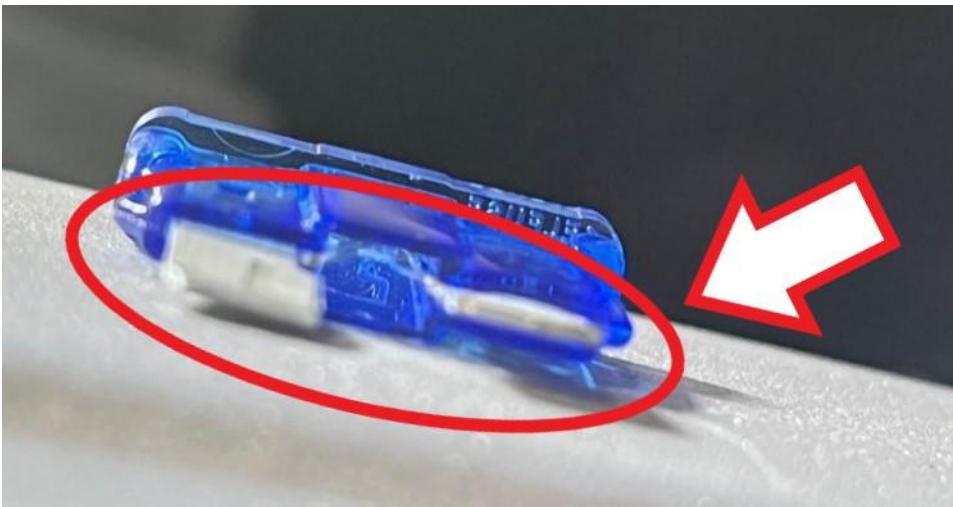
Hint: The fuse blades shown in Figure 1 are damaged / bent, in this scenario the fuse must be renewed, ensure both blades are aligned to both terminals before fitting the fuse

Hint: In this scenario the terminals must be repaired / replaced (depending on damage) once repaired / replaced the fuse must be renewed, ensure both fuse blades are aligned to both terminals before fitting the fuse
