Technical product information

Topic	Fuel gauge operational issues - DTC's B103E1B and/or B10581B evident within address 0046
Market area	Bentley: worldwide (2WBE),China 796 VW Import Comp. Ltd (Vico), Beijing (6796)
Brand	Bentley
Transaction No.	2075354/1
Level	EH
Status	Approval
Release date

Continental GT/C and Flying Spur

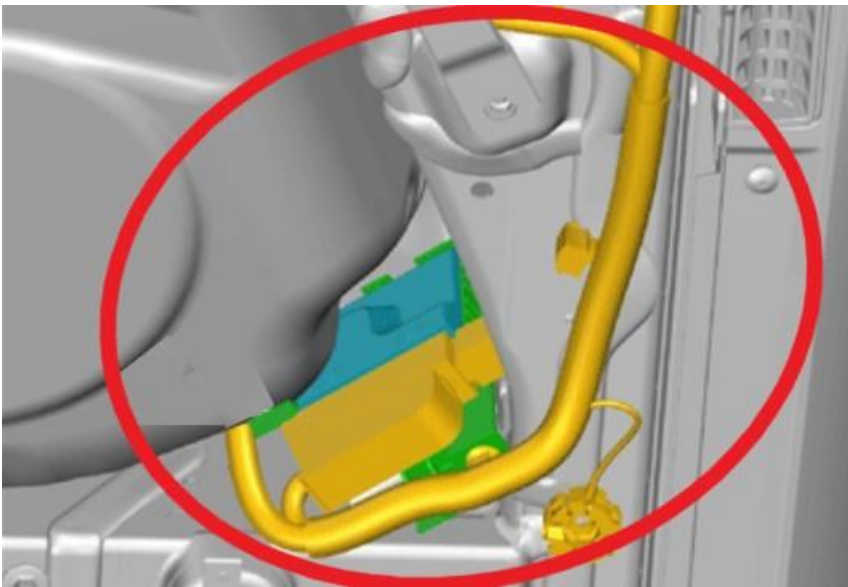
- Referring to Figure 7 and 8 (Point A) - Conduct a check of the wiring harness to confirm if any damage is evident

Should any issues be found regarding wiring harness damage – The operative must raise a new DISS query or update the already existing query ensuring photographs of the issue and a description of the damage is included
