Required Dealer Action

Table 4. Skyline OS Universal Software Update

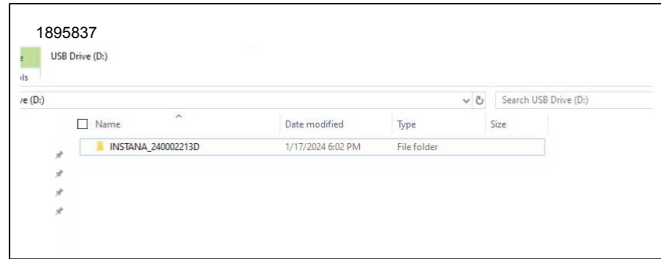
Figure 2. One File on USB 1

- Make sure there is only one Folder on **USB 1**. Figure 2

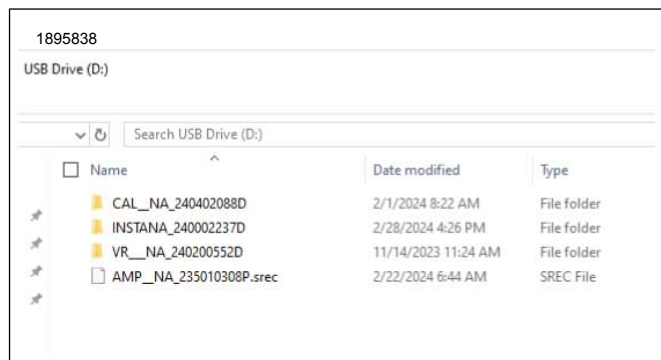
Figure 3. Three Folders and One File on USB 2

- Make sure there are three Folders and one file on **USB 2**. Figure 3

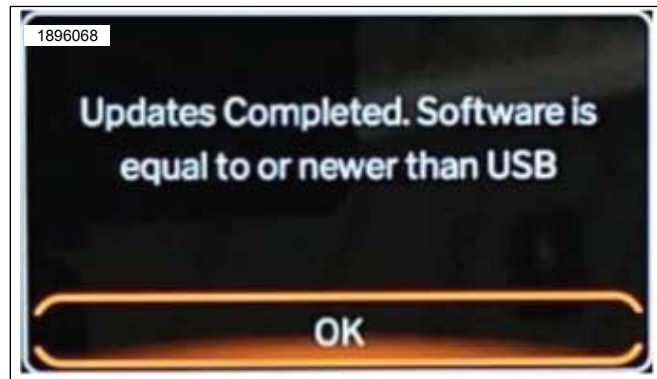
Figure 4.

11. Figure 4 After the last update has been completed, a pop-up message will say: **Updates Completed. Software is equal to or newer than USB.**
 - a. This message will only display for 10 seconds and then will self-clear.
 - b. This message will not display if USB1 is reinstalled on a bike that has already been updated.
