REFERENCE:	TSB: 08-048-24 REV. A GROUP: 08 - Electrical	Date:	October 1, 2024	REVISION:	08-048-24
VEHICLES AFFECTED:	2023 - **2024** (GC) Alfa Romeo Tonale This bulletin applies to vehicles built on or before September 04, 2023 (MDH 0904XX).			MARKET APPLICABILITY:	
				<input checked="" type="checkbox"/> NA	<input type="checkbox"/> MEA
				<input type="checkbox"/> SA	<input type="checkbox"/> IAP
				<input type="checkbox"/> EE	<input type="checkbox"/> CH
CUSTOMER SYMPTOM:	Customers may experience one or more of the following: <ul style="list-style-type: none"> Dome lamps do not illuminate when the door is opened. Dome lamps do not illuminate when switched to ON. 				
CAUSE:	Wiring issue

This bulletin involves modifying the dome lamp wiring harness by adding a resistor in line with circuit M24.

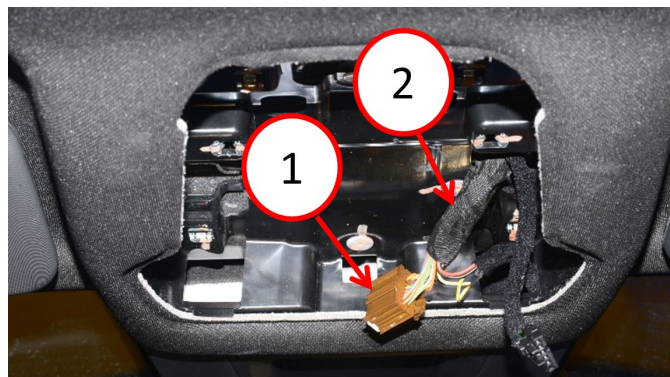
Fig. 1
Dome Lamp Wiring Harness Connector And Tape

1 - Dome Lamp Wiring Harness Connector
2 - Tape To Remove

5. Remove approximately 0.7 - 1.18 cm (2 - 3 in.) of the wiring harness tape, from the dome lamp wiring harness [Fig. 1](#).

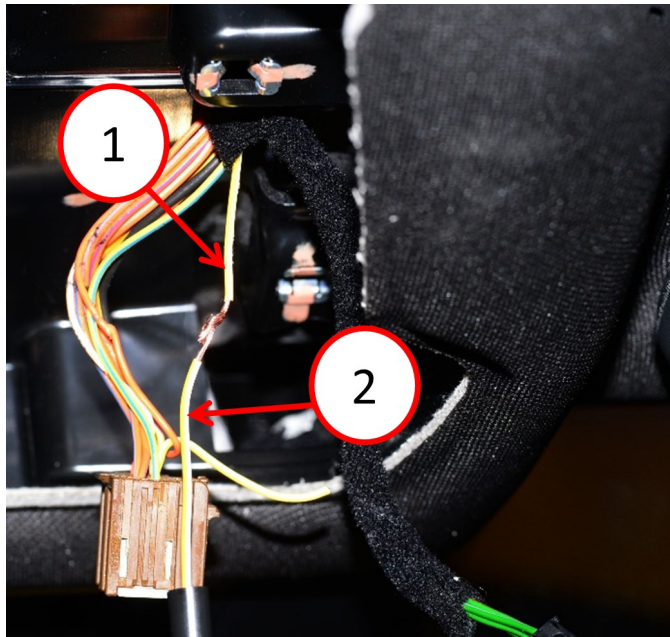
Fig. 4
Yellow/White Wires To Solder

- 1 - Yellow/White Wire From Connector
2 - Yellow/White Wire From Jumper

8. Solder the jumper harness to the dome lamp wire harness (pin 6) yellow/white wire [Fig. 4](#).

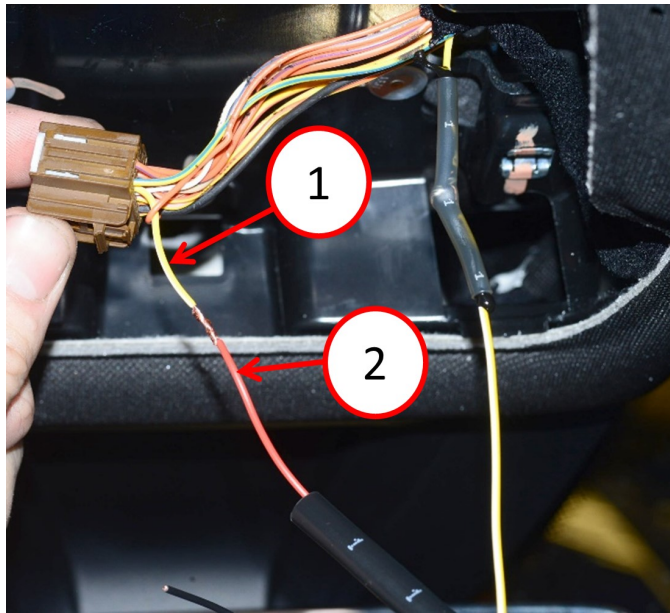
Fig. 5
Red Jumper Harness Wire To Dome Lamp Yellow/White Wire

- 1 - Yellow/White Dome Lamp Connector Wire (pin 6)
2 - Red Jumper Wire Harness Wire

9. Using a suitable heat gun, heat the heat shrink tubing until it is tightly formed around the wires and sealant begins to seep out of both ends of the tubing.
10. Position heat shrink onto the red jumper harness wire and connect the red wire to the cut dome lamp yellow/white wire connector side (pin 6) [Fig. 5](#). **Do not heat the heat shrink tubing.**

11. Solder the red jumper harness wire to the yellow/white dome lamp connector wire (pin 6) [Fig. 5](#).
12. Using a suitable heat gun, heat the heat shrink tubing until it is tightly formed around the wires and sealant begins to seep out of both ends of the tubing.

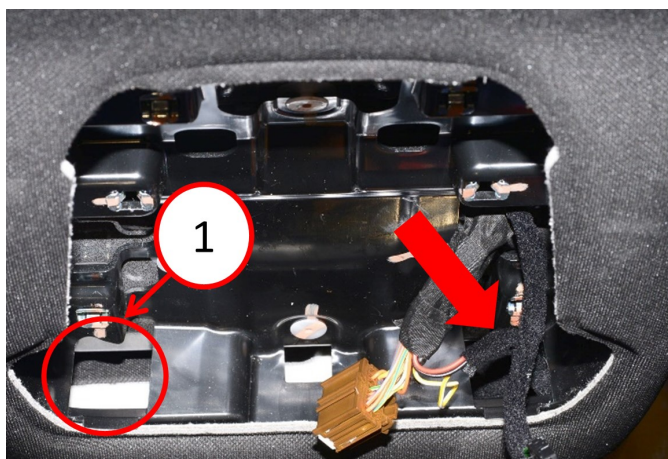
Fig. 7
Dome Lamp Assembly Mounting Cavities

1 - Left Side Dome Lamp Assembly Mounting Square Cavity Shown (Right Side Similar)

14. Position heat shrink onto one of the black wires and connect all three black wires [Fig. 6](#). **Do not heat the heat shrink tubing.**
15. Solder all three black wires from the jumper harness and the dome lamp wire harness black wire [Fig. 6](#).
16. Using a suitable heat gun, heat the heat shrink tubing until it is tightly formed around the wires and sealant begins to seep out of both ends of the tubing.
17. Using tesa tape, tape the soldered wire connections to the dome lamp wiring harness.
18. Insert the dome lamp wire harness with jumper wire harness, into the right side dome lamp assembly mounting square cavity [Fig. 7](#).
