REFERENCE:	TSB: 25-006-24 GROUP: 25 - Emissions Control	Date:	October 1, 2024	REVISION:	14-008-24
VEHICLES AFFECTED:	<p>2019 - 2022 (DJ) RAM 2500 Pickup 2019 - 2022 (D2) RAM 3500 Pickup 2019 - 2022 (DD) RAM 3500 Cab Chassis 2019 - 2022 (DP) RAM 4500/5500 Cab Chassis This bulletin applies to vehicles equipped with the 6.7L I6 Cummins Turbo Diesel engine (Sales Codes ETL and ETN) or a 6.7L I6 Cummins HO Turbo Diesel engine (Sales Code ETM).</p>	MARKET APPLICABILITY:			
		<input checked="" type="checkbox"/> NA		<input type="checkbox"/> MEA	
		<input type="checkbox"/> SA		<input type="checkbox"/> IAP	
		<input type="checkbox"/> EE		<input type="checkbox"/> CH	
CUSTOMER SYMPTOM:	<p>Customers must experience a Malfunction Indicator Lamp (MIL) illumination and the vehicle must exhibit/set the following Diagnostic Trouble Code (DTC):</p> <ul style="list-style-type: none"> • P203E-00 - Reductant Level Sensor 1 Circuit Intermittent-Erratic. <p>Customers may also experience one or more of the following:</p> <ul style="list-style-type: none"> • Repeated freeze/thaw cycles of the urea tank to cause solid DEF crystals to form and settle on the focus tube, blocking the level sensor signal. • Rapi

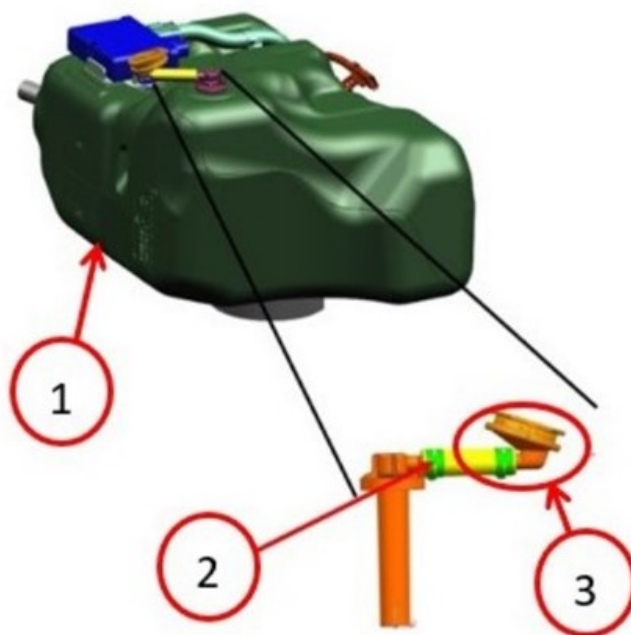
Fig. 1
DEF Tank Assembly

- 1 - DEF Tank
- 2 - Hose Clamp
- 3 - GVV

2. Loosen the hose clamp on the Grade Vent Valve (GVV) hose from the DEF tank [Fig. 1](#).
