Technical Service Bulletin (TSB)
Radio Over The Air Update from
U31.42 to U33.43 Software Version (FOTA)

REFERENCE:	TSB: 08-215-24 GROUP: 08 - Electrical	Date:	October 2, 2024	REVISION:	-						
VEHICLES AFFECTED:	<p>2024 - 2025 (MP) Jeep Compass This bulletin applies to vehicles built on or before November 11, 2024 (MDH 1111XX) equipped with a Global Telematics Box Module (TBM) (Sales Code RDG) and one of the following radios:</p> <ul style="list-style-type: none"> • Uconnect 5 Nav w 10.1" Display (USA) (Sales Code UBN). • Uconnect 5 Nav w 10.1" Display (CAN) (Sales Code UEN). 			<p>MARKET APPLICABILITY:</p>

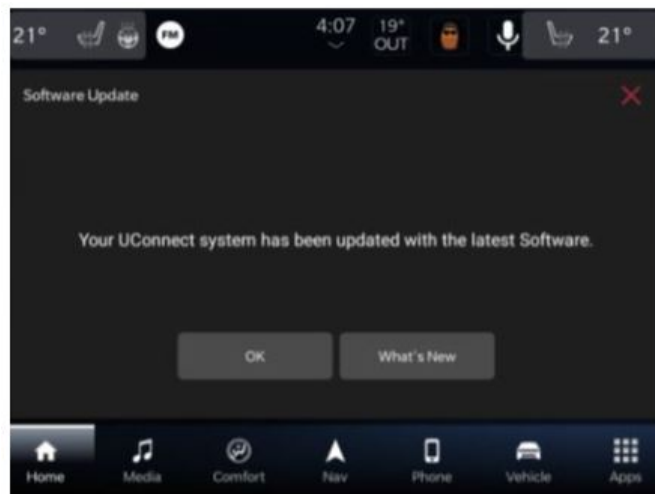
**Fig. 2**

Software Update Confirmation Screen

3. Upon completion of update, the radio will display a confirmation message [Fig. 2](#).
