Technical Service Bulletin (TSB)
Rear Windshield Wipers Operate Continuously

REFERENCE:	TSB: 08-219-24 GROUP: 08 - Electrical	Date:	October 4, 2024	REVISION:	-
VEHICLES AFFECTED:	2022 - 2024 (MP) Jeep Compass This bulletin applies to vehicles equipped with the 2.0L I4 DOHC DI Turbo Engine w/ ESS (Sales Code EC1).	MARKET APPLICABILITY:			
		<input checked="" type="checkbox"/> NA <input type="checkbox"/> MEA <input type="checkbox"/> SA <input type="checkbox"/> IAP <input type="checkbox"/> EE <input type="checkbox"/> CH			
CUSTOMER SYMPTOM:	<p>Customers must experience a Malfunction Indicator Lamp (MIL) illumination and the vehicle must exhibit/set one or more of the following Diagnostic Trouble Codes (DTCs):</p> <ul style="list-style-type: none"> • U1046-00 - LIN 4 Bus. • U0140-00 - Lost Communication With Body Control Module. • U121E-00 - Lost Communication With Steering Wheel Cruise Control Switch. <p>Customers may also comment on one or more of the following:</p> <ul style="list-style-type: none"> • Rear windshield wipers will continue to operate after the windshield wiper switch is turned to OFF. • Electronic Vehicle Information Center (EVIC) is flashing. • The front windows may

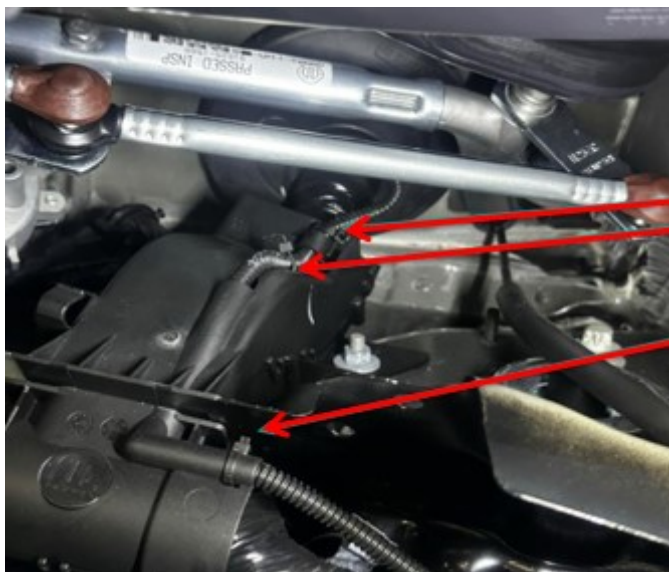
Fig. 1

Washer Hose Trough Tie Down Strap Locations

4. Remove and **DISCARD** the washer hose trough tie down straps [Fig. 1](#).

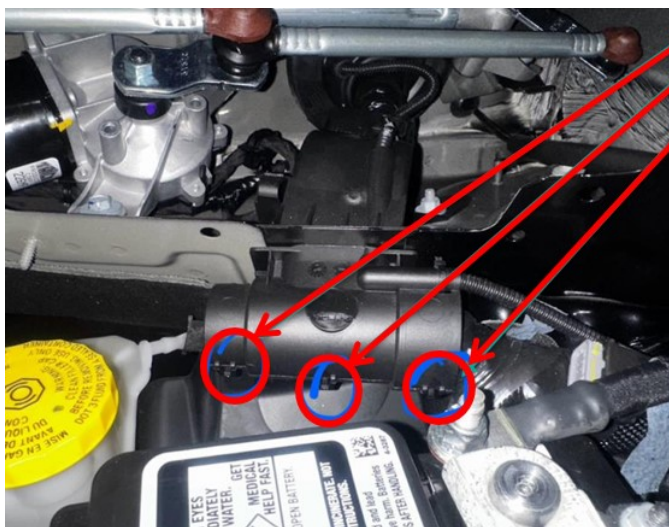
Fig. 2

Washer Hose Trough Clip Locations

5. Release the trough clips [Fig. 2](#).

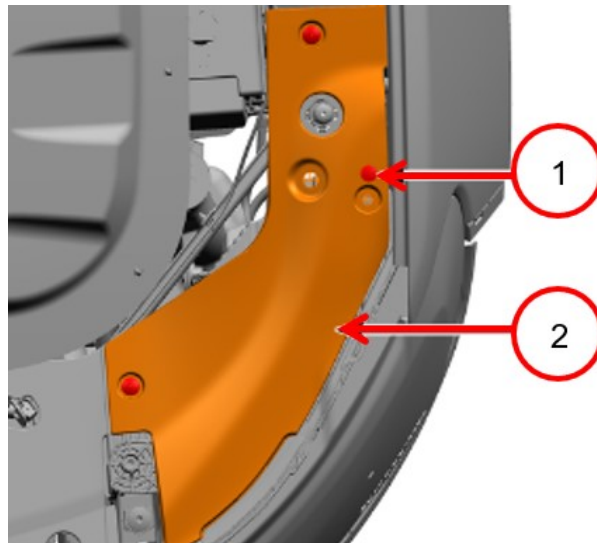
Fig. 3

Headlamp Close Out Panel

6. Remove the headlamp close out panel [Fig. 3](#).

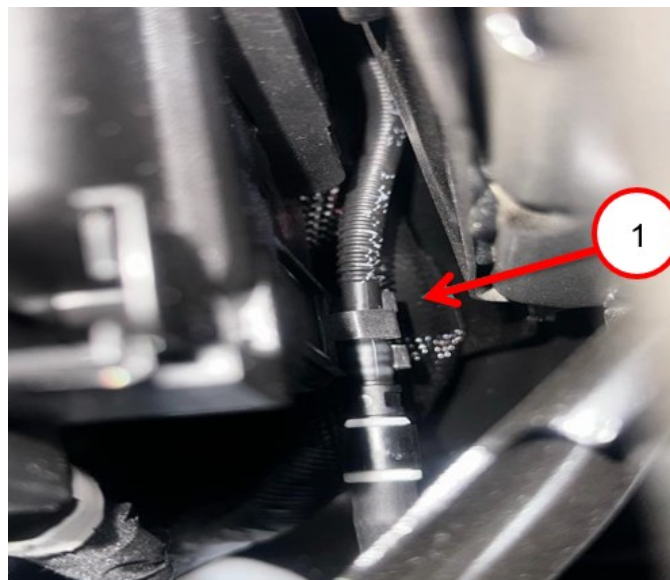
Fig. 4

Washer Hose Location - PDC Support

7. Remove the washer hose from the Power Distribution Center (PDC) support [Fig. 4](#).

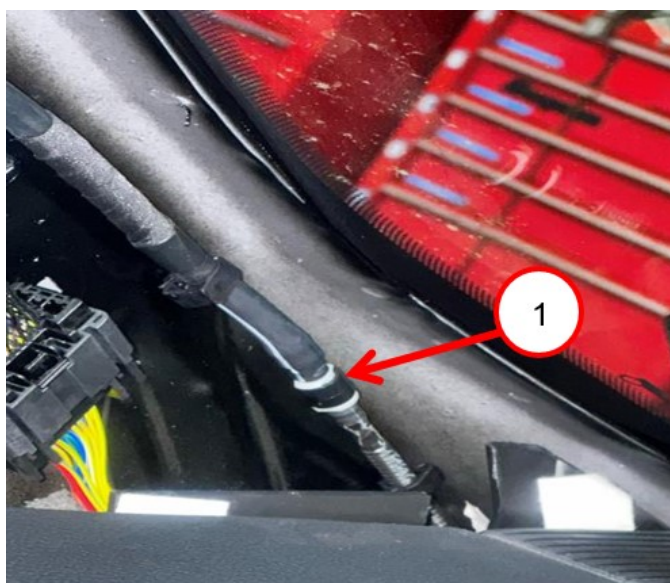
Fig. 5
Rear Windshield Inline Wiper Hose Connection

11. Disconnect the washer hose from the rear windshield inline wiper hose coupler [Fig. 5](#).

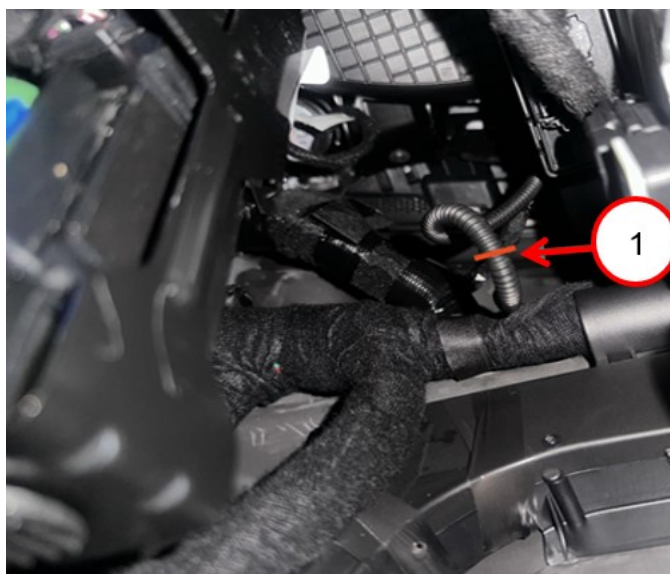
Fig. 6
Damaged Hose Location

1 - Cut Location For Existing Hose

12. Cut the damaged hose under the instrument panel [Fig. 6](#). **Do not remove the hose at this time.**

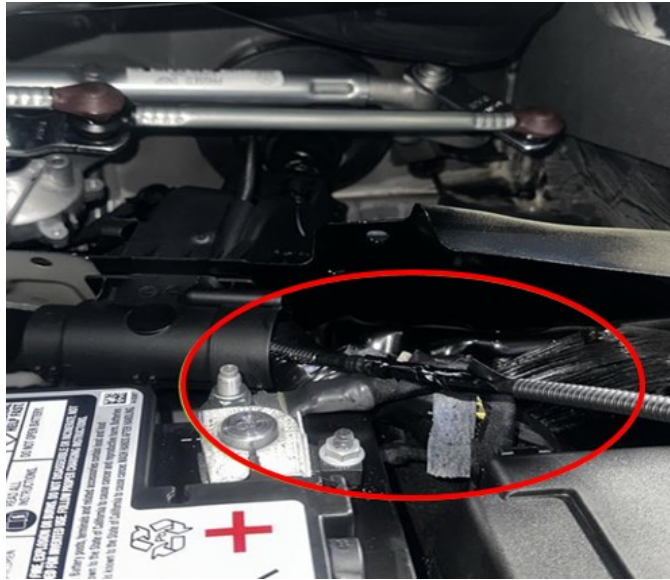
Fig. 7
Hose Overlay

13. Using the cut hose as a guide, secure the new hose with tape to pass the hose through the grommet and the instrument panel to the A-Pillar [Fig. 7](#).

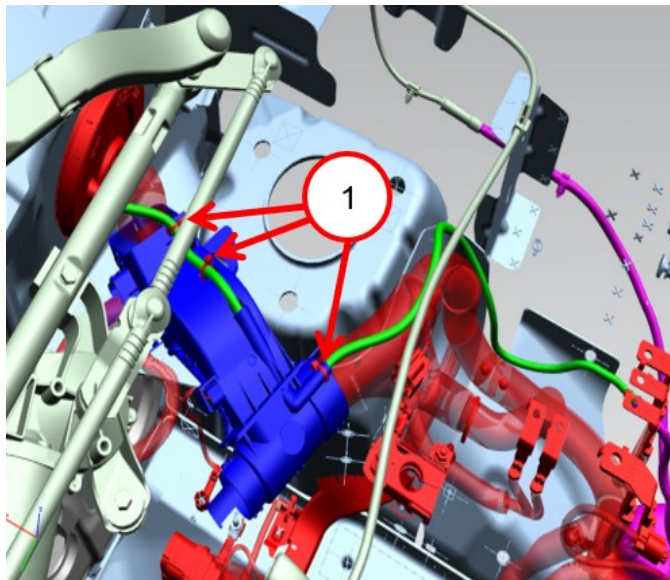
Fig. 8
Washer Hose Trough

14. After routing the new hose, close the clips in the trough and install **NEW** tie down straps [Fig. 8](#).

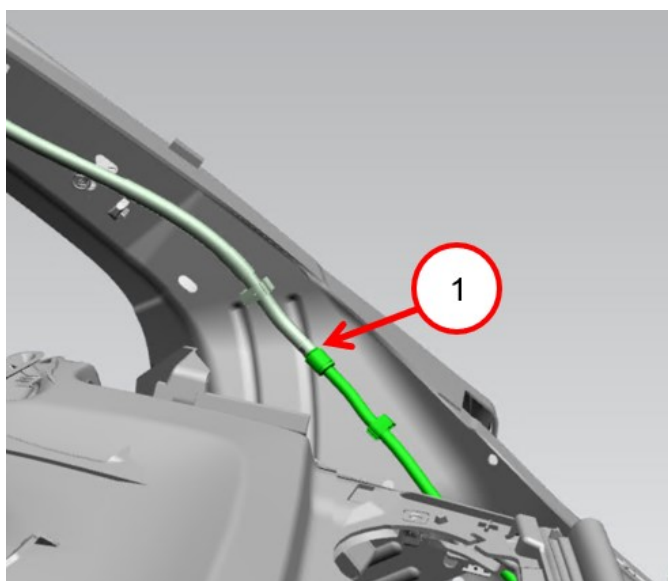
Fig. 9
Rear Washer Inline Hose

15. Connect one end of the new hose to the rear windshield wiper inline hose [Fig. 9](#).

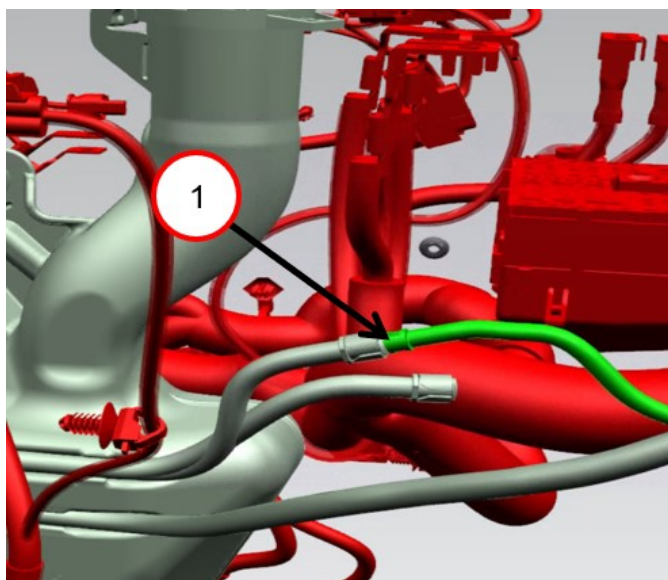
Fig. 10
Windshield Washer Reservoir

8. Disconnect the washer hose from the windshield washer reservoir [Fig. 10](#).
9. Remove the instrument panel end cap. Refer to the detailed service procedures available in DealerCONNECT/Service Library under: Service Info> 23 - Body / Instrument Panel / Cap, Instrument Panel End / Removal.
10. Remove the left side A-Pillar trim panel. Refer to the detailed service procedures available in DealerCONNECT/Service Library under: Service Info> 23 - Body / Interior / Panel, A-Pillar Trim / Removal.

16. Connect the other end of the new hose to the windshield washer reservoir [Fig. 10](#).
