Technical Service Bulletin

SUBJECT:		No:	TSB-24-54-006
DRIVER SIDE DOOR MIRROR DOES NOT OPEN/ CLOSE ON VEHICLES EQUIPPED WITH AUTOMATIC DRIVE POSITIONER SYSTEM		DATE:	September 2024
		MODEL:	Outlander/Outlander Plug-in Hybrid
CIRCULATE TO:	<input type="checkbox"/> GENERAL MANAGER	<input checked="" type="checkbox"/> PARTS MANAGER	<input checked="" type="checkbox"/> TECHNICIAN
<input checked="" type="checkbox"/> SERVICE ADVISOR	<input checked="" type="checkbox"/> SERVICE MANAGER	<input checked="" type="checkbox"/> WARRANTY PROCESSOR	<input checked="" type="checkbox"/> SALES MANAGER

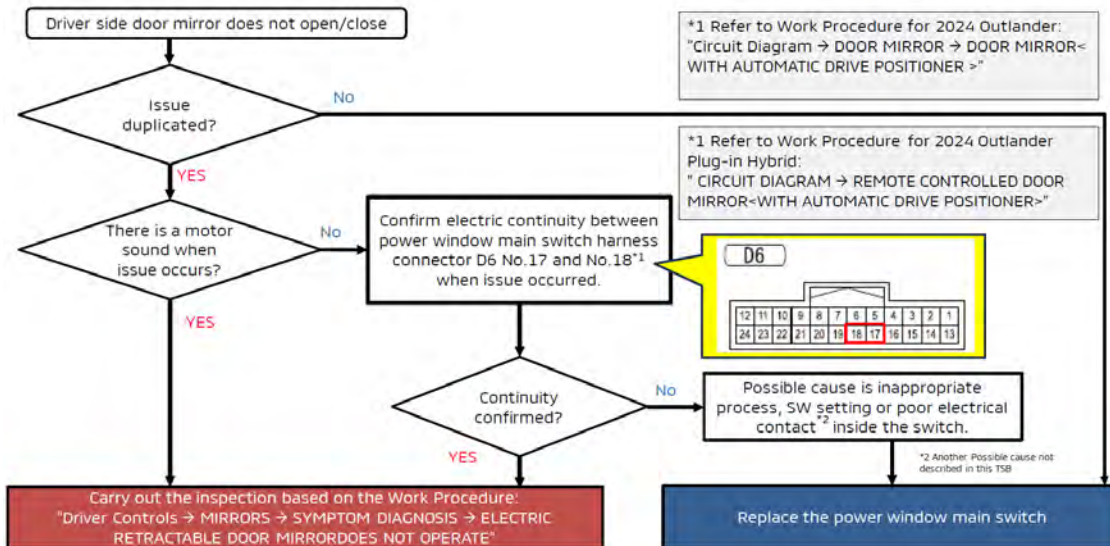
INSPECTION FLOW CHART

The driver side door mirror does not open/close on Outlander and Outlander Plug-in Hybrid vehicles equipped with automatic drive positioner system. This occurs when the driver side Power Window Main Switch fails to receive a signal from the BCM (Body Control Module), causing the software process to stop.

Upon customer complaint and confirmation of the concern, please inspect and if necessary, replace the Power Window Main Switch.

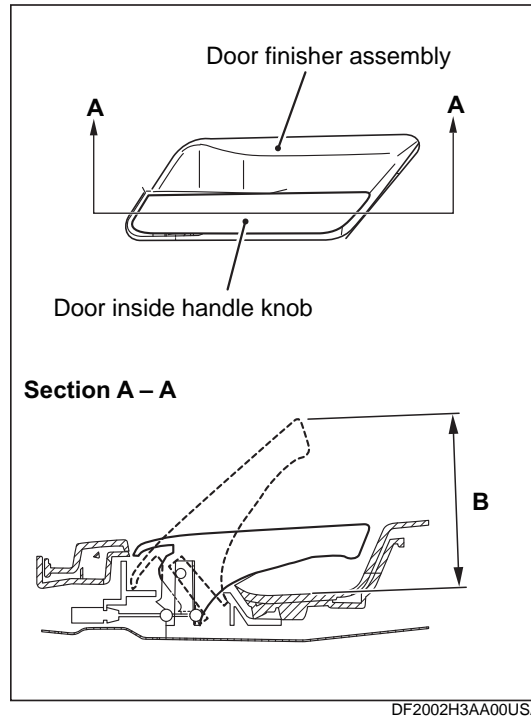
DOOR INSIDE HANDLE KNOB PLAY CHECK

Standard value (B): 13.8 - 30.0 mm (0.55 - 1.18 inch) [Target value: 21.7 mm (0.85 inch)]

1. Check that the door inside handle knob play (stroke until the door latch unlocks) meets the standard value.

2. Check the door inside handle knob and door lock assembly. Replace them if the play is out of the standard value.

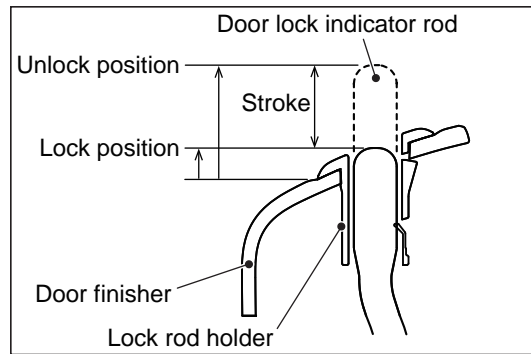
DOOR LOCK INDICATOR ROD STROKE CHECK

Standard value:

Front door: Approximately 12.3 mm (0.48 inch)

Rear door: Approximately 12.0 mm (0.47 inch)

1. Measure the amount of protrusion from the door finisher at the lock position and the unlock position of the door lock indicator rod.

2. Check whether the difference between the amounts of protrusion (stroke) is within the standard value.

3. If it is not within the standard value, check the door lock indicator rod, the door lock assembly and the door inside lock cable (rear only) and replace the defective parts.
