Technical Journal

PS3 Software download issues, temporary solutions

REF NO: TJ 37066.1.0	ISSUING DEPARTMENT: Technical Service	CAR MARKET: United States and Canada	
PARTNER: 3 US 7515 Polestar		ISSUE DATE: 2024-09-04	STATUS DATE: 2024-09-11
FUNC GROUP: 3018	FUNC DESC: Software	Page 1 of 5

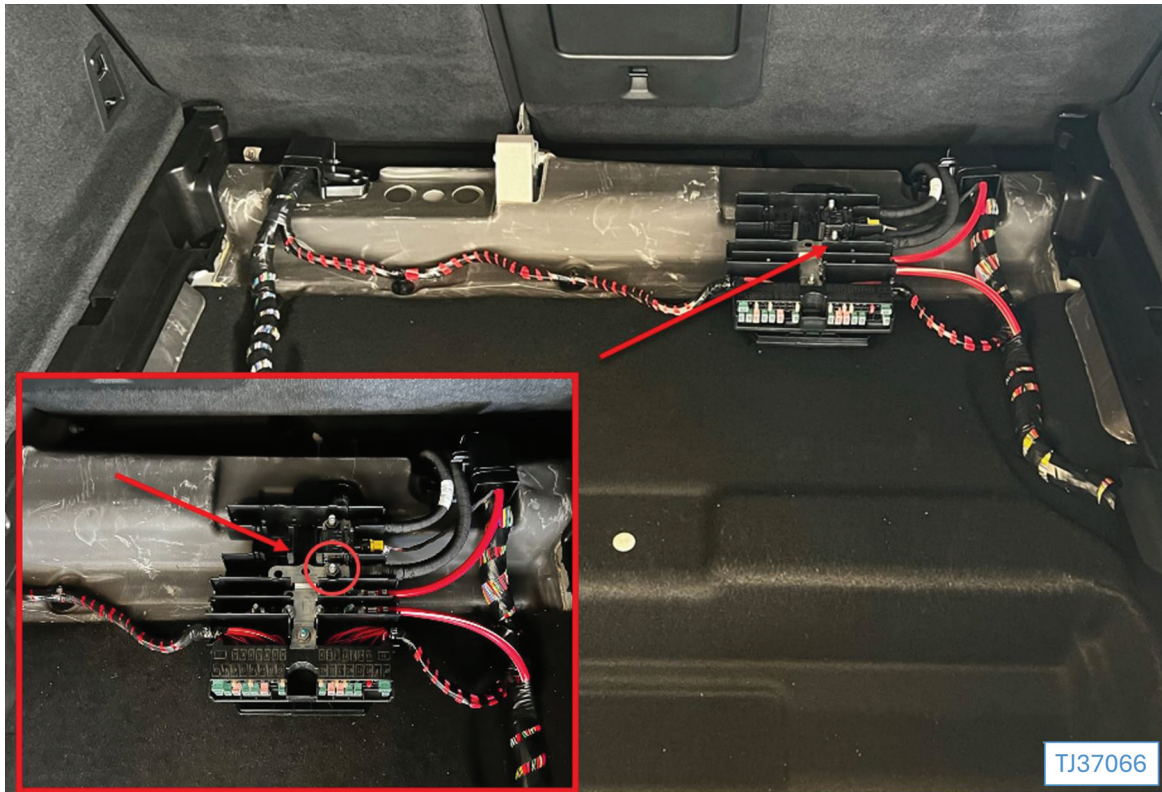
- How to do a 12V hard reset:
 - 1. Disconnect HLCM from RMDB (picture HLCM).
 - 2. Disconnect 12V battery.
- #3. If SWDL failed due to VIUP/D is partly installed (picture VIDA2) follow this:
Check if VIUP/D is in programming or not responding.
