THIS IS A TECH TIP, NOT A TECHNICAL BULLETIN.

Revision Table			
Instance Number	Published Date	Version Number	Reason For Update
2075146/1	09/12/2024	00-24-01TT	Original Publication

Customer complaint regarding wind leak and or water leak while operating vehicle.

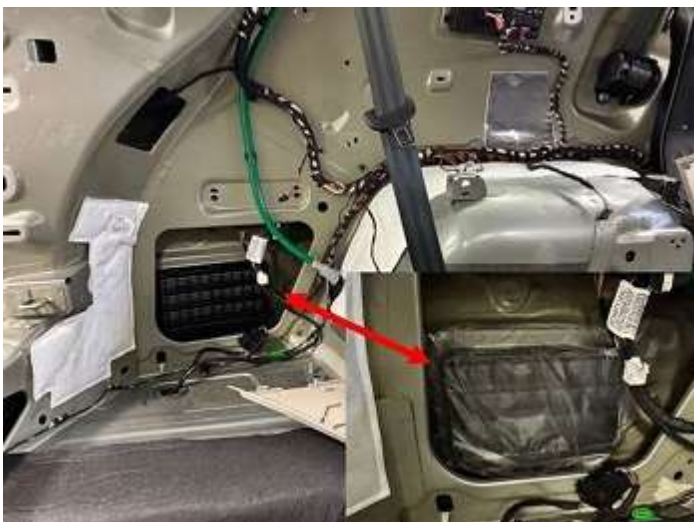
Figure 1.

Figure 1 displays the left rear body vent that needs to be sealed to ensure cabin pressure is retained.

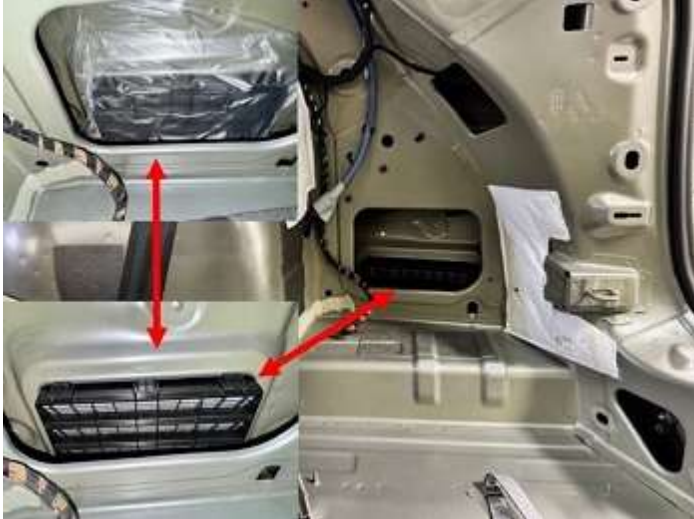
Figure 2.

Figure 2 displays the right rear body vent that needs to be sealed to ensure cabin pressure is retained.

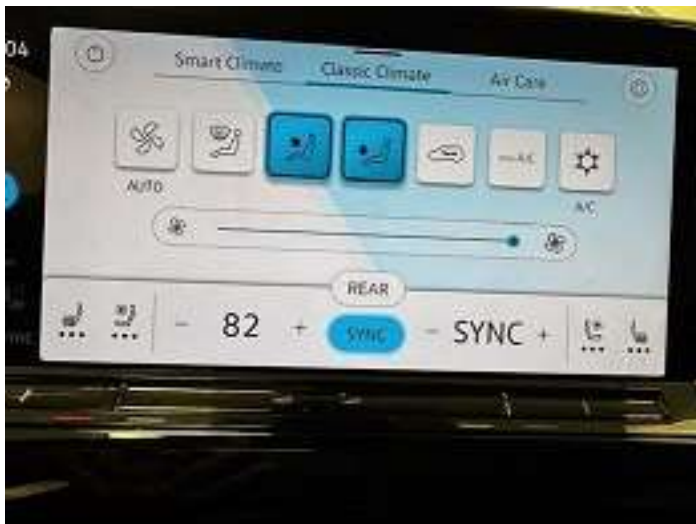
Figure 3.

Figure 3 displays HVAC controls need to be open and set to vent front and lower feet with recirculation OFF and blower speed on high.

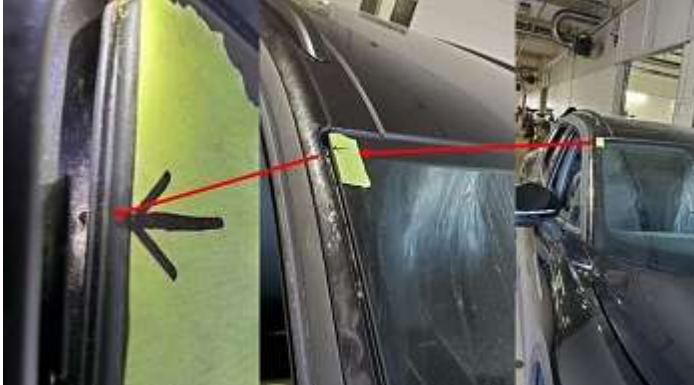
Figure 4.

Figure 4 displays where soapy water can be sprayed and during cabin pressurized will show bubbles forming.

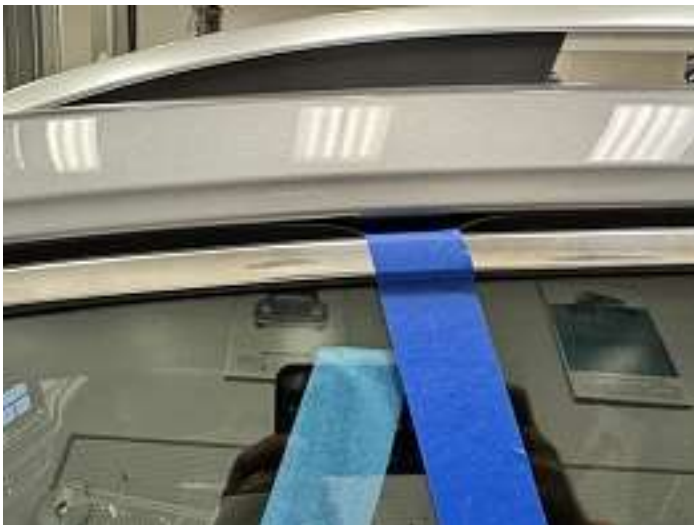
Figure 5.

Figure 5 displays a simulation of a door seal being distorted.

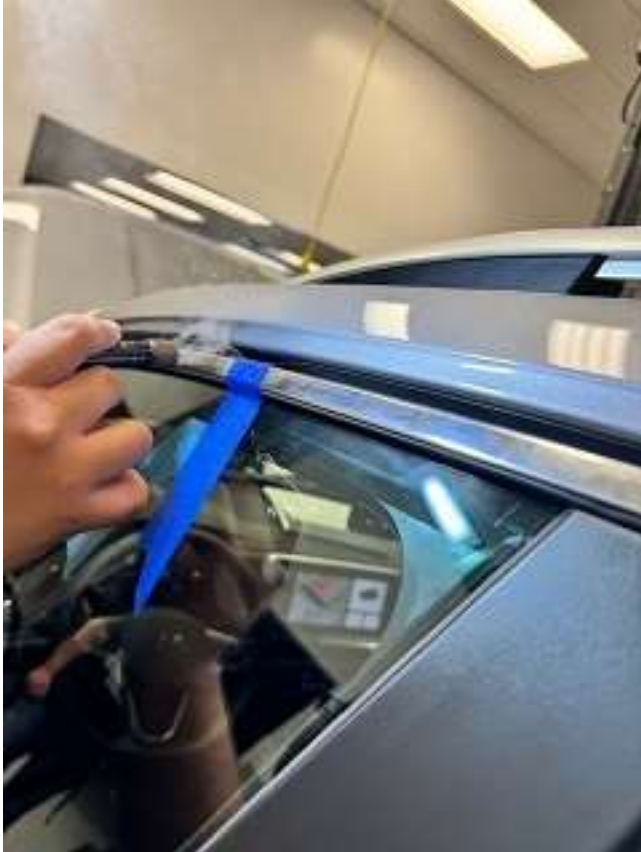
Figure 6.

Figure 6 shows smoke machine on low going towards where the seal is distorted.

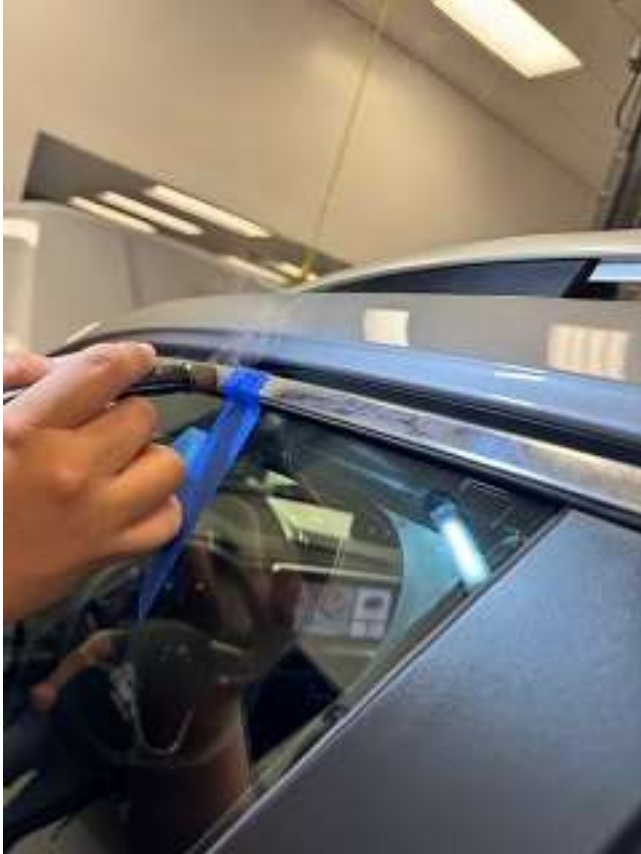
Figure 7.

Figure 7 shows smoke escaping outward due to cabin pressure pushing smoke to indicate a leak.
