01-24-01TT - Front O2 Sensor Bent

Release date: 9/12/2024

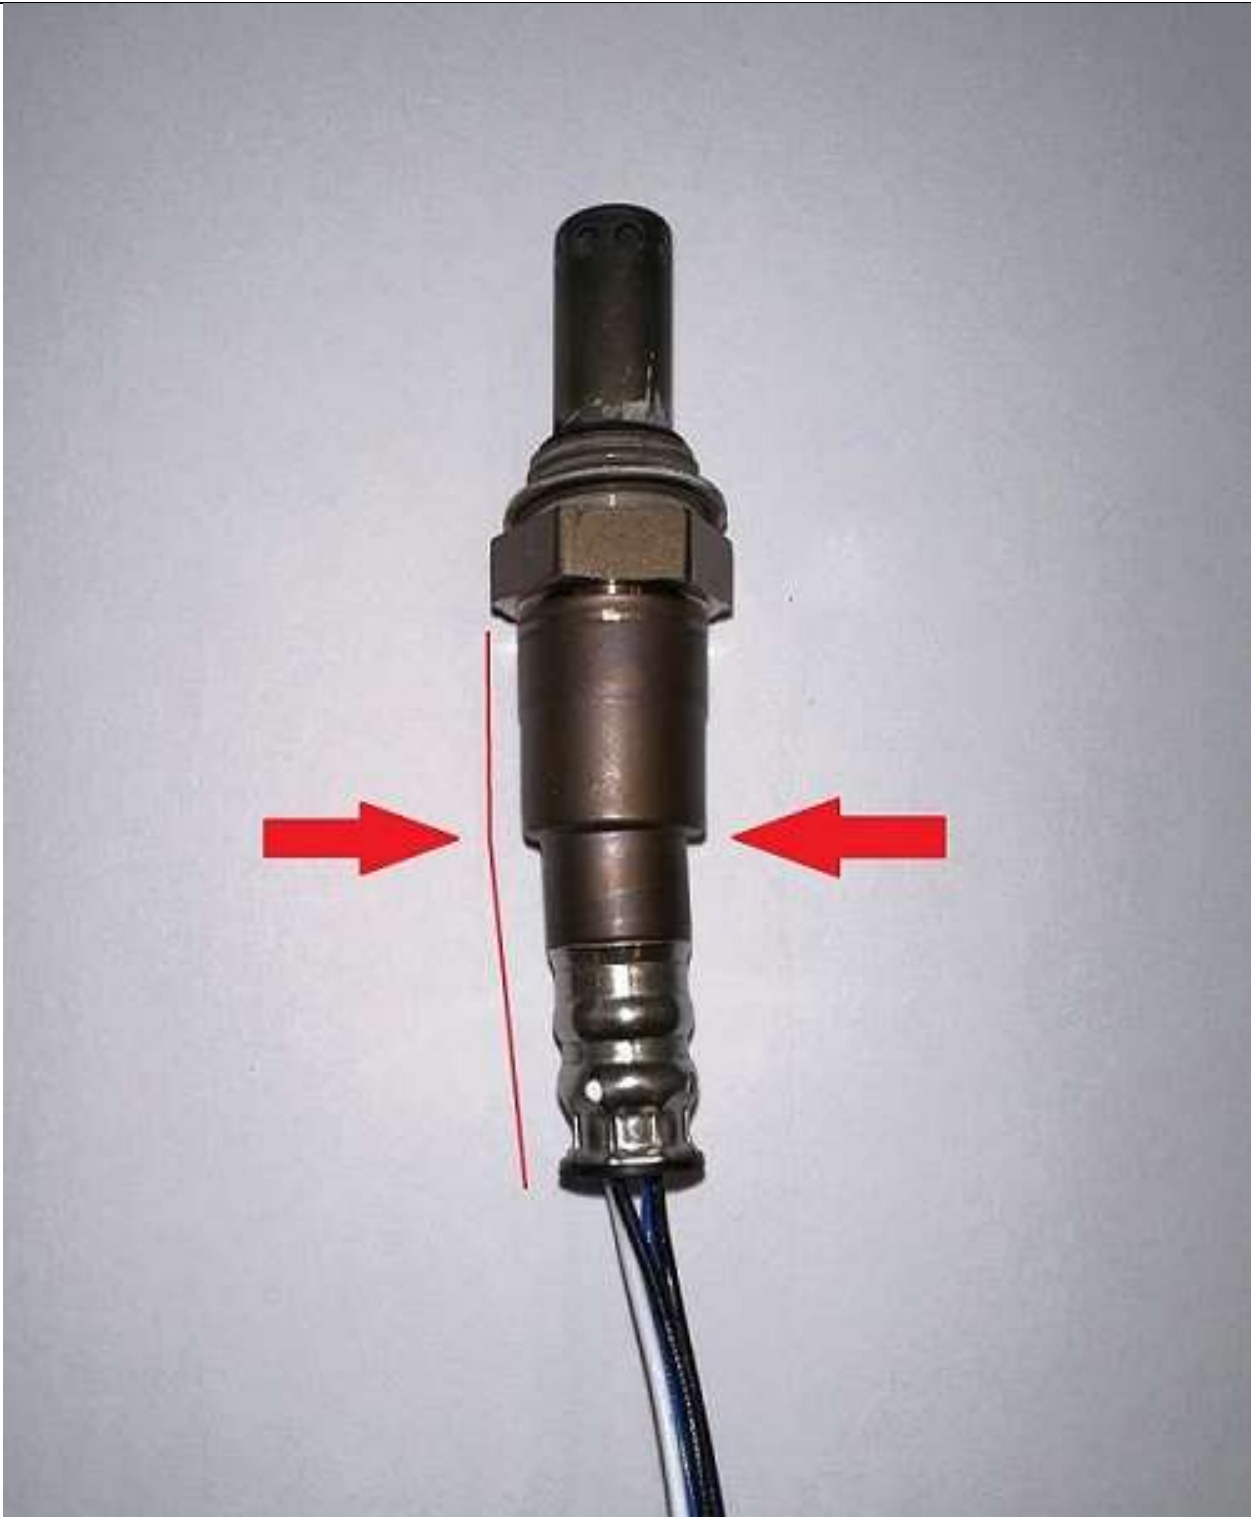
Figure 1.

Damage to the front O2 sensor during factory installation can cause erroneous readings that may result in drivability issues and/or a MIL on. (See Figure 1 below for an example.)

Visually inspect the front O2 sensor for signs of the upper housing being bent. If damage is found, replace the front O2 sensor.
