Tension-releasing impact of the propeller shaft after vehicle has stopped

Topic number	LI27.00-P-074450
Version	3
Function group	27.00 - General
Date	10/1/24
Validity	Diverse model series S-Class, E-Class and C-Class with derivatives with transmission 725 or 722.9 with two-piece propeller shaft, EXCEPT SUV model series 253/166/292/167/463
Reason for change	Clarify Wording

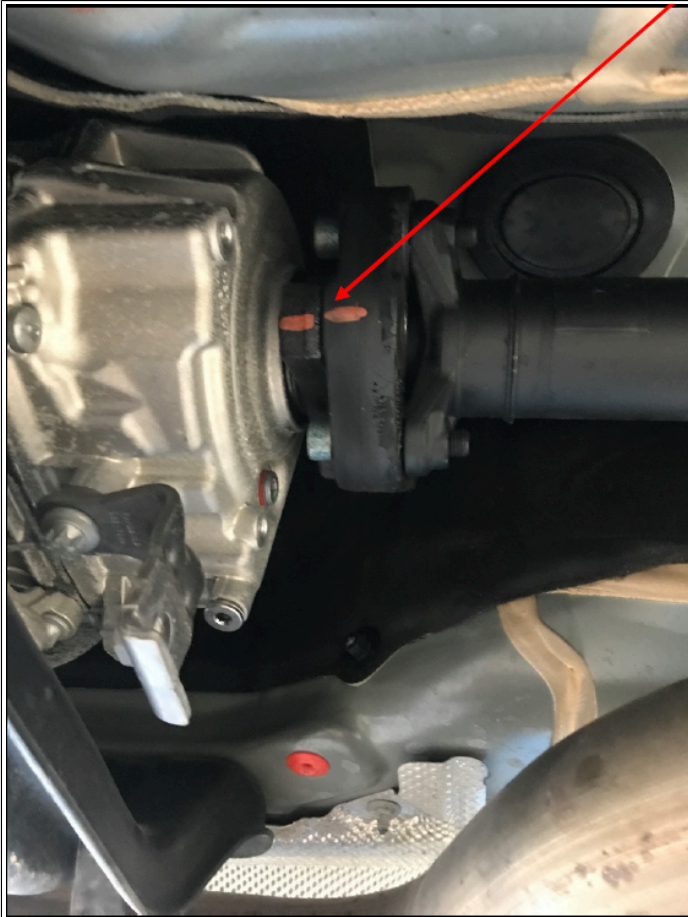
Attachments	
File	Description
Einbauposition_Installation_Position.png	Picture a: Mark installation position

1. Mark the installation position of the joint prior to the removal (picture a+b). This is important for vehicles with a weighted drivetrain ex factory to ensure correct installation after operations have been completed.
2. Clean and degrease propeller shaft toothing. The toothing must be free of grease, e.g. through the use of a brake cleaner. Do not use wire brushes, else the surface could be damaged (picture c).
3. Coat propeller shaft toothing with A 000 989 16 08 Antifriction coating. Coat the entirety, ensuring that the sub-surface is no longer visible. When doing so, only coat the outer toothing. Ensure that the coat is not too thick, otherwise the coating could chip (picture d).
4. Observe the drying time of at least 1 hour.
5. Lightly grease the propeller shaft toothing at the outer and inner toothing with A 001 989 44 51 12 Grease (picture e).

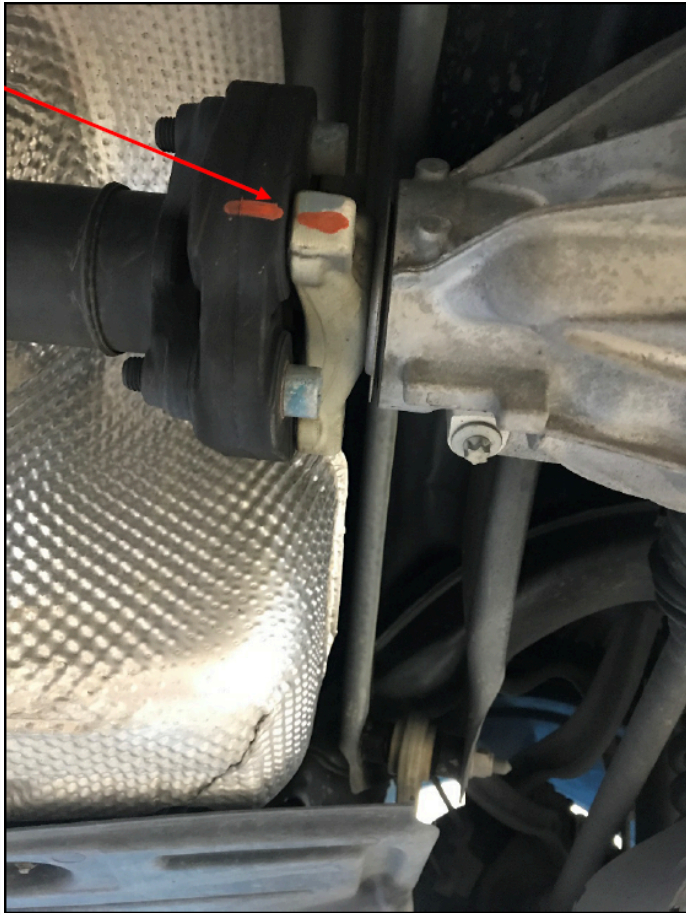
[Einbauposition_Installation_Position_2.png](#)

Picture b: Mark installation position 2

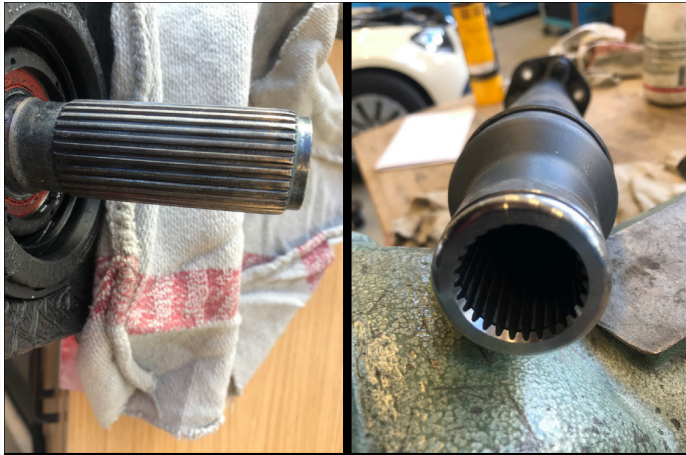
Gelenkwellenverzahnung reinigen und entfetten_Cleaning propeller shaft tothing.png

Picture c: Clean and degrease propeller shaft tothing

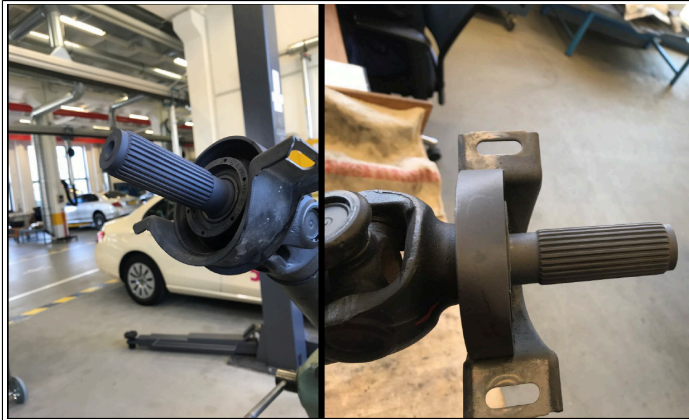
Gelenkwellenverzahnung mit Gleitlack beschichten_Coat prop shaft gears.png

Picture d: Coat propeller shaft tothing with antifriction coating

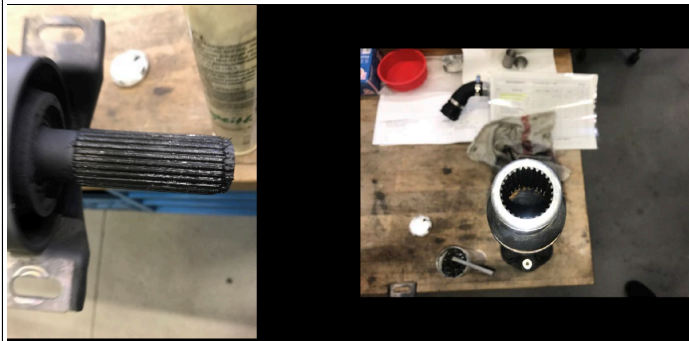
[Gelenkwellenverzahnung_fetten_Grease_Propeller shaft toothing.png](#)

Picture e: Grease propeller shaft toothing
