STAR ONLINE PUBLICATION

Case Number: S2408000113

Symptom/Vehicle Issue: Malfunction Indicator Lamp (MIL) on, Stop Start Inoperative, Electronic Throttle Control (ETC) Lamp Flashes

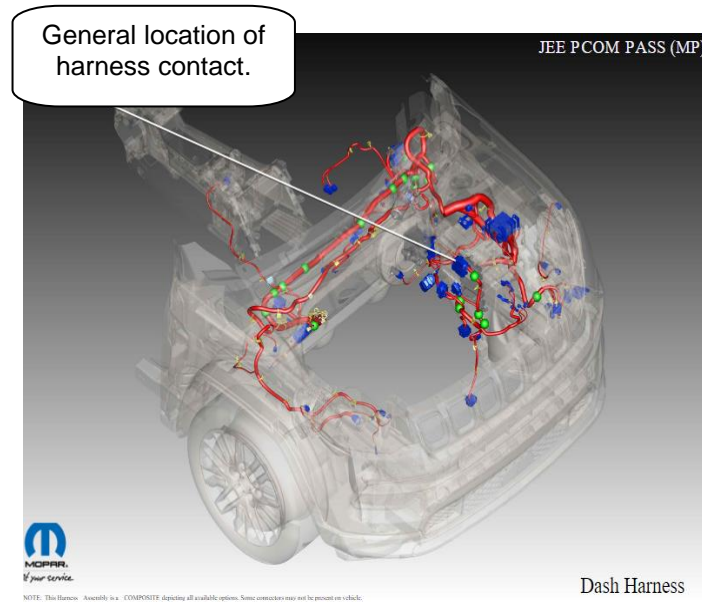
Customer Complaint/Technician Observation: The customer may complain of one or all of the above issues. The technician may find multiple codes setting in the Powertrain Control (PCM) module that may relate to Diagnostic Trouble Code (DTC) P0652 Sensor Reference Voltage Low.

Inspect for the harness routing near the PCM bracket lower mounting stud. Repair and isolate the harness as needed no parts required.
