**Subject: Engine Wire Harness Chafing / IPC Gauges Sweep / IPC Warning Message / SES/Check Engine/MIL / No Start / No Crank / Runs Rough / Stalls / Reduced Engine Power / Various DTCs**

*This bulletin replaces PIT5677E, PIT5713A, PIT5751C and PIT5742. Please discard PIT5677E, PIT5713A, PIT5751C and PIT5742.*

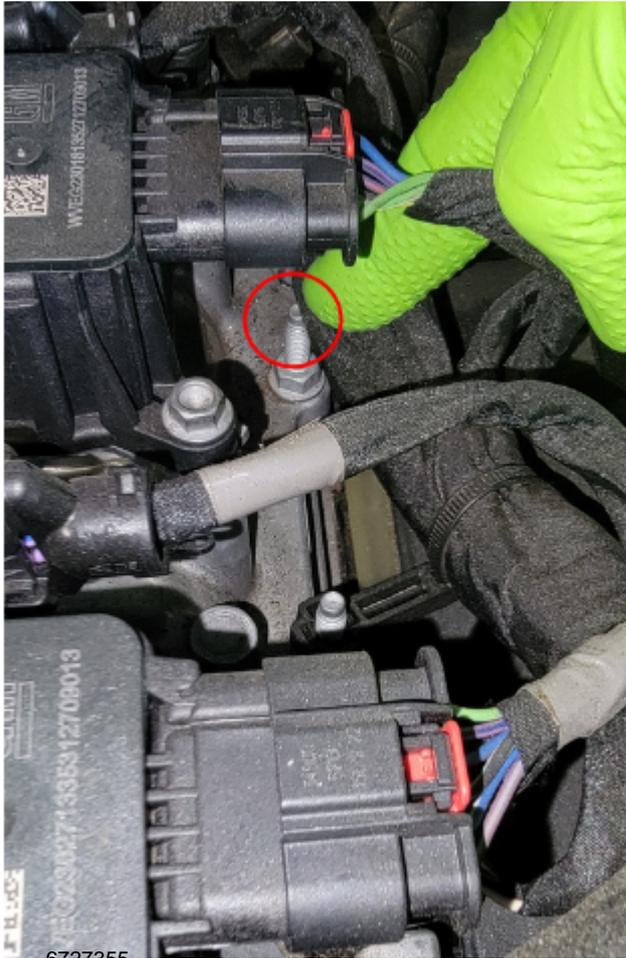
6727355

Inspect the engine harness as it crosses over top of the Camshaft Carrier Cover.

Harness damage can occur at any point across the Camshaft Carrier Cover.

Typical inspection locations shown below.

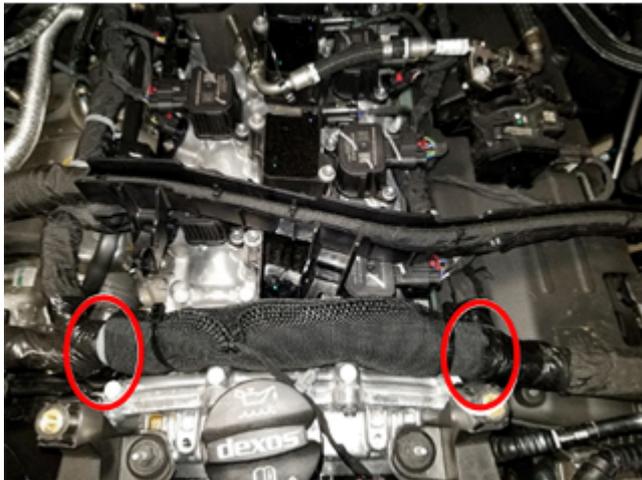
5394681

Wiring harness rub through on a cam cover stud/bolt.

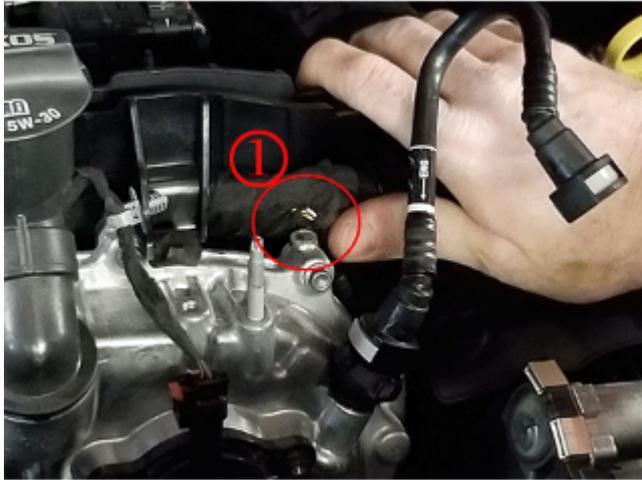
5324748

Example of engine wiring harness damage at Camshaft Carrier Cover shown below.

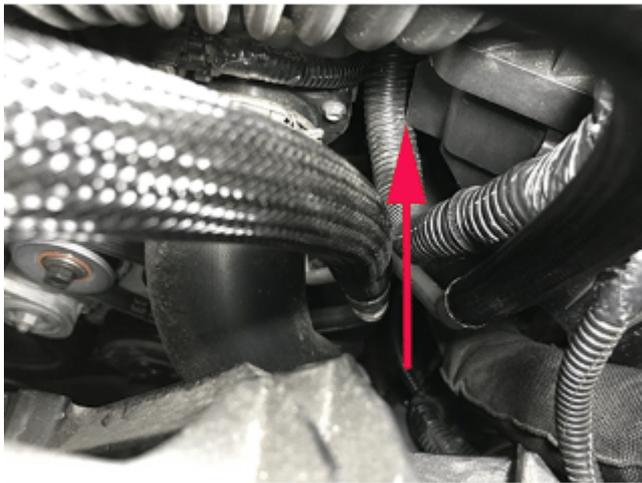
5394683

Inspect the engine harness at the Lower Air Cleaner Housing as shown below.

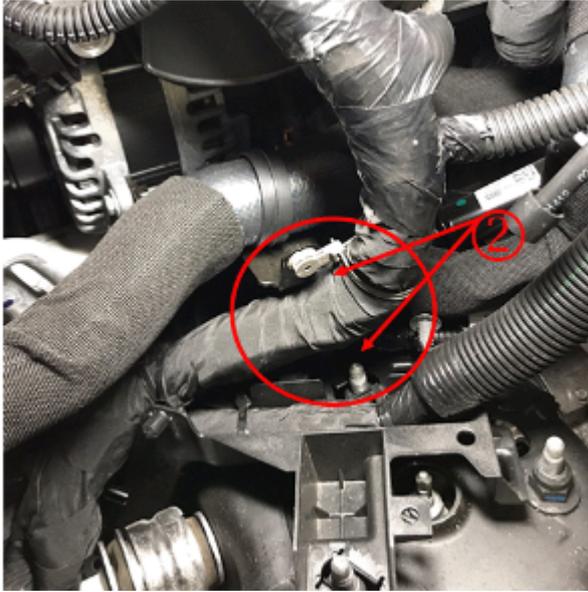
5324752

Inspect the engine harness at the Generator Bracket and Left Front Coil Spring stud as shown below.

**Note:** Under normal driving conditions, the engine will rock back and forth in its mounts.

This may result in harness contact with this bracket that may not be present during engine off inspections.

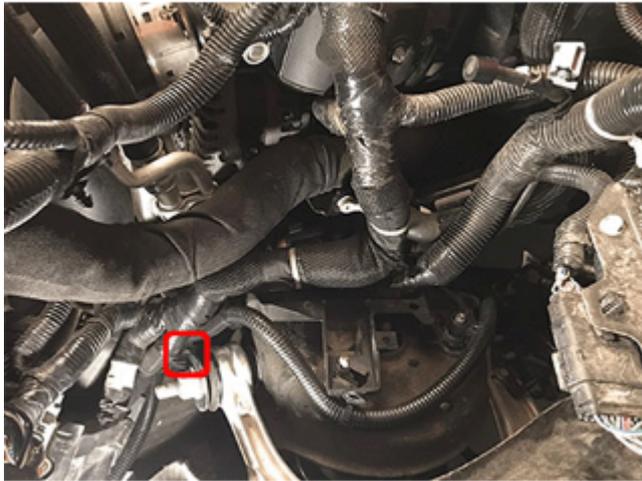
5394677

Inspect the engine harness at the Left Front Upper Control Arm Bushing as shown below.

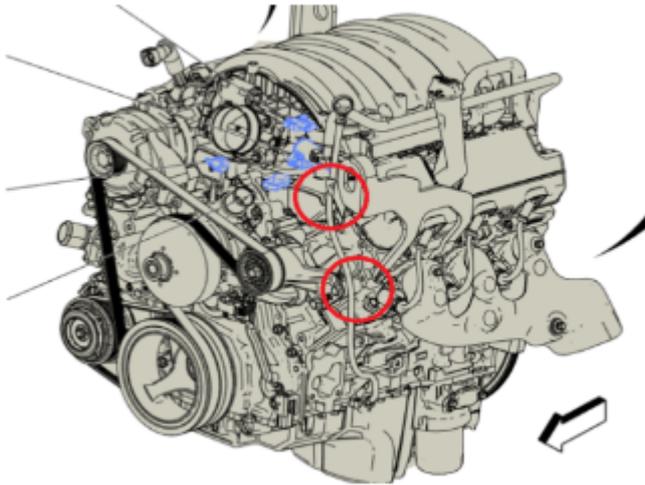
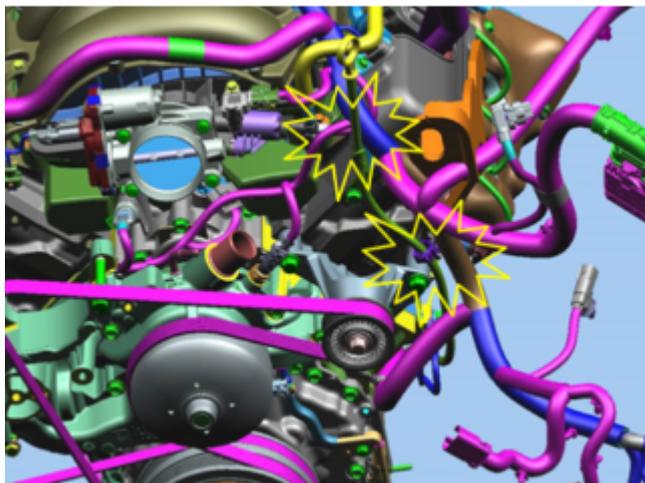
These concerns could be caused by engine wiring harness chafe on underhood components at various locations such as: Front corner of the left-hand cylinder head, drive belt idler pulley bracket, or oil dipstick bracket; noted by the circled and starred areas in the graphics above.

This harness chaffing could cause shorting of any number of circuits to ground. Due to the number of circuits in the harness, there is a wide variety of different symptoms that could occur depending on which circuit(s) are damaged.

To correct this concern, repair the damaged wiring following the SI wire-to-wire repair procedures. Once repaired, protect, and reposition the engine wiring harness to prevent future harness damage.

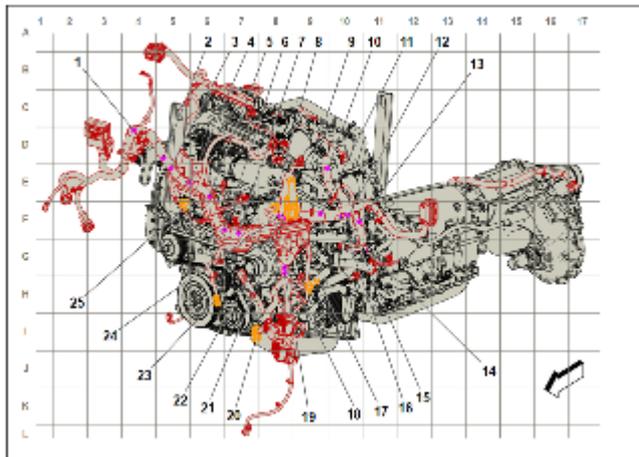
6163833

1. The engine harness pinched/shorted/chaffed at grid coordinates G-8, as shown above. This location is approximately 18 inches from the ECM connectors (1) and on top of the generator (2), as shown below. Due to the number of circuits in the harness, there is a wide variety of different symptoms that could occur, depending on which circuit(s) are damaged.

2. The engine harness shorted/chaffed at grid coordinates C-9, as shown above. The engine harness could be shorted out on the PVC hose clamp at the crankcase pressure regulator, as shown below (6). This is located approximately 4 inches from the crankcase sensor connector pigtail harness breakout.

Inspect areas designated by the graphics and callouts in Cause #3. In many cases, the ECM has been unnecessarily replaced for these concerns. Please thoroughly inspect the areas shown above and follow published SI diagnostics before any parts are replaced. If any concerns are found, then follow SI Wiring and Connector repair instructions to correct the concern.

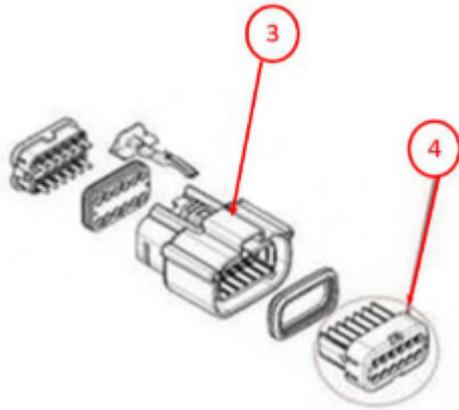
5643650

1. Inspect for poor terminal tension at connector X160, shown in the grid above, as callout 25. While inspecting X160 make sure the terminal locking feature (4), shown below, is not missing.

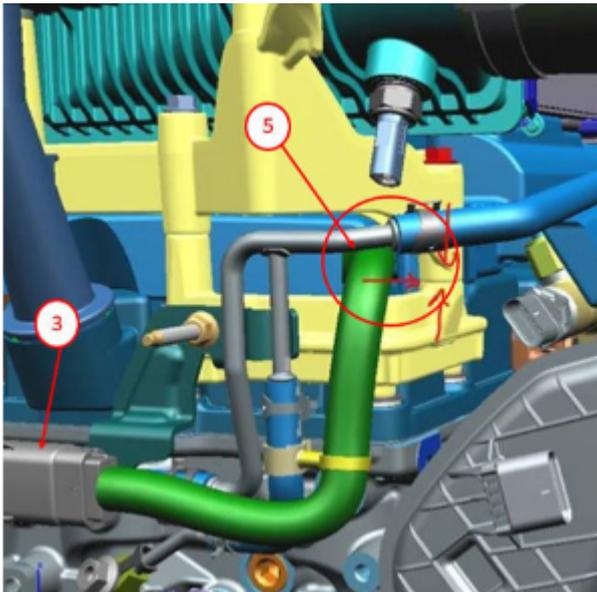
5643651

2. Inspect the fuel injector connectors to make sure they are fully connected/seated.
3. Inspect the fuel injector wiring harness near the X160 connector (3) for being pinched/shorted/chaffed, as shown below (5).

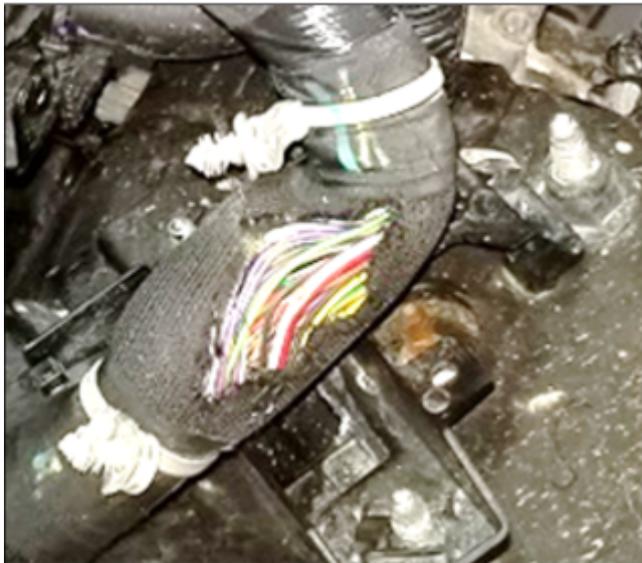
5868347

Examples of extreme wire chaffing.

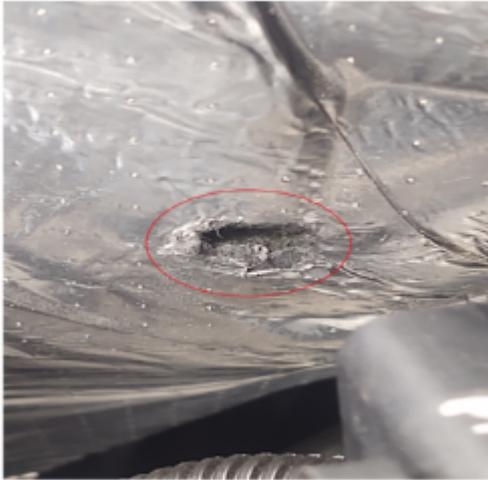
5949751

An example of firewall insulator chaffing

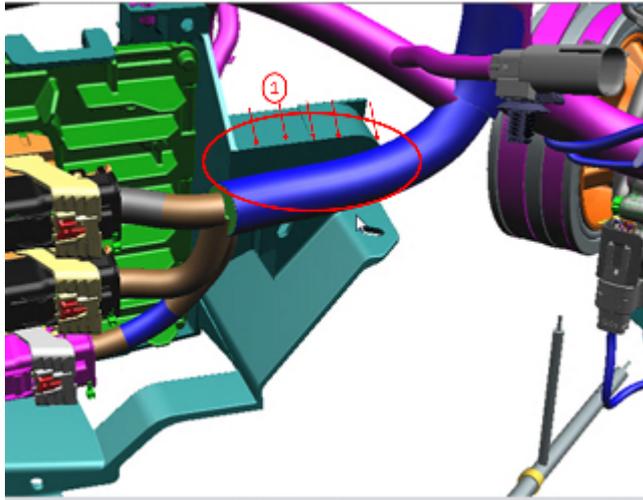
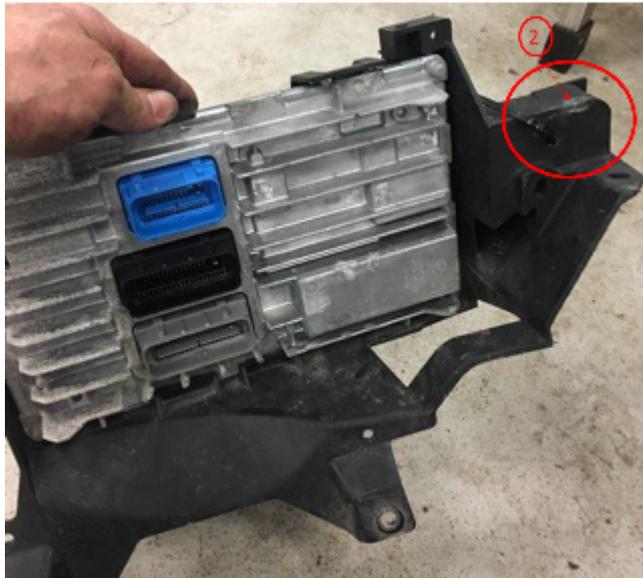
The cause of the condition may be an engine wire harness clip was removed during production due to ergonomic issues (hand clearance and branch stiffness). This led to an uncontrolled branch that came into contact with a sharp edge (1) & (2) on the ECM/TCM bracket, driver side upper control arm, and/or shock tower and caused chaffing during engine vibration and roll.

Utilizing Engine Harness sleeves, anti-abrasion tape, and zip-ties to secure the harness away from one or more of the chaffing points. Follow the Service Procedure steps below.

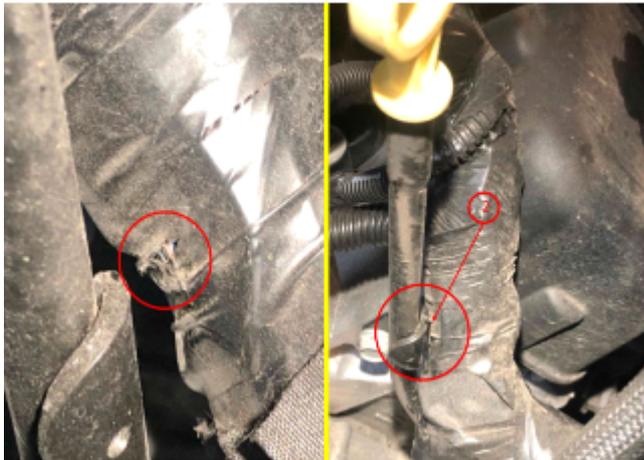
5911722

**Note:** The first graphic below is a before, and after (2), repair example of harness chaffing at the Oil Dipstick bracket.

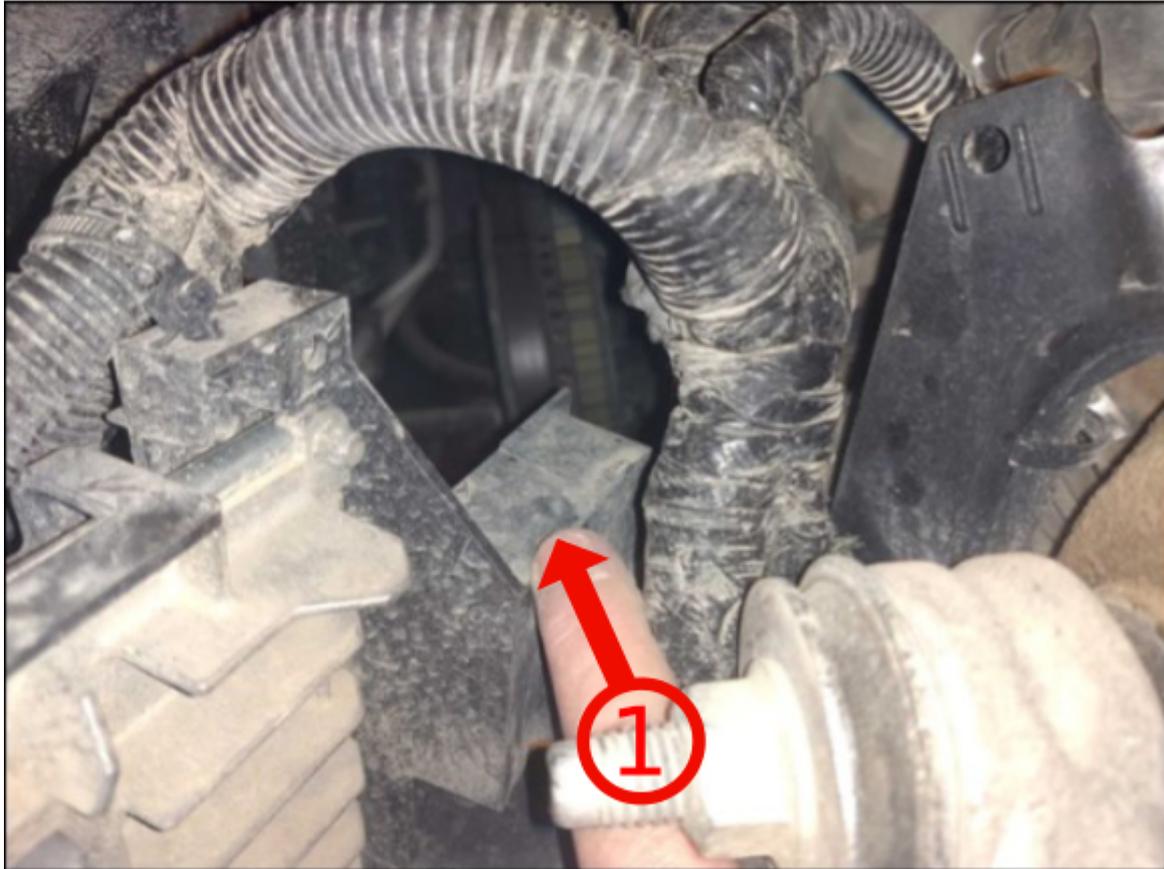
5868349

3. Locate the three contact points where the wire harness is chaffing, the ECM/TCM black bracket (1), the upper control arm (2), and the shock tower bolt (3).
