GENERAL MOTORS
DCS7051
URGENT - DISTRIBUTE IMMEDIATELY

Subject: REVISION: N242456100-01– Service Update
Body Control Module Reprogramming

Models: 2024-2025 Chevrolet Corvette

N242456100 Body Control Module Reprogramming

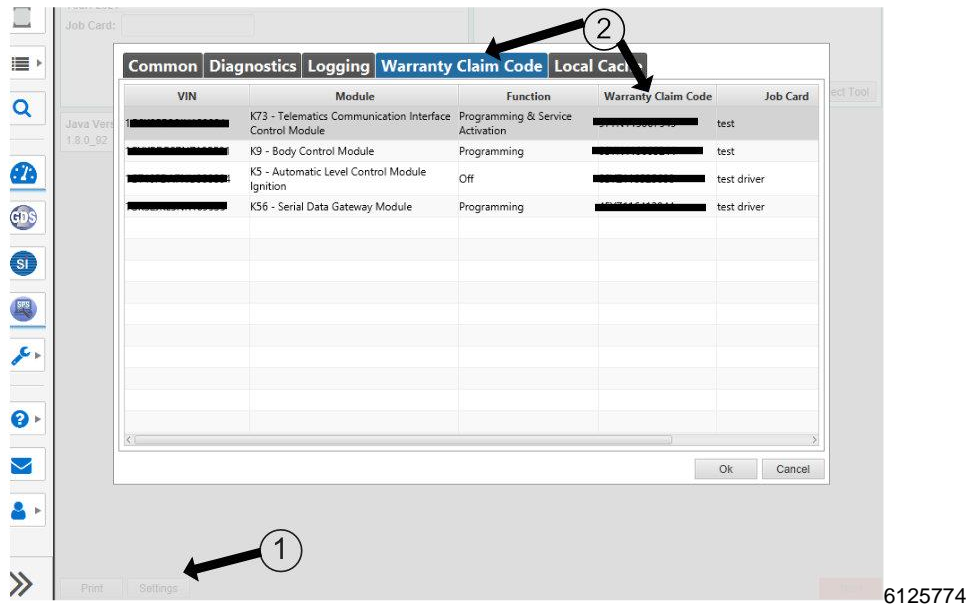
Warranty Claim Code Information Retrieval

If the Warranty Claim Code was not recorded on the Job Card, the code can be retrieved in the SPS2 system as follows:

1. Open TLC on the computer used to program the vehicle.
2. Select and start SPS2.
3. Select Settings (1).
4. Select the Warranty Claim Code tab (2).

The VIN, Warranty Claim Code and Date/Time will be listed on a roster of recent programming events. If the code is retrievable, dealers should resubmit the transaction making sure to include the code in the SPS Warranty Claim Code field.

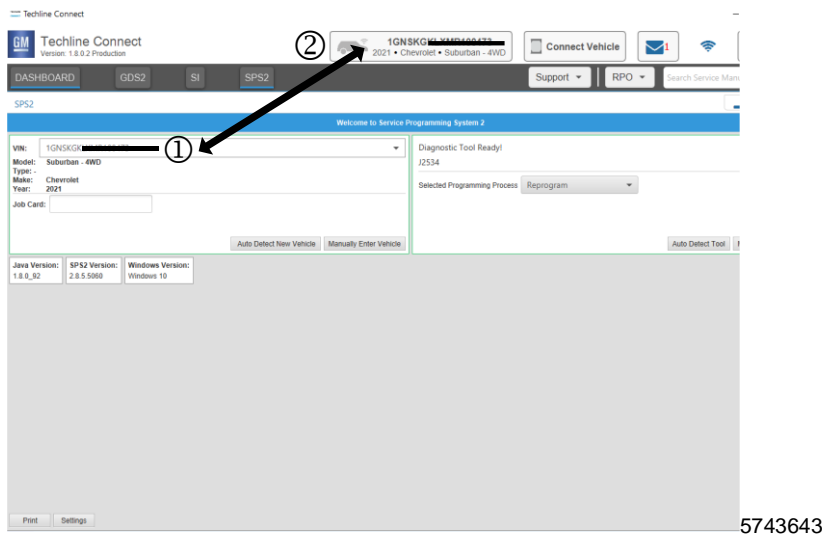
Caution: Be sure the VIN selected in the drop down menu (1) is the same as the vehicle connected (2) before beginning programming.

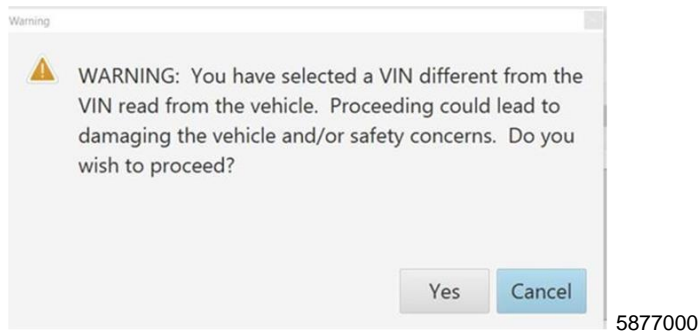
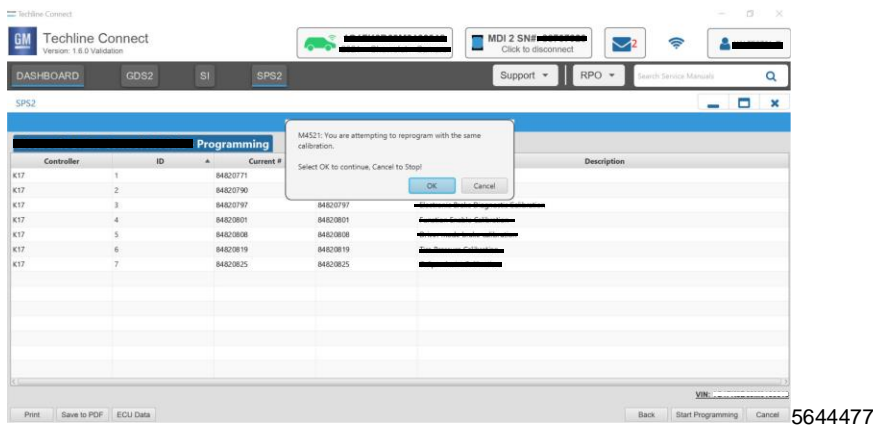
Important: If the vehicle VIN DOES NOT match, the message below will be shown.

- If the VIN that shows up in the TLC top center window after correctly reading the VIN from the vehicle does not match the VIN plate of the vehicle, manually type in the VIN characters from the vehicle VIN plate into the TLC top center window and use these for programming or reprogramming the subject module with the correct vehicle VIN and software and/or calibrations.

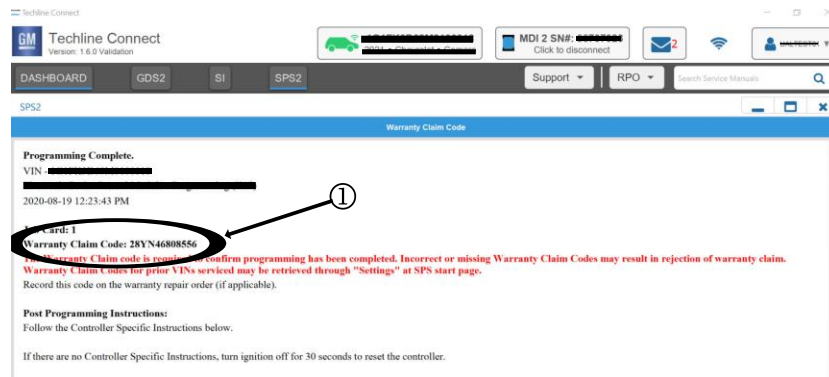
Note: The screenshot above is an example of module programming and may not be indicative of the specific module that is being programmed. Module selection and VIN information have been blacked out.

Important: To avoid warranty transaction rejections, you **MUST** record the warranty claim code provided on the Warranty Claim Code (WCC) screen shown above on the job card. Refer to callout 1 above for the location of the WCC on the screen.

1. Reprogram the K9 Body Control Module. Refer to *K9 Body Control Module: Programming and Setup* in SI.

2. Record SPS Warranty Claim Code on job card for warranty transaction submission.
