Service Bulletin

Bulletin No.: 18-NA-073

Subject: Repair Guidelines for Engine Component Wear

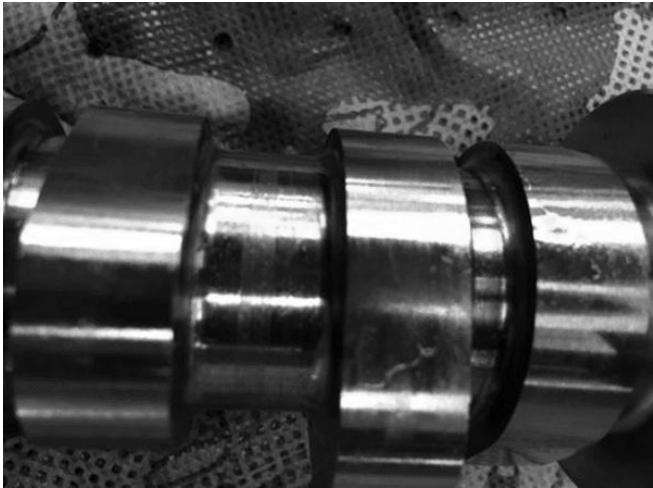
4994025

Example of minor scratching/scoring visible on camshaft lobes and/or camshaft bearing journals. In this example, the scored components can be replaced without need for engine assembly replacement.

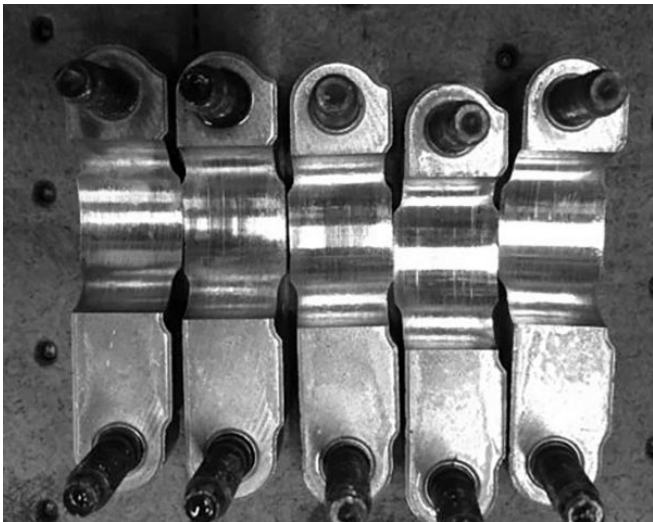
4991477

Example of minor scratching/scoring visible on camshaft bearing caps. In this example, the scored components can be replaced without need for engine assembly replacement.

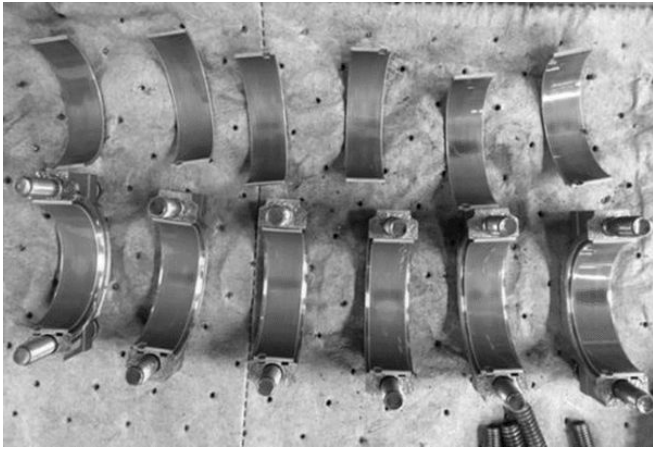
4992132

Example of minor scratching/scoring visible on connecting rod bearings. In this example, the scored components can be replaced without need for engine assembly replacement.

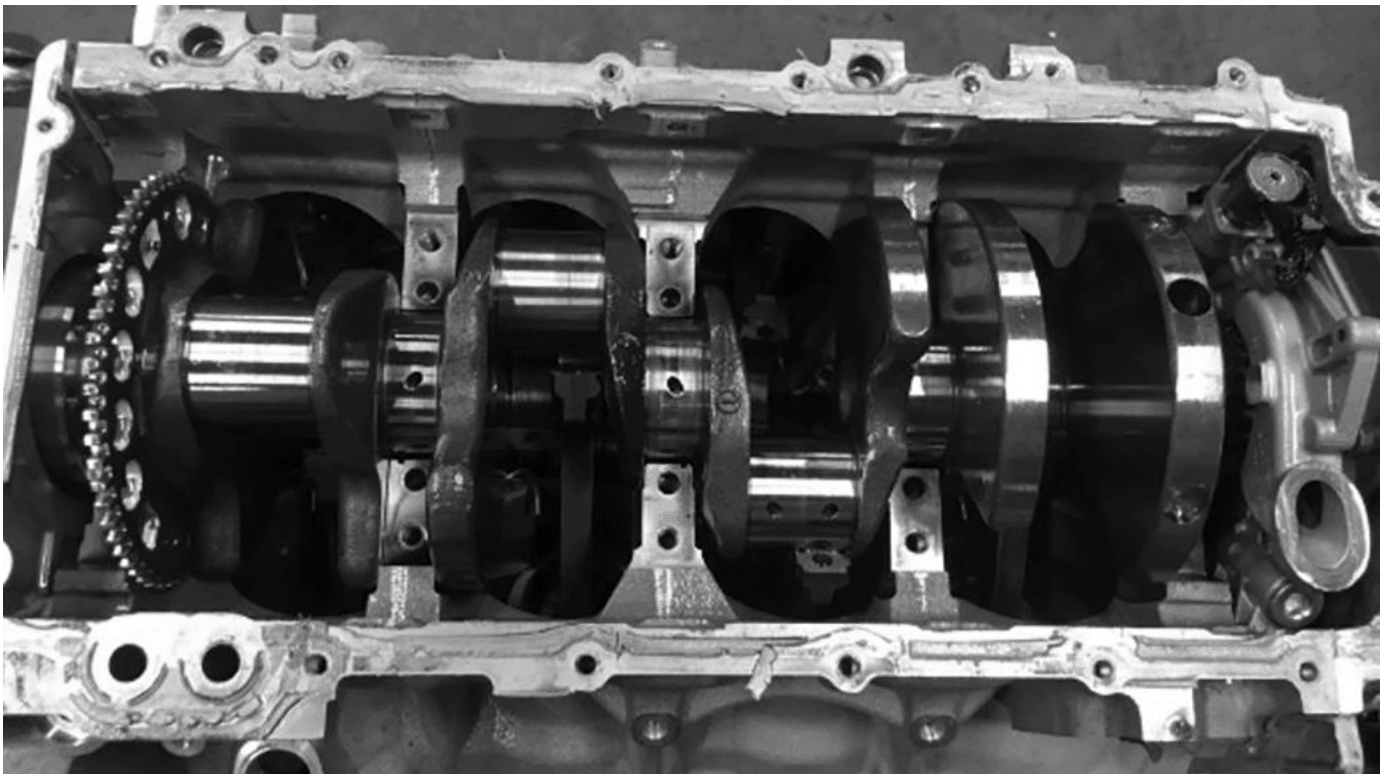
4990880

Example of minor scratching/scoring visible on crankshaft. In this example, the scored components can be replaced without need for engine assembly replacement.

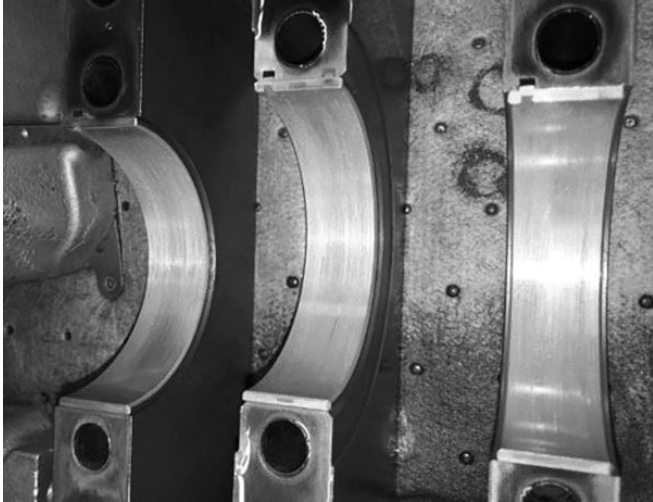
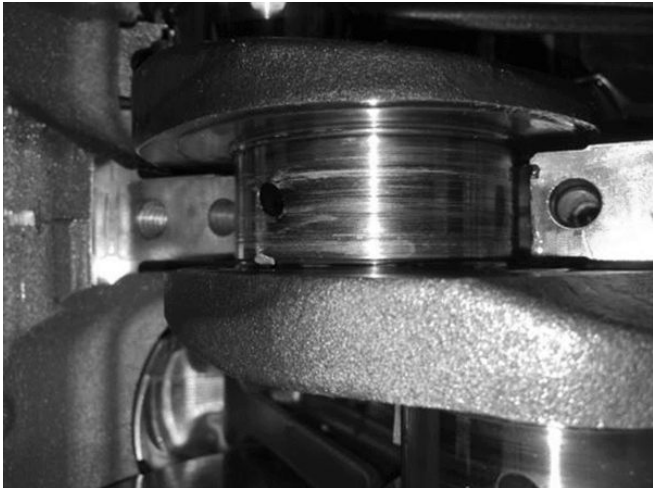
Example of minor scratching/scoring visible on crankshaft. In this example, the scored components can be replaced without need for engine assembly replacement.

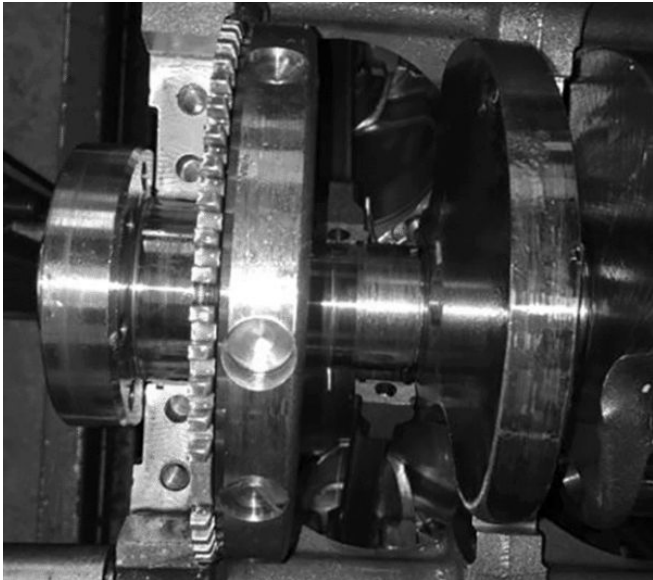
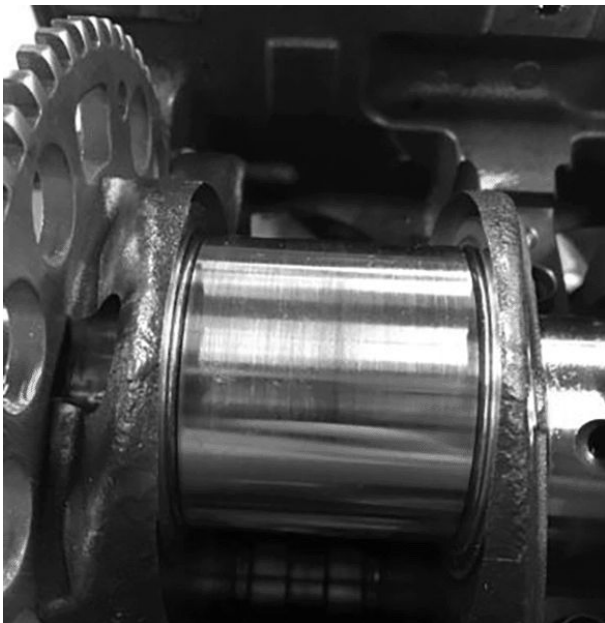
Example of minor scratching/scoring visible on crankshaft. In this example, the scored components can be replaced without need for engine assembly replacement.

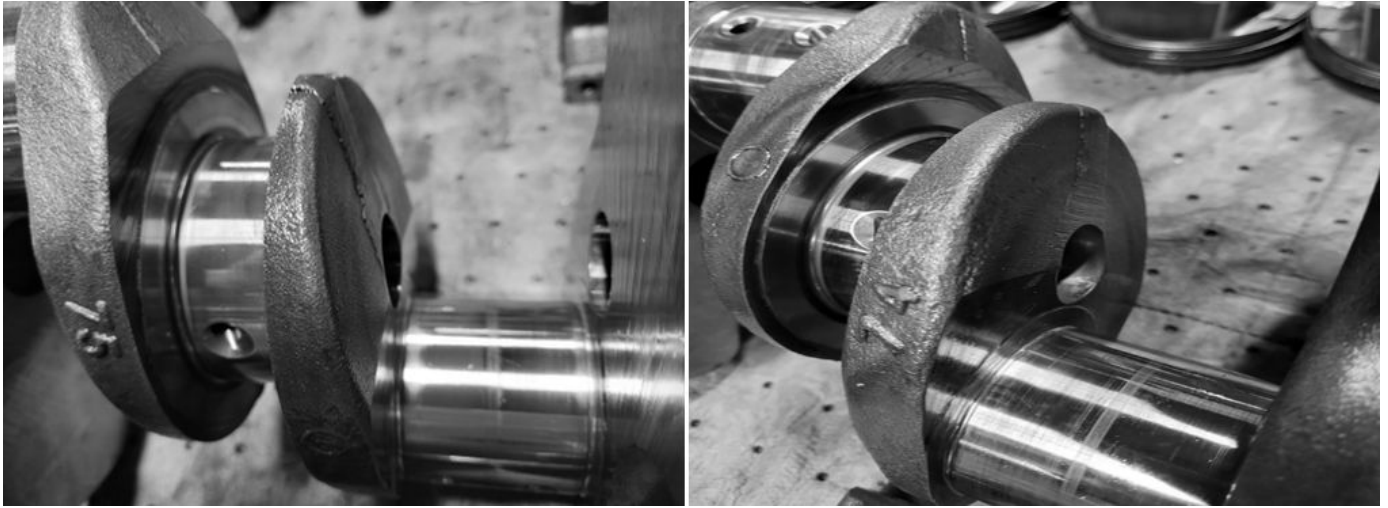
6719801

Example of crankshaft bluing on the counterweights. In this example, the bluing is caused from the heat-treating process and is not an indication of a damaged crankshaft. These crankshafts can be reused.

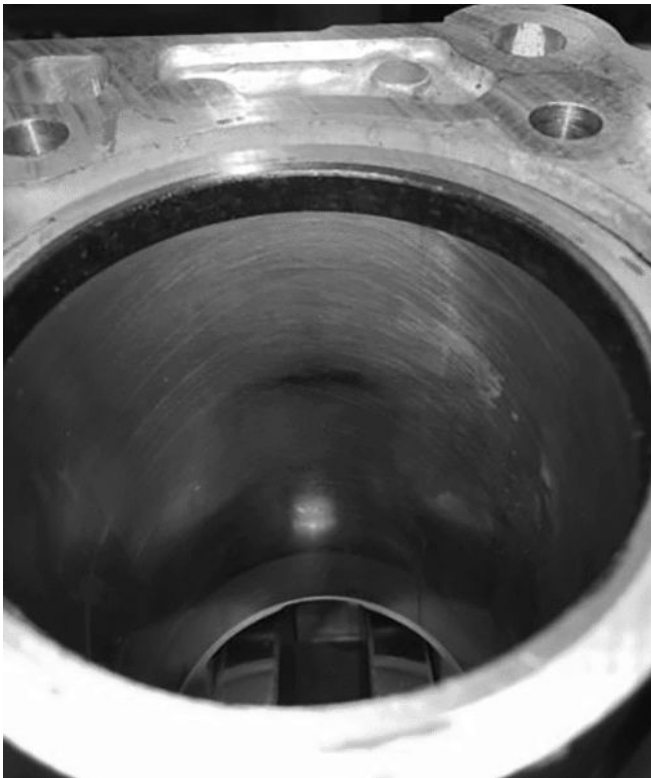
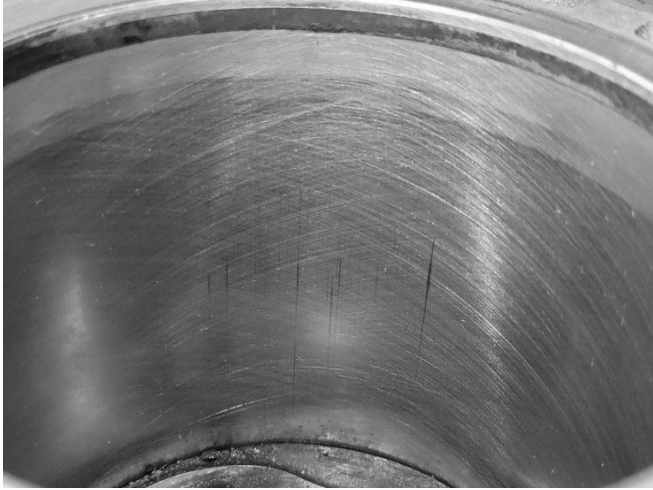
Example of minor scratching/scoring visible on cylinder wall. In this example, if you cannot catch a pick or fingernail on the scratch, the cylinder bore/engine block does not require replacement. If the piston is slightly scored, the scored piston can be replaced without need for engine assembly replacement.

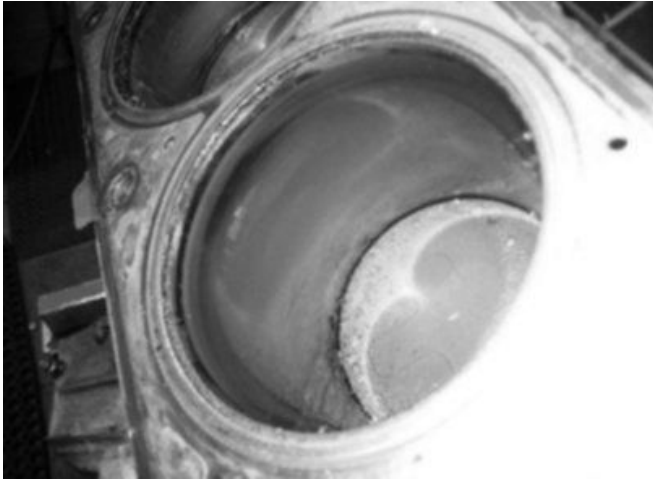
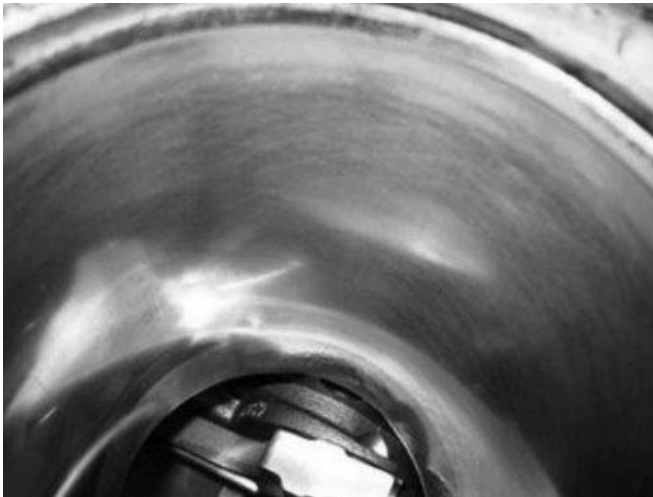
Suspecting an engine block of possible cylinder bore damage, scoring or out of round as the possible cause of engine oil consumption, misfire, cylinder leakage or blow by.

Note: The peak to valley suspecting an engine block of possible cylinder bore damage, scoring or out of round as the possible cause of engine oil consumption, misfire, cylinder leakage or blow by. spec for crosshatch is .65-2.8 microns. Any deviation and the crosshatch will be gone even if a cylinder is suspected of being oversize, we can only confirm that by checking with an air gauge at the engine plant.

1. Cylinder damage or scoring – The cylinder walls will contain grooves deep enough to catch with a fingernail.
2. Out of round cylinder bore – Contains areas where the crosshatch is missing or worn from different sections of the cylinder bore. If there is crosshatch all the way around the bore from top to bottom, the cylinder bore is not out of round.

3. Dirt intrusion – If the filtering system has been compromised, the engine will wear out very quickly. You will find grit in the intake runners and the cylinder bores will look lightly sand blasted. The crosshatch will be faint and there will not be sharpness. At high mileage this may not be Warrantable if the air filtering system has been opened numerous times for service in dusty climates.
4. Catalytic converter failure – If a converter fails and the brick is broken, the dust can be drawn back into the engine. A block showing this type of failure will have bores that look to be sand blasted. Back cylinders go first if caught early. Otherwise, there will be no crosshatch and the engine will need to be replaced.

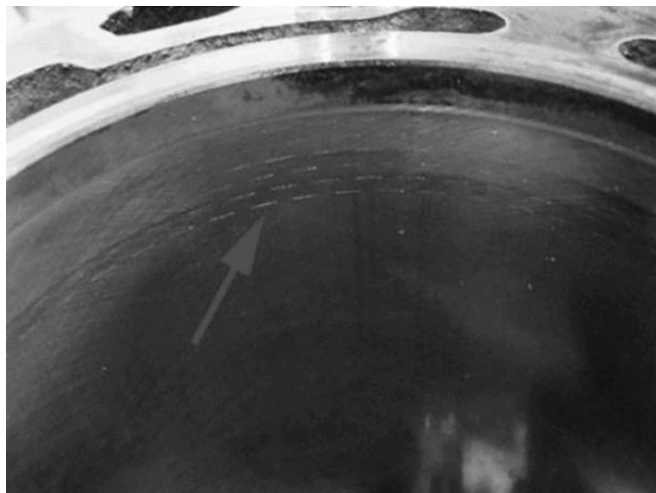
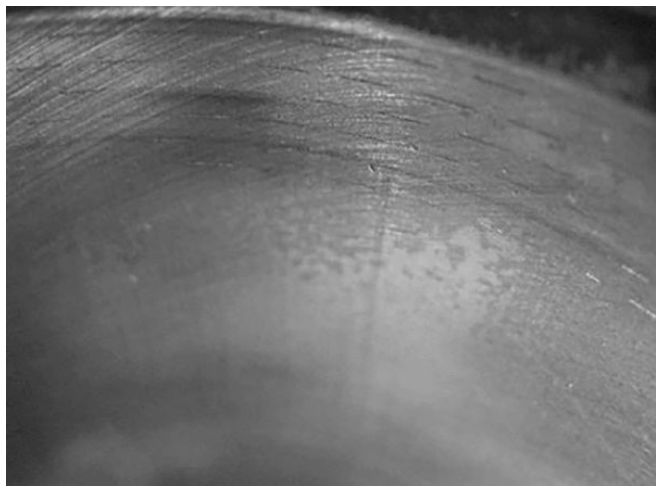
Some technicians may be replacing entire engine assemblies due to marks found at the top of the cylinder bore. These marks are considered normal and are left as a result of a manufacturing laser honing process. **DO NOT** replace the cylinder block or the engine for these normal laser honing marks (refer to PI0725B).

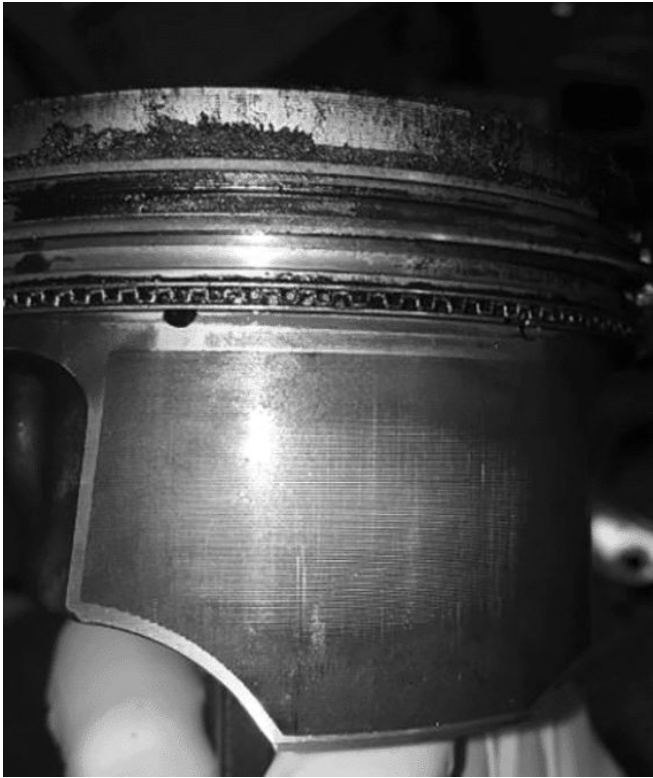
4992916

Example of minor scratching/scoring visible on piston. In this example, inspect for broken and/or stuck rings and piston ring lands and cylinder wall for damage. If no cylinder wall damage or other significant damage, components can be replaced without requiring an engine assembly replacement.

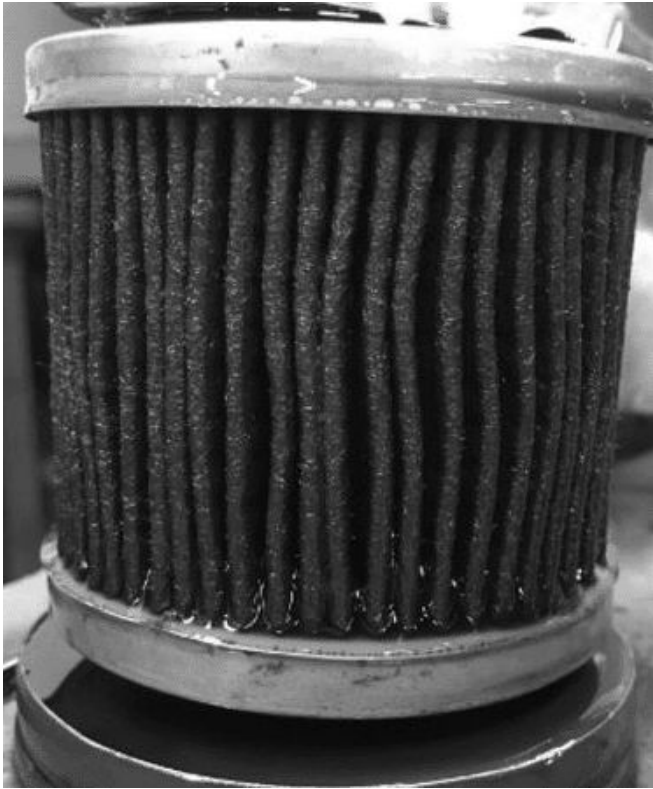
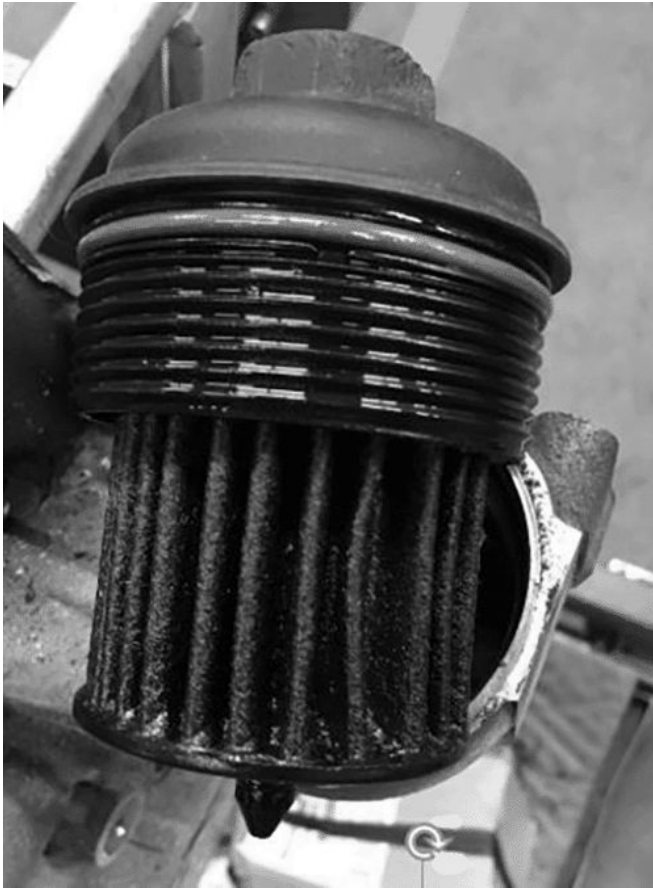
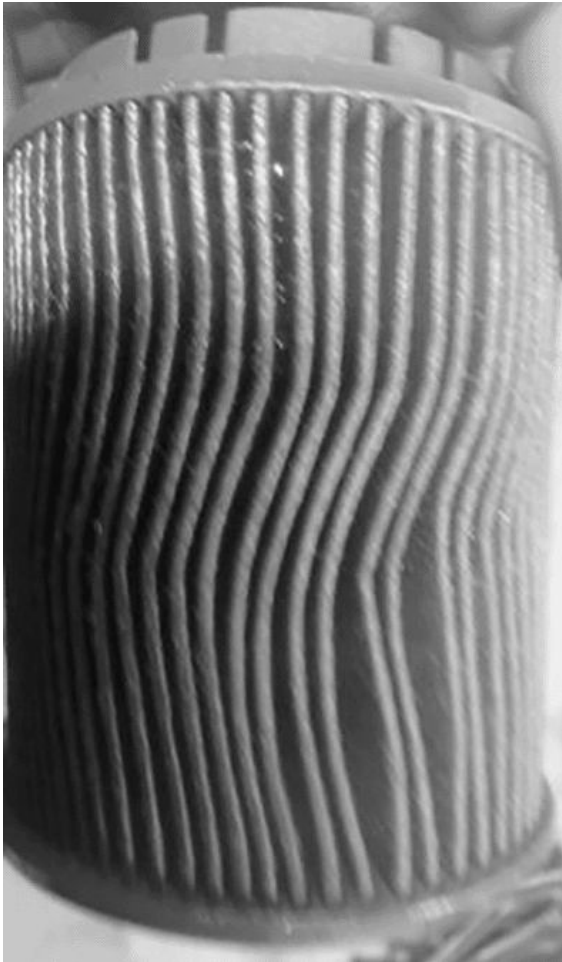
4994408

Shown are oil filter pleats with visible metal particles.

In this example, minimal amounts of metal particles are visible on oil filter pleats and should not pose a concern. When inspecting the pleats of an original oil filter it is normal to find small pieces of debris or very light glitter. This is build debris that has been flushed out of the engine assembly. Do not replace the engine if this is noticed. If the debris is questionable, then perform an oil change and then reinspect at the next service interval.

If excessive amounts of metal particles are observed, or if there is evidence of damaged oil filter pleats, then unfiltered oil with bearing debris may have been pumped into the oil lubrication galleries throughout the engine. This will require further inspection to confirm the degree of contamination and appropriate repair direction. Refer to Service Bulletin #19-NA-256 for HFV6 Gen 1 and Gen 2.
