# HYUNDAI

## Technical Service Bulletin

GROUP <b>BODY</b>	NUMBER <b>24-BD-012H</b>
DATE <b>OCTOBER 2024</b>	MODEL(S) <b>IONIQ 5 (NE EV)</b>

**SUBJECT:** TAILGATE RATTLE & FRICTION NOISE REWORK

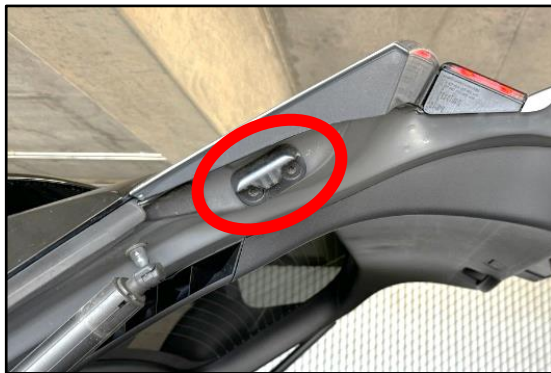
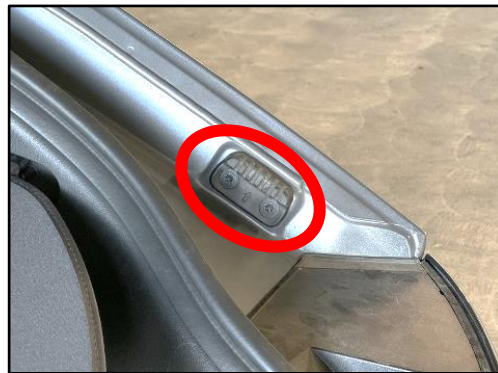
**Description:** Certain IONIQ 5 (NE EV) vehicles may exhibit rattle and friction noises from the tailgate while driving. This bulletin provides instructions to adjust the gap between the tailgate and vehicle body to eliminate the rattle and friction noise.
